## Do not Wait to Apply the Engine Fire Procedure

Several recent engine fire events highlight the importance of timely application of the engine fire procedure.

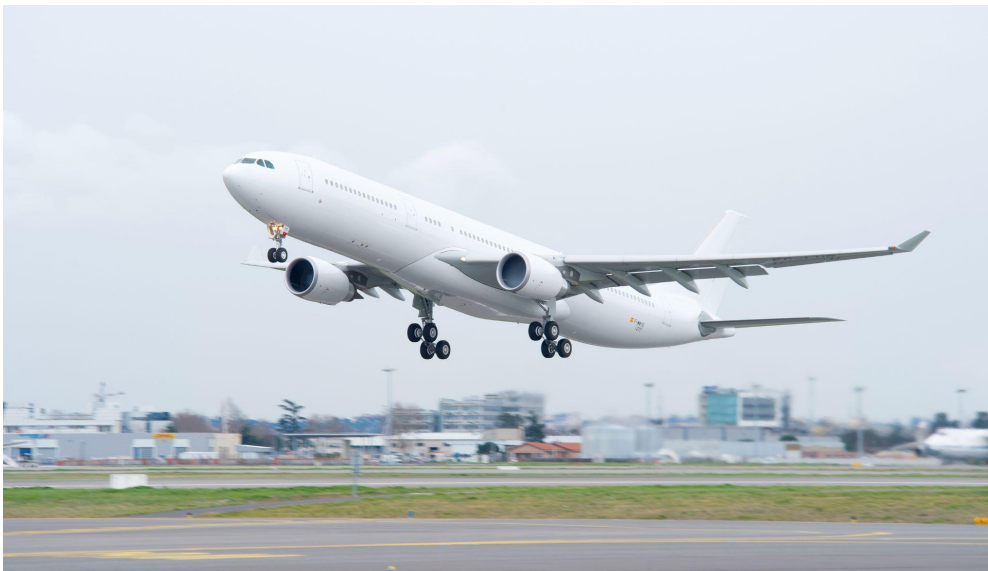
An A330 aircraft departed for a long-range flight. The aircraft was in CONF 2 for the takeoff. The takeoff roll was normal, but the **ENG 2 FIRE** red ECAM alert triggered (**T0**) 17 s after liftoff. The flight crew continued the climb. The engine display showed stable engine parameters for both engines.

**At T0 + 51 s**, the aircraft reached 2 400 ft RA. The PF set the engine 2 thrust lever to IDLE and pushed the engine 1 thrust lever to TOGA.

**At T0 + 52 s**, the PF set the engine 1 thrust lever to MCT and this caused the autothrust to engage in thrust mode.

**At T0 + 2 min 27 s**, the flight crew set the engine 2 master lever to OFF.

**At T0 + 2 min 43 s**, the flight crew pressed the ENG FIRE pushbutton and discharged AGENT 1 followed by AGENT 2. The **ENG 2 FIRE** alert remained after both agents were discharged.

**At T0 + 9 min 39 s**, the EGT indication for engine 2 started to increase, even though it had shown decreasing EGT from the time when the engine 2 master lever was set to OFF.

**At T0 + 10 min 03 s**, the **ENG 2 FIRE** alert stopped and the **ENG 2 FIRE DET FAULT** amber ECAM alert triggered.

**At T0 + 11 min 23 s**, the **ENG 2 EGT OVERLIMIT** amber ECAM alert triggered when engine 2 EGT reached 600 °C.

**At T0 + 15 min 09 s**, the engine 2 N1 value became invalid.

**At T0 + 17 min 35 s**, the engine 2 EGT reached a peak value of 801 °C.

**At T0 + 25 min 02 s**, the aircraft touched down on the runway and safely came to a stop. Smoke and flames coming from engine 2 were seen. The fire brigade arrived and extinguished the fire.

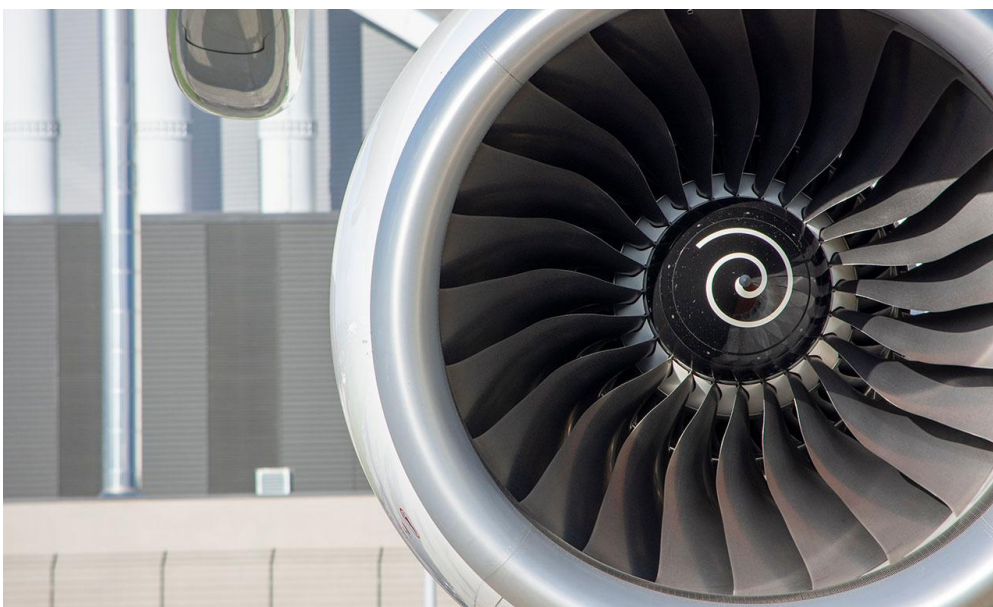
Investigation enabled Airbus to conclude that the most probable cause of the engine fire was a leak from the green hydraulic circuit, which may have been due to damage on a green hydraulic line during maintenance.

During this event, the engine 2 thrust lever was not set to IDLE until 51s after the **ENG 2 FIRE** alert was triggered. A further 1m 36s passed (T0 + 2m 27s) before the ENG FIRE procedure was completed to isolate the fire and use the fire extinguishing system.

The engine indications in the cockpit appeared to show that engine 2 operation was normal. This may have been a factor in the flight crew's decision to delay application of the engine fire procedure.

Analysis showed that the engine fire extinguishing system operated as intended and both extinguisher bottles correctly discharged during the event. It is likely that the fire reignited shortly after extinction due to remaining conditions for fire reignition in the nacelle.

The EGT increased up to 801 °C, which is a sign that the fire spread toward the EGT thermocouples. The fire continued to cause destruction of the fire detection loops and damage to wiring. This was the reason the **ENG 2 FIRE** ECAM alert stopped and was replaced by the **ENG 2 FIRE DET FAULT** amber alert. Note that this alert was in the overflow part of the warning display, indicated by a green arrow.

Similarly, the loss of the N1 information was due to damage to wiring. ■

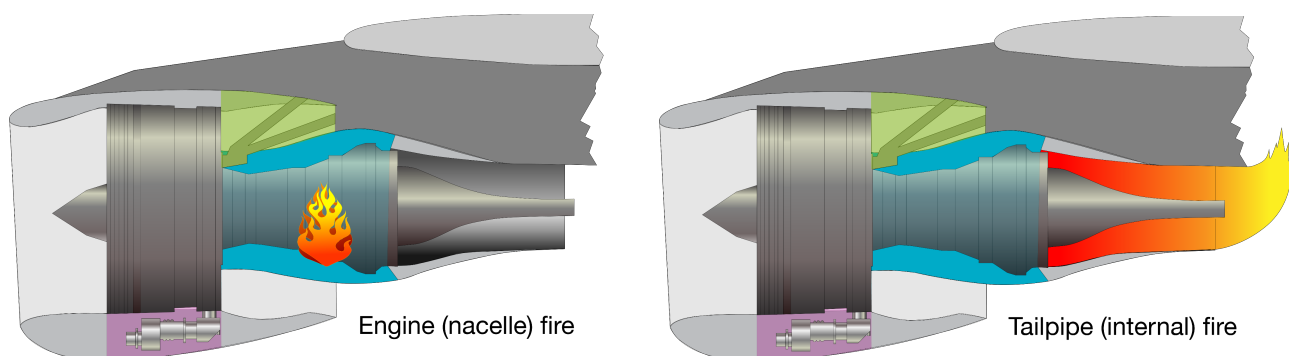
**(fig.1)** Engine fire vs Tailpipe fire

There are two types of engine fire (**fig.1**): an engine fire (nacelle fire) and tailpipe fire (internal fire) . Both types of fire affect the engine, but must be treated differently.

An engine fire affects the external part of the engine core, but is contained within the engine nacelle. This type of fire can occur on ground or in flight and is usually caused by a malfunction or rupture of a component or pipe, which contains flammable liquids (e.g. fuel, oil, hydraulic fluid). When these liquids come into contact with hot surfaces on the engine case, such as the high pressure compressor, combustor, or turbine, they can self-ignite and cause a fire. This type of engine fire can also be caused by rupture of a part of the engine core causing damage to components and pipes, which can lead to a fire.

A tailpipe fire occurs inside the engine core. This type of fire will only occur during the engine start or shutdown sequence. A tailpipe fire occurs when the engine rotates at a very low speed and residual fuel is present in the combustion chamber or turbine area, or if there is an oil leak in the tailpipe of the engine. The risk of tailpipe fire is higher in the case of a second engine start attempt, because residual fuel may remain in the engine after the first attempted engine start.

The fire detection system does not detect tailpipe fires, because they occur inside the hot sections of the engine core, and therefore, are outside of the fire detection zone. Flight crews can detect tailpipe fires by observing any abnormal increase in EGT during the engine start sequence or if the EGT does not decrease after engine shutdown. Ground crew, cabin crew, or air traffic controllers may also observe a tailpipe fire and must inform the flight crew.

The engine fire protection system will detect the fire and trigger the red **ENG X FIRE** ECAM alert (**L ENG FIRE** or **R ENG FIRE** on A220 aircraft). The flight crew must apply the associated engine fire procedure without delay.

In the case of a tailpipe fire, the flight crew must apply the **ENGINE TAILPIPE FIRE** abnormal procedure from the QRH. This will ventilate the engine, and the airflow will extinguish the fire and remove any residual fuel or vapor from the engine. On the A220, a tailpipe fire procedure is under study to be introduced in the QRH/FCOM.

After any tailpipe fire, inspection by maintenance is required to check that there is no flame damage to the flaps, wing, or pylon areas. ■

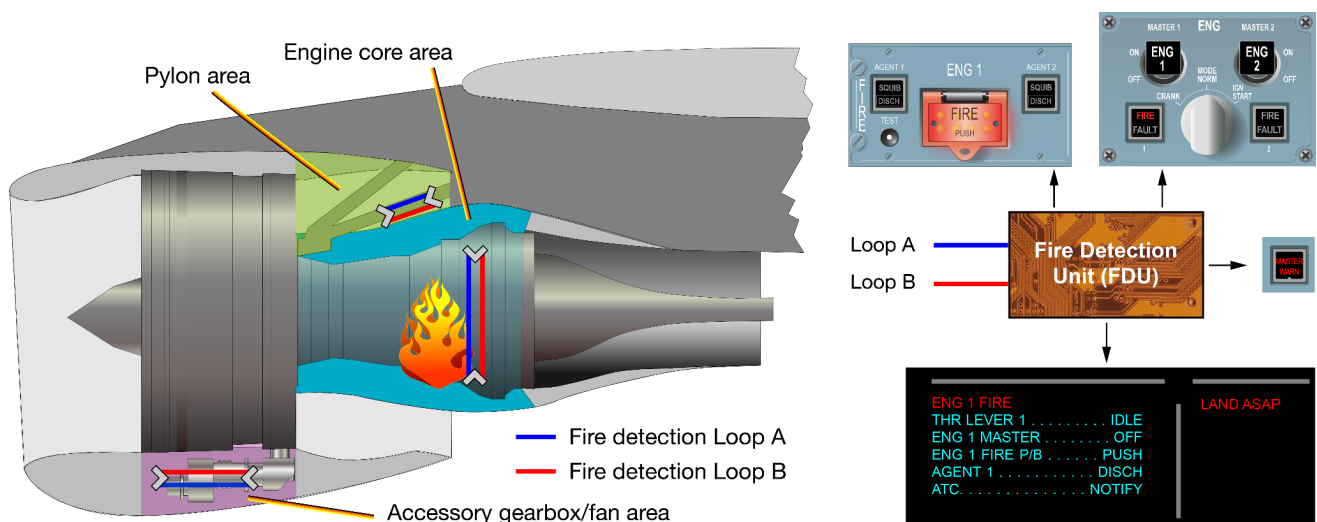
(fig.2) Example of engine fire detection system on an A320 aircraft with CFM engines

The detection system for engine fire is composed of dual sensing element loops. They are located in the areas around the engine with the highest risk of fire and near compartment air exhausts for overheat detection. These are zones where flammable liquids are present with a potential ignition source, such as the accessory gearbox area, the pylon area above the combustion chamber, the combustion chamber area, and the fan area on certain engines. Each loop is doubled (loop A and loop B) for redundancy purposes. The loops can detect fire or hot air leaks.

The design and redundancy of the detection loops ensure a high level of reliability for the engine fire detection system. In the event of an engine fire alert, the flight crew must rely on it.
