# Don't Forget to Check the Alternate

Pre-flight checks are essential to detect any hidden failure before the flight.

This article explains why failing to perform the pre-flight check may prevent the detection of a hidden failure of the alternate braking system. It also includes maintenance recommendations for troubleshooting when the flight crew reports the failure of an alternate braking test.

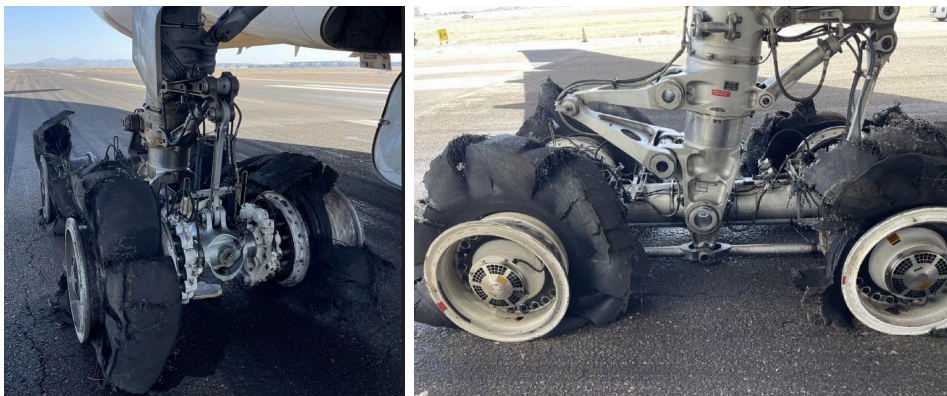
All tires of the main landing gear burst **(fig.1)**. Damage occurred to the main landing gear, the main landing gear doors, the forward water drain mast and the left engine.

**(fig.1)** All wheels of the main landing gear burst during the event (images from the investigation board)

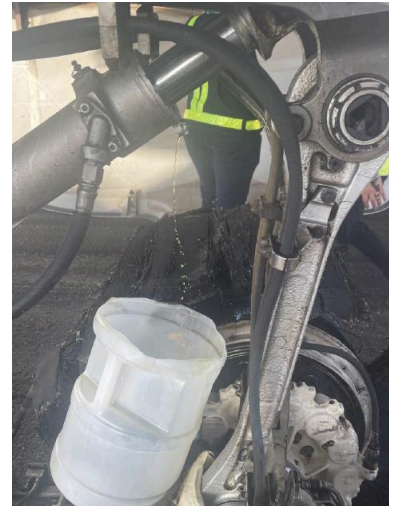
The loss of the normal braking system during flight was caused by the failure of the green hydraulic system. An overpressure inside the pitch trimmer actuator of the right main landing gear bogie resulted in the crushing of its piston rod, which caused an hydraulic leak (**fig.2**).

This type of damage on the pitch trimmer actuator can result from shocks caused by a damaged runway at the departure airport.

**(fig.2)** Visible hydraulic leak on the actuator of the pitch trimmer of the RH main landing gear (photo from the investigation board)

An enhancement of the pitch trimmer actuator is available to prevent this type of damage. Refer to the Technical Follow-Up **TFU 32.11.00.018** available on the AirbusWorld portal for more information.

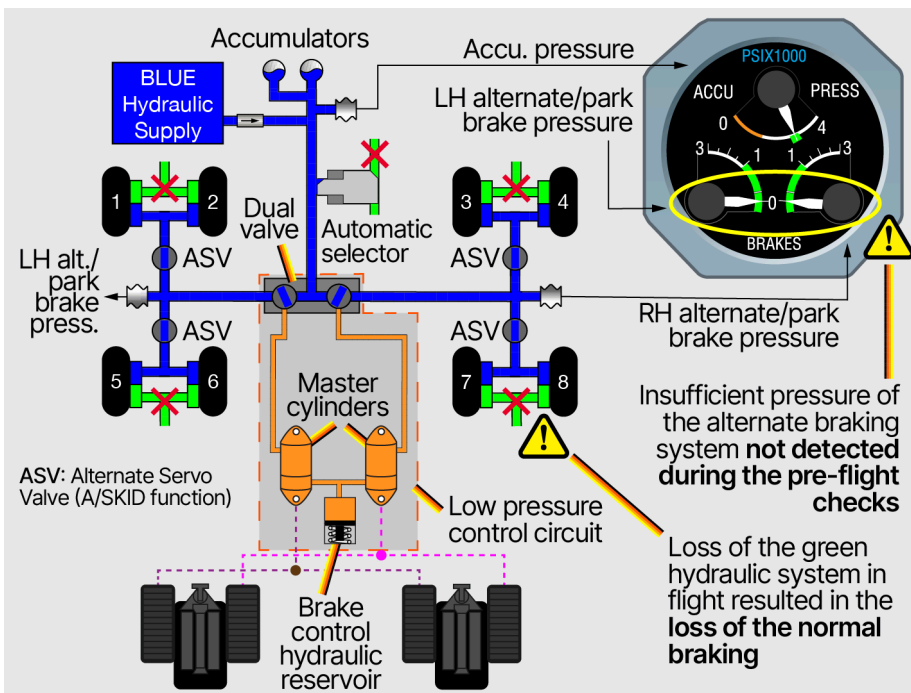
Recorder data analysis indicated that when the flight crew performed the pre-flight check of the alternate braking system, the pressure only reached a maximum of 416 psi instead of the expected value between 2200 and 2700 psi. Despite this low pressure value, the flight crew proceeded with the flight without seeking maintenance intervention, allowing the aircraft to take off with an inoperative alternate braking system.

The combination of the undetected alternate braking system malfunction during the pre-flight checks, with the in-flight failure of the normal braking system, caused the loss of braking during the landing roll. Consequently, the flight crew could only rely on the parking brake to stop the aircraft during the landing roll.

**(fig.3)** An undetected insufficient pressure of the alternate braking system during the pre-flight checks, combined with a loss of normal braking caused by a leak on the green hydraulic system during flight, are at the origin of the event.

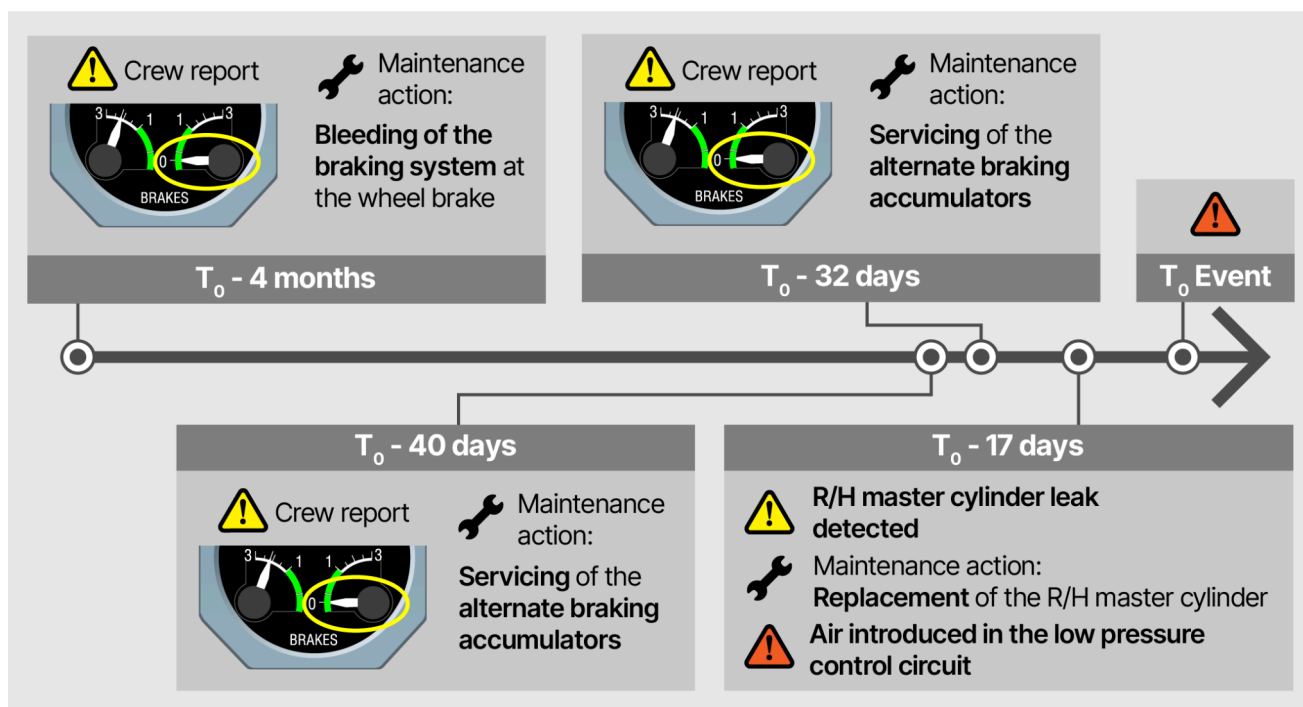
Analysis of the aircraft maintenance records indicates that several malfunctions of the alternate braking system were reported during the four months before the event (**fig.4**). Three separate flight crew reports of a low brake pressure indication on the right side during the check of the alternate braking system were recorded, including one with a "spongy" right brake pedal.

Each time either the high-pressure circuit of the alternate braking system at the wheel brakes was bled, or the nitrogen charge pressure of the brake accumulators was adjusted. This did not address the issue.

17 days before the event, maintenance personnel found a leak on the right master cylinder, which was probably the root cause of the previous low alternate braking pressure events on the right side. The cylinder was replaced by a new one.

Investigation revealed the presence of air in the low pressure control circuit of the alternate braking system that caused the insufficient pressure on both sides of the alternate braking system during the event.

An incorrect servicing of the low pressure control circuit after the installation of the new master cylinder is most probably the cause of the introduction of air in the system. ■

(fig.4) Sequence of maintenance actions performed before the event

Application of the appropriate TSM task in the case of reported low alternate brake pressure (TSM 32-43-00-810-807-A "Brakes - Alternate-Braking Pressures Do Not Get to 2200 psi When Brake Pedals Applied (with Blue Hydraulic System Depressurized)") would have helped the maintenance personnel to identify and fix the issue.
