# Engine Relight After an All-Engine Flameout

An all-engine flameout is one of the most stressful situations where flight crews need to urgently relight the aircraft engines. Incorrect application of the engine relight sequence can lead to delayed or unsuccessful engine restarts.

This article describes an in-service event in which such a situation was encountered. It recalls the various steps of the engine relight sequence in the ALL ENG FAIL procedure of the QRH and highlights the improvements that have been made on the operational procedure of A300, A310, A320 family, A330, A340, A350 and A380 aircraft.

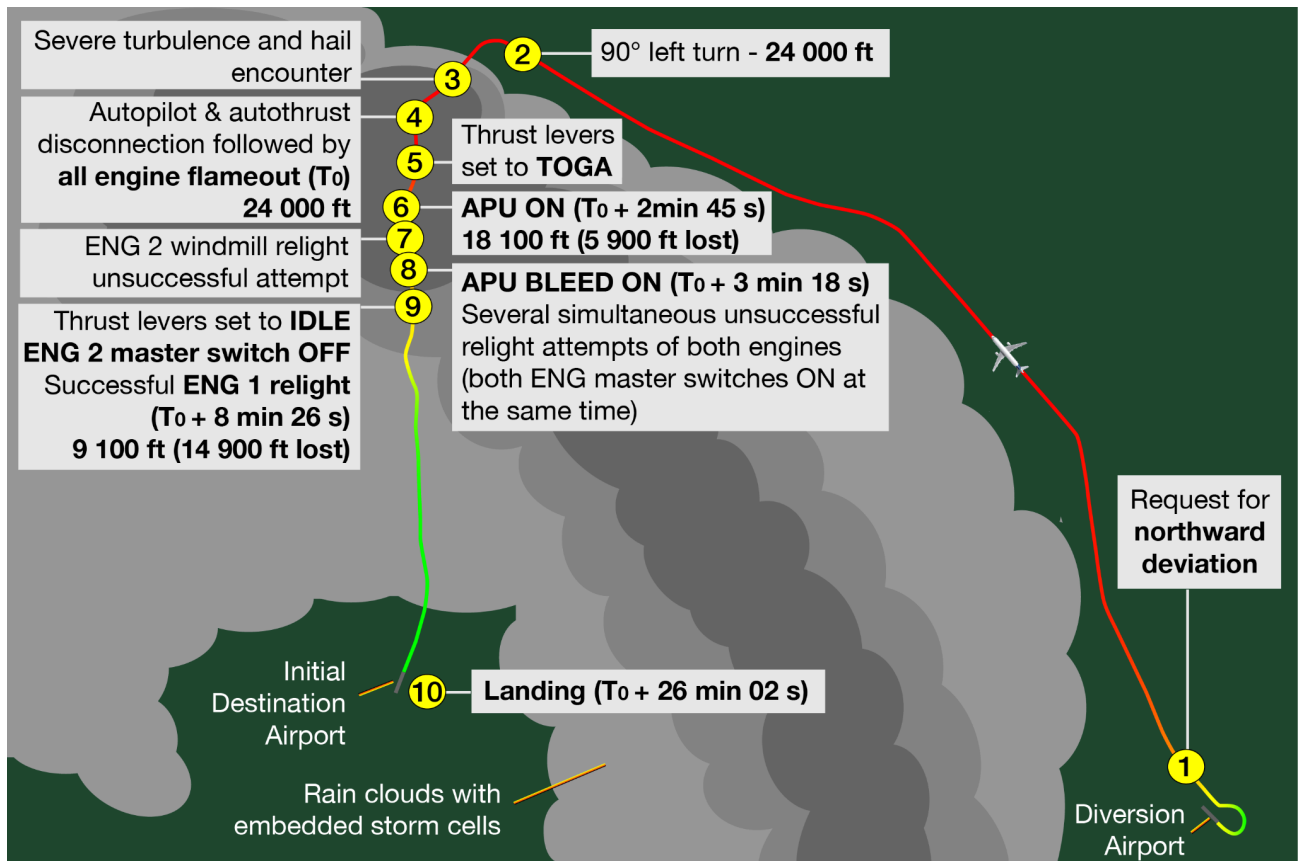
(fig.1) Lateral trajectory of the aircraft during the event

During the night flight, persistent adverse weather remained along their route. ① The flight crew requested a northward deviation to avoid storm cells that they detected on their weather radar. ② The aircraft was cruising at FL 240 with autopilot and autothrust ON when the flight crew executed a 90° left turn toward their final destination.

③ Shortly after the turn, the aircraft encountered severe turbulence and hail. Loud impact noises were heard, and both the left and right windscreen sustained damage. Several ECAM alerts were triggered, including **ANTI ICE R WINDSHIELD**, **ANTI ICE L WINDSHIELD**, **ENG 1 STALL**, **NAV RA 2 FAULT**.

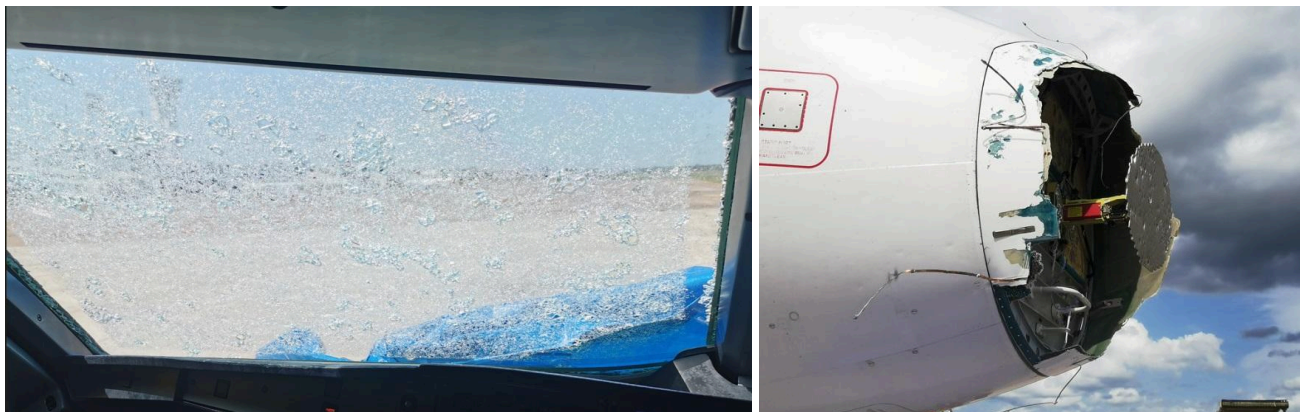
(fig.2) View of the damaged windshield and radome after the event (photos: Investigation Board)

When the aircraft came to a stop, the crew assessed the aircraft's damage, including a destroyed radome.

Radome damage disrupted airflow around the air data probes, causing unreliable airspeed indications and reversion to the ALTERNATE flight control law.

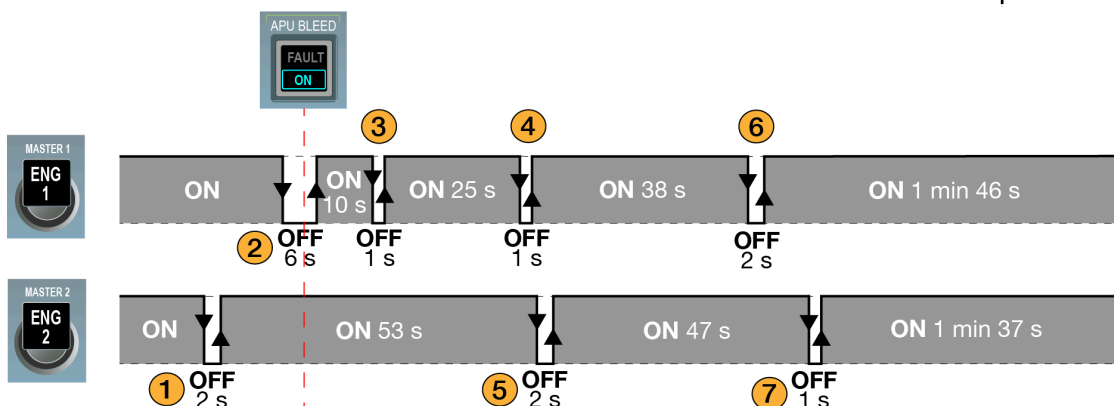
(fig.3) Sequence of unsuccessful relight attempts during the event

The thrust levers remained in the TOGA position during seven relight attempts. The **ALL ENG FAIL** QRH procedure requires setting the thrust levers to IDLE before attempting to relight the engines.

① The flight crew cycled the ENG 2 master switch OFF then ON 2 s later. ② They switched the ENG 1 master switch to OFF. APU BLEED was set to ON shortly after. The ENG 1 master switch was then set back to ON 6s after being switched OFF. 10 s later, ③ the ENG 1 master switch was cycled OFF then ON. 25 s later, both ④ ENG 1 and ⑤ ENG 2 master switches were cycled OFF then ON. The flight crew then ⑥ cycled ENG 1 master switch again shortly followed by ⑦ ENG 2 master switch. All relight attempts were unsuccessful. The thrust levers remained in the TOGA position.

These Simultaneous starter-assisted relight attempts failed due to the fact that APU bleed provides sufficient air pressure to restart only one engine at a time. It was observed that no ventilation of 30s was performed between each relight attempt.

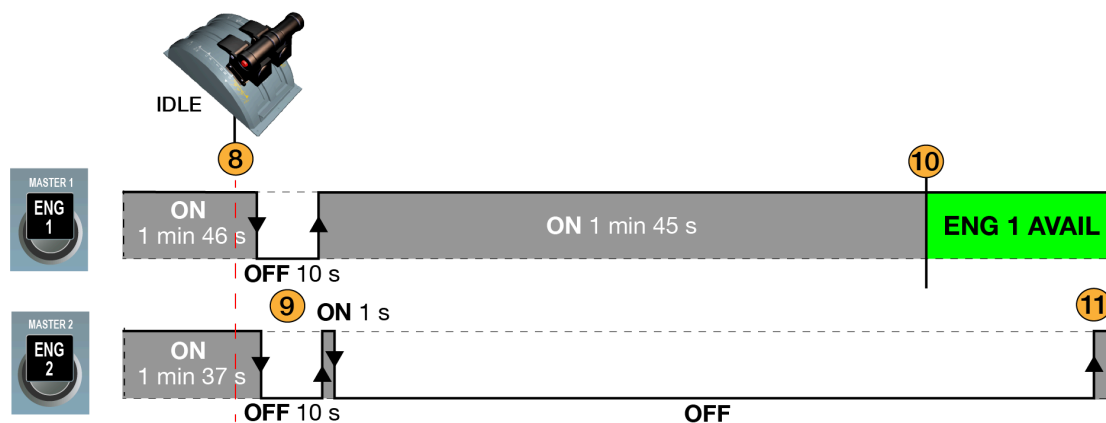
(fig.4) Successful ENG 1 relight

⑧ The crew then set the thrust levers to IDLE and ⑨ set both engine master switches to OFF. The ENG 1 master switch was set back to ON, while the ENG 2 master switch was briefly set to ON then back to OFF. Within 1 minute and 45 seconds, ENG1 N2 and EGT increased and ⑩ ENG1 successfully restarted.

The ENG 2 master switch being OFF enabled sufficient bleed pressure to be delivered to ENG 1 starter for a successful relight.

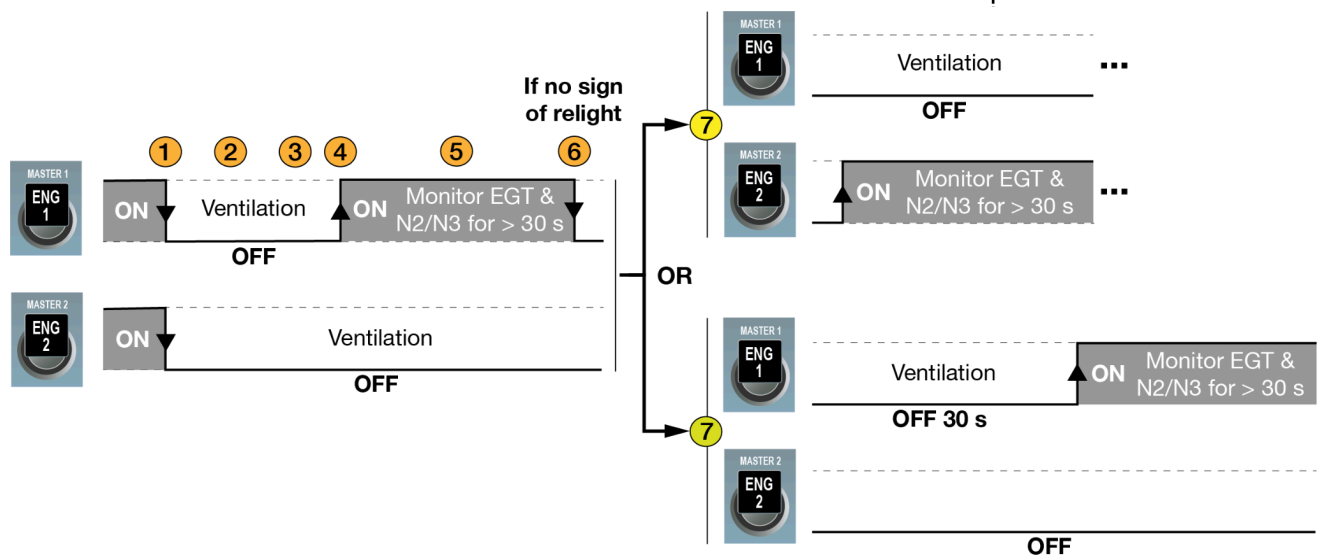
**(fig.8)** Starter-assisted relight sequence (one engine at a time)

The APU cannot provide sufficient bleed pressure to relight two (or four) engines at the same time. On A380 aircraft, the relight attempt can be done on two engines simultaneously.

**The flight crew must attempt to relight only one engine at a time during a starter-assisted relight on A300, A310, A320, A330, A340 and A350 aircraft.**

If there is no sign of relight within 30 s, the flight crew should switch the engine master switch back to OFF to ventilate the engine.

If the flight crew wants to relight the same engine if the other engine is damaged, they have to wait for 30s with the master switch to OFF until the engine is ventilated.
