# Fuel Leak Management in Flight

A fuel leak can have serious consequences, especially because of the risk of fire and fuel starvation. When a fuel leak is detected, it is essential to follow the operational procedures to maintain the safety of the flight. This article highlights how to detect and confirm a fuel leak on A300-600, A310, A320 family, A330, A340, A350, and A380 aircraft. It also recalls which actions to perform, especially shutting down the engine in the case of an engine fuel leak to prevent any risk of engine fire. Fuel leak management for A220 aircraft will be addressed in a future article.

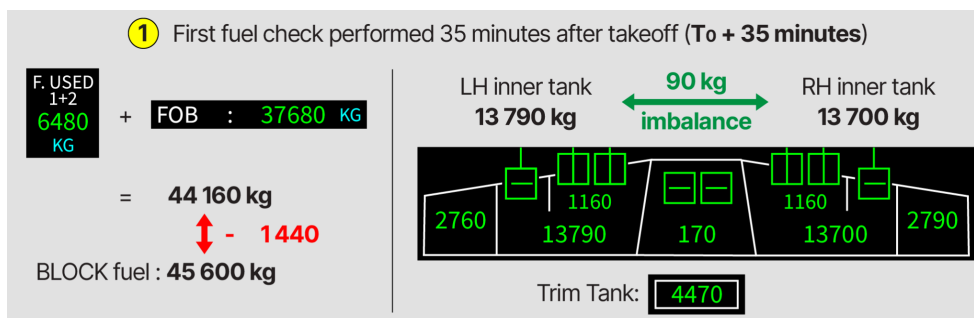
① The first fuel check showed a Fuel On Board (FOB) value of **37680 KG** with an indicated fuel used quantity of **6480 KG**. Their sum represented a **discrepancy of 1 440 kg** with the BLOCK fuel value. A non-significant lateral fuel imbalance between the two inner tanks (90 kg) was displayed. The captain attributed the 1.4 T fuel quantity discrepancy to the ongoing fuel transfers from the inner wing tanks to the trim tank and suggested monitoring the evolution of the fuel quantity.

(fig.1) First fuel check performed during the event

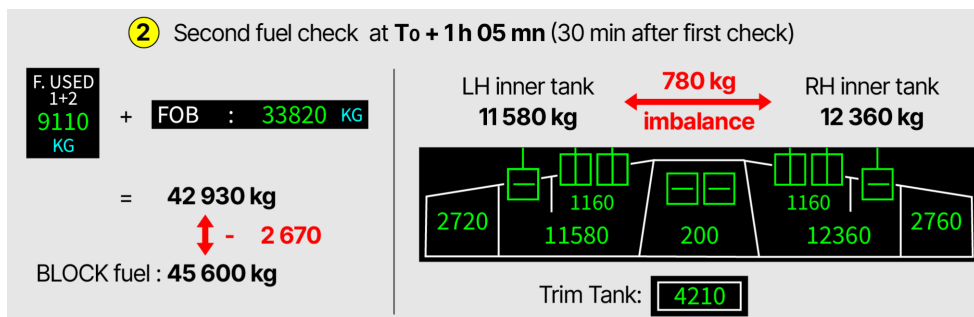
② 30 minutes later (**T0 + 1 h 05 mn**), the flight crew noticed that 2 670 kg of fuel was missing with an imbalance of 780 kg indicating a possible fuel leak on the left side.

(fig.2) The flight crew noticed an increase in fuel loss and a significant imbalance

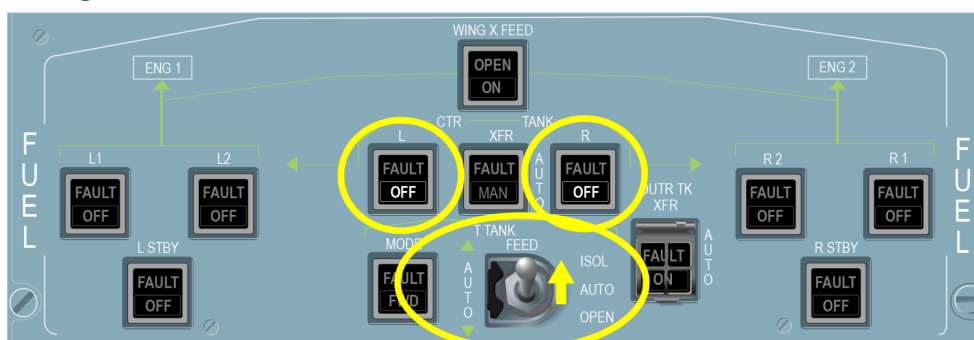
The flight crew initiated the FUEL LEAK QRH procedure: ③ They maintained the crossfeed valve closed, set the L CTR TANK and R CTR TANK pushbutton switches to OFF, and set the T TANK FEED selector to ISOL. The procedure then requests that the flight crew monitor the fuel depletion rate of each inner tank.

(fig.3) The flight crew applied the first step of the FUEL LEAK procedure to isolate the tanks

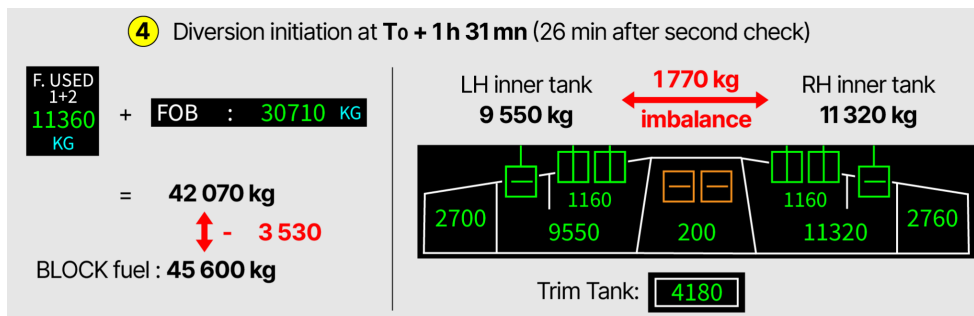
④ 26 minutes later (**To + 1 h 31 mn**), 3 530 kg of fuel was missing and there was an imbalance of 1 770 kg (+990 kg in 26 minutes) between the two inner tanks. Given the significant fuel imbalance, the FUEL LEAK QRH procedure requests that the affected engine be shut down. The flight crew initiated a diversion and decided to keep the left engine running.

(fig.4) The fuel imbalance increased by almost 1 ton within 26 minutes with the tanks isolated

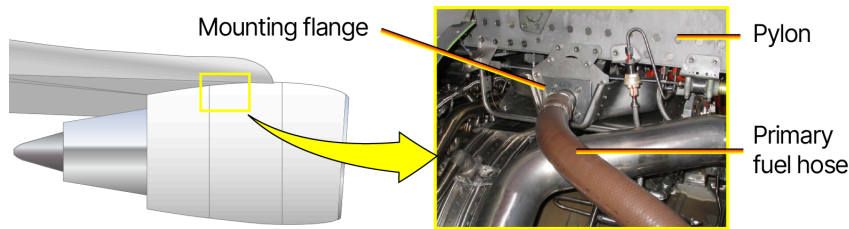
Examination of the engine showed that the fuel leak was located downstream of the LP valve, at the interface between the left pylon and the left engine (fig.5). The primary fuel hose, which brings fuel from the pylon to the engine, was not correctly installed. Its mounting flange that connects it to the pylon was not correctly aligned. Vibrations caused the flange to move and created a leak.

**(fig.5)** Location of the engine leak during the event

The Aircraft Maintenance Manual (AMM) task 73-11-46-400-801-A "Installation of the Primary Fuel Hose" provides specific recommendations to prevent any incorrect installation with the associated risk of assembly distortion.

In addition, the engine manufacturer designed an improved mounting flange to limit the possibility of a mounting flange alignment error. This improved design can be installed by the Airbus Service Bulletin 73-3066.

Technical Follow Up **TFU 73.11.00002** is also available on Airbusworld with further information.

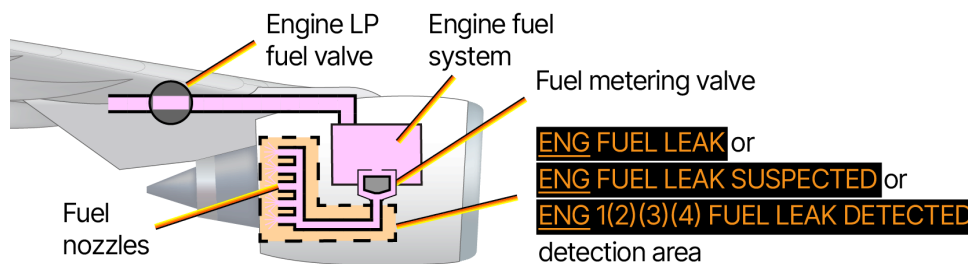
In the previous case study, the fuel leak was located downstream of the LP valve but upstream of the fuel metering valve, therefore, the **ENG FUEL LEAK** alert could not be triggered. ■

**(fig.7)** The engine fuel leak automatic detector detects potential leaks downstream of the fuel metering valve

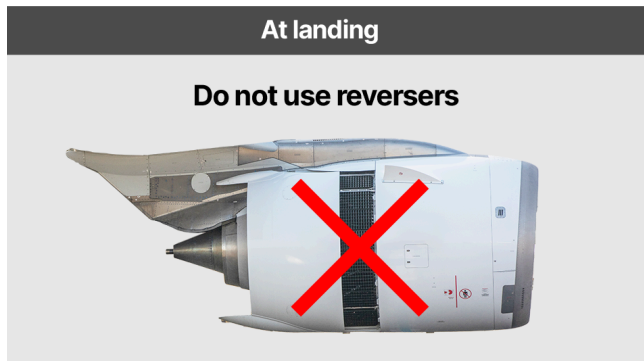
Thrust reversers must not be used at landing to avoid blowing the leaking fuel toward the engine air inlet or the hot brakes. This could cause the overheat of the engine, reduced performance of the brakes, and most of all the start of a fire in the engine or on the hot brakes. ■

**(fig.12)** Thrust reversers must not be used at landing
