# Fuel monitoring on A320 Family aircraft

# Safety first

**Safety first, #20** July, 2015. Safety first is published by Airbus S.A.S. - 1, rond point Maurice Bellonte - 31707 Blagnac Cedex/France. Publisher: Yannick Malinge, Chief Product Safety Officer, Editor: Corinne Bieder, Director Product Safety Strategy & Communication. Concept Design by Airbus Multi Media Support 20151274. Reference: GS 420.0045 Issue 20. Photos by Airbus, H. Goussé, Lindner Fotografie, A. Doumenjou, P. Pigeyre, P. Masclet, B. Sveinsson, C. Brinkmann, Aneese. Printed in France.

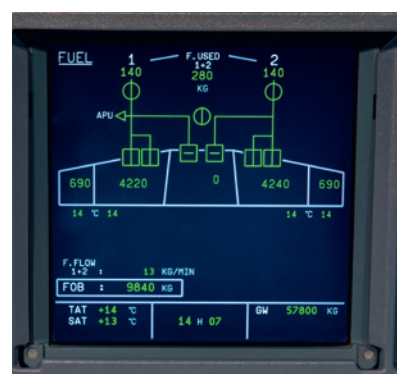
**(fig.1)**

Yet the information that is needed by pilots is the quantity of fuel on board expressed as a weight. The translation of fuel volume into fuel weight is performed by the FQIC using the fuel density measured by specific devices in each wing tank **(fig.1)**.

FUEL System page on Lower ECAM Display Unit

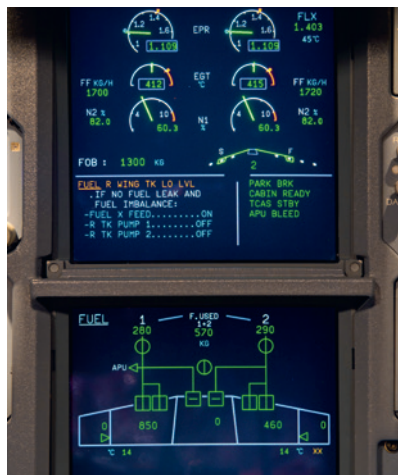
(fig.2)

Low level alert display on ECAM

become dry when the remaining fuel in the tank is approximately 750 kg. If two sensors in the same tank remain dry for more than 30 seconds, a low level alert triggers in the cockpit (fig.2).
