# Hard Landing, a Case Study for Crews and Maintenance Personnel

# Safety first

**Safety first**, #17 January 2014. Safety first is published by Airbus S.A.S. - 1, rond point Maurice Bellonte - 31707 Blagnac Cedex/France. Editor: Yannick Malinge, Chief Product Safety Officer, Nils Fayaud, Director Product Safety Information. Concept Design by Airbus Multi Media Support Ref. 20132304. Computer Graphic by Quat'coul. Copyright: GS 420.0045 Issue 17. Photos by Airbus, Teledyne Controls, ExM Company, master image. Printed in France by Airbus Print Centre.

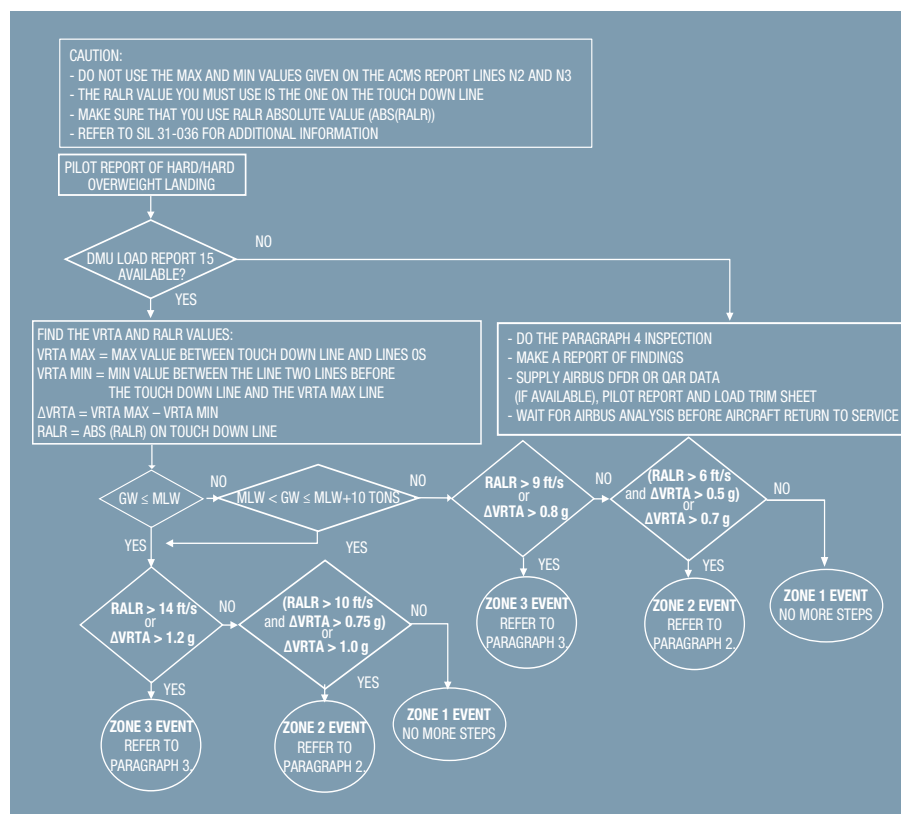
**Figure 2**  
Hard landing flowchart to be added to the A330/A340 AMM in April 2014

To avoid any possible confusion, A330/A340 AMM 05.51.11 will be amended in April 2014 to include:

- A modified wording of the first phrase of the above procedure, which now reads: "If load report 15 or the DFDRS data are not available or you cannot read them..."
- A flowchart to guarantee the same level of readability as on the A320 Family AMM (fig 2).

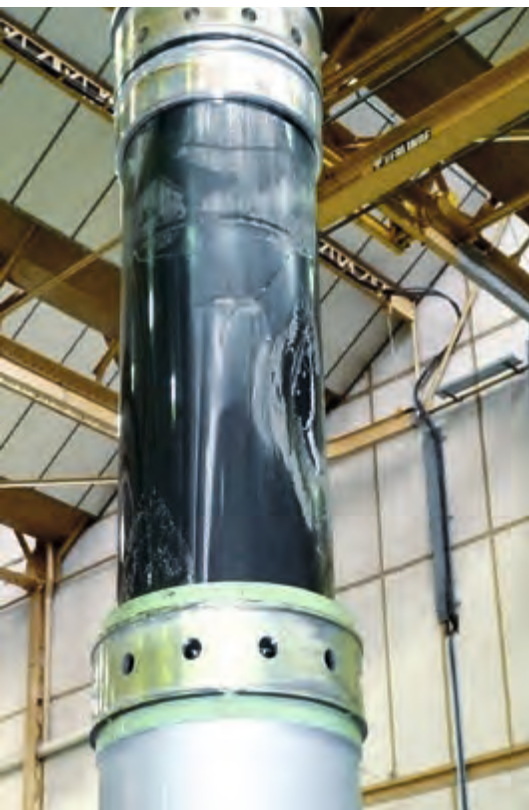
However, by 150 ft radio altitude, the aircraft is above the glide by more than one dot and two nose-down inputs are applied. The rate of descent increases to -1,100 ft/min and the EGPWS alert "SINK RATE" sounds twice, the second time below 50 ft. Despite a nose up input during the flare the aircraft impacts the ground at -1,260 ft/min with a vertical acceleration of 2.74 g.

After take-off, due to the damage sustained during the hard landing, the landing gear failed to retract and the flight crew elected to perform an In Flight Turn Back after enough fuel was burnt to land below MLW. The aircraft landed safely.

**Figure 3**  
Damage on the aircraft following the hard landing:  
aircraft's Landing Gear

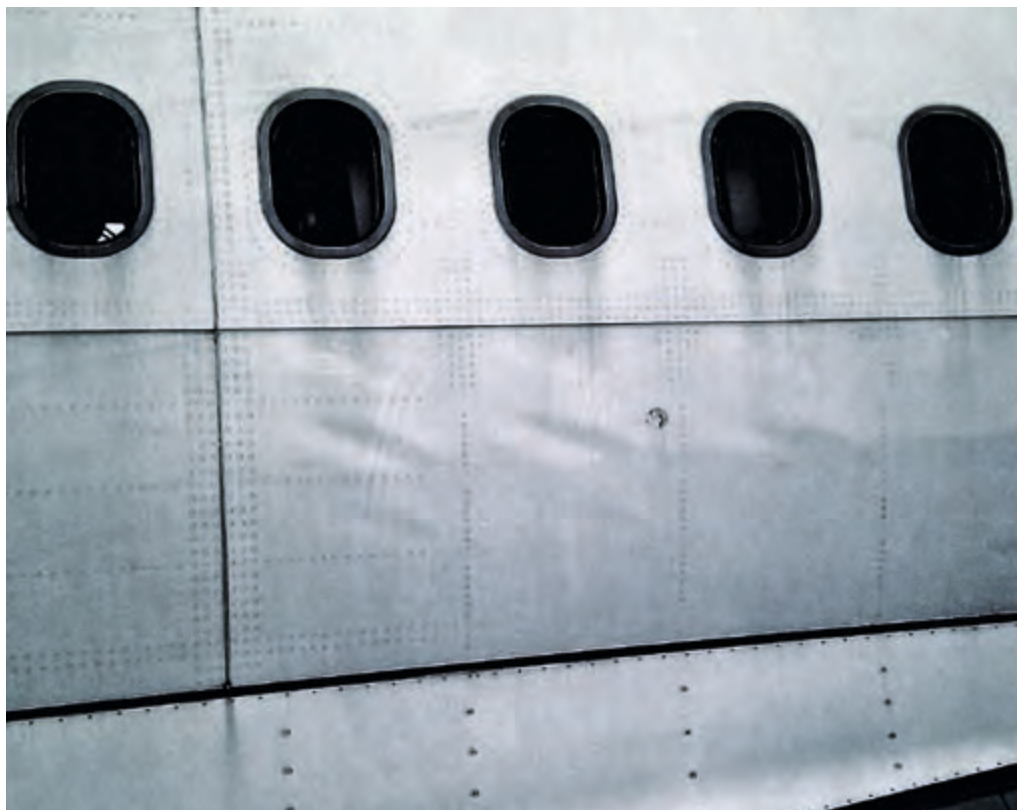
**Figure 4**  
Damage on the aircraft following the hard landing: ripples on the fuselage
