# Inadvertent Autopilot Engagement during Takeoff on A220 Aircraft

Several in-service events were reported to Airbus where the flight crew inadvertently selected the autopilot while attempting to engage the autothrottle during the takeoff roll. Inadvertent autopilot engagement may result in early rotation that can lead to a tail strike, inability to climb, runway overrun, or even loss of control.

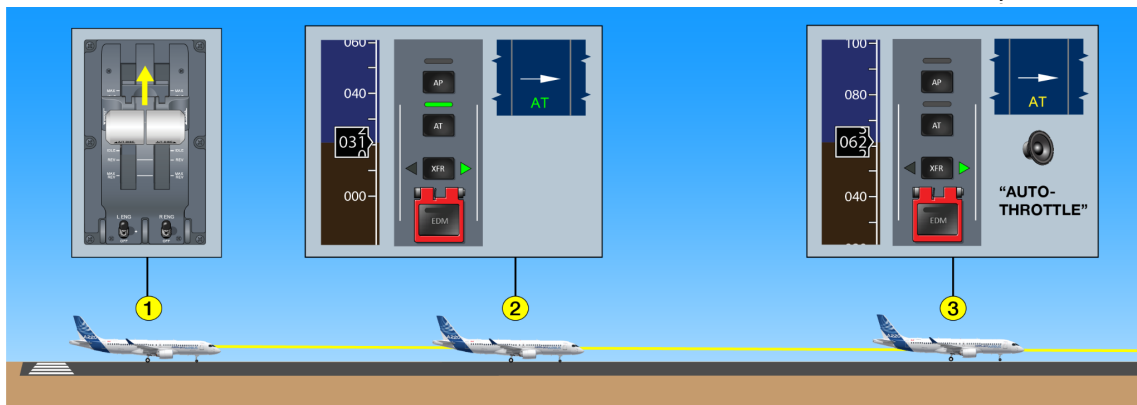
(fig.1) illustration of the event - part 1

An A220 aircraft was aligned on the runway and ready for a flap 2 and TO-3 derated takeoff. The computed takeoff speeds were 135 kt for V1, 137 kt for VR, and 141 kt for V2. The autothrottle was armed (**fig.1**).

① The flight crew moved the thrust levers forward to initiate takeoff. ② The autothrottle engaged at approximately 31 kt and the takeoff thrust (81.5% N1) was reached at approximately 40 kt. ③ At 62 kt, the autothrottle unexpectedly disconnected, accompanied by the “**AUTOTHROTTLE**” aural alert.

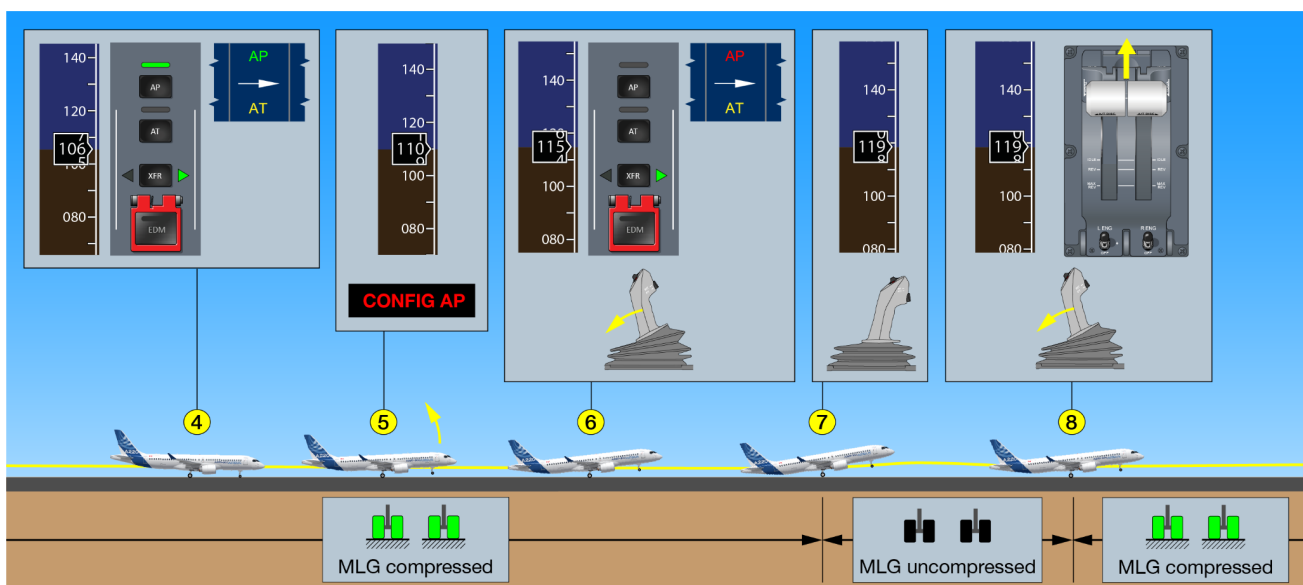
(fig.2) illustration of the event - part 2

④ At 106 kt, the flight crew wanted to re-engage the autothrottle but they pressed the autopilot AP switch instead of the AT switch on the Flight Control Panel (FCP). ⑤ The **CONFIG AP** EICAS alert triggered at 110 kt (VR- 27 kt), but without the associated “**CONFIG AUTOPILOT**” aural alert as the “**AUTOTHROTTLE**” aural alert was still repeating. With the AP engaged, the aircraft started to rotate. ⑥ At 115 kt (VR-22 kt), the PF disconnected the autopilot and briefly applied 66% backstick input before releasing the sidestick to neutral. ⑦ At 119 kt (VR-18 kt), the aircraft pitch reached 10.7 ° and the strut of the main landing gear decompressed. ⑧ 1s later, the landing gear was compressed again and the aircraft pitch reduced slightly to 7.5 °. The captain (PM) pushed the thrust levers to MAX and the first officer applied 50% backstick inputs.

When the autothrottle unexpectedly disconnected during the takeoff roll, the flight crew tried to manually reengage it using the autothrottle switch, but they inadvertently pressed the autopilot switch instead. This caused the autopilot to be engaged with the aircraft still on ground.

The autopilot commanded a pitch-up when it was inadvertently activated on the ground to reach the flight guidance pitch target. This caused the aircraft to rotate too early when the aircraft was still 27 kt below VR.

The "CONFIG AUTOPILOT" aural alert did not sound, because the repetitive “**AUTOTHROTTLE**” aural alert was still active when the **CONFIG AP** EICAS alert was triggered.

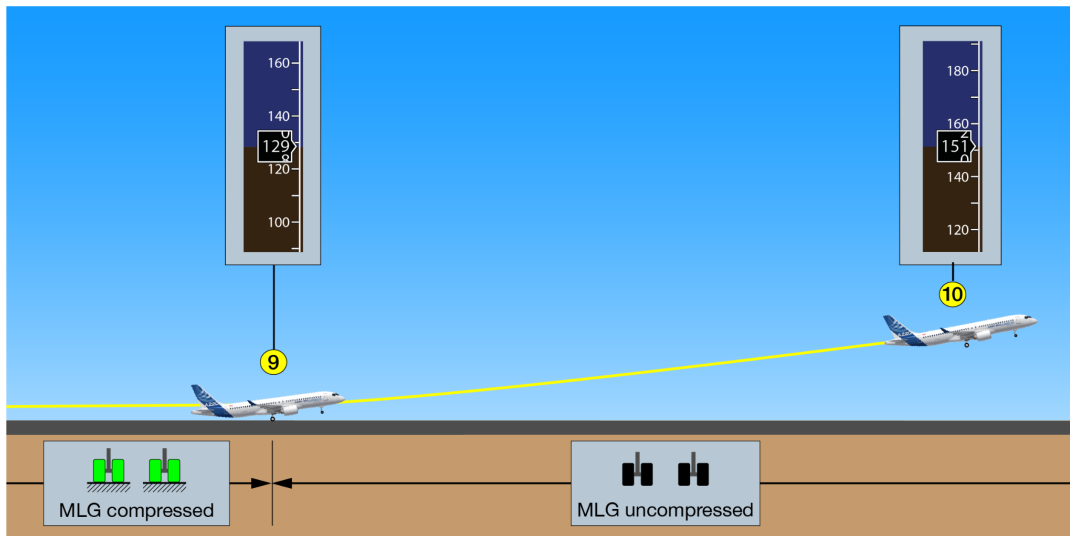
(fig.3) Illustration of the event - part 3

⑨ The landing gear decompressed again when the aircraft reached 129 kt (VR-8 kt) and began to climb. ⑩ The aircraft reached 151 kt (V2 + 10kt) at 100 ft RA. The flight crew deactivated the repetitive “**AUTOTHROTTLE**” aural alert and continued the flight.

During the event, at step ⑦, the aircraft pitch attitude was 10.7° when the aircraft was still on the ground, which corresponds to a tailstrike margin as low as 1 to 2 ft.

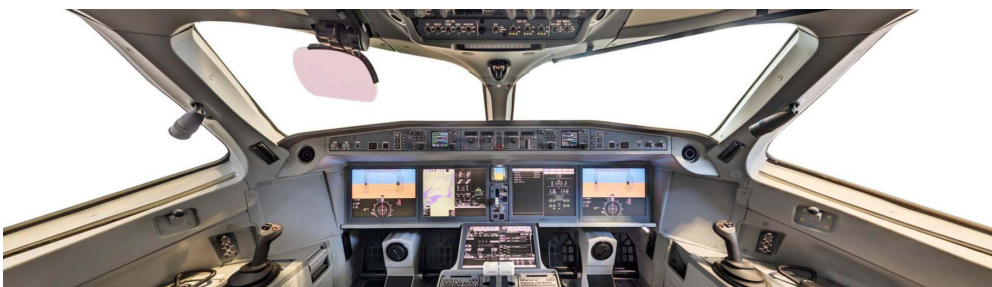
The AFM was updated to add a warning in the limitations section for the autopilot. It states that **“Autopilot engagement during takeoff roll can result in premature rotation, possibly leading to tail strike, inability to climb or loss of control. Immediate crew intervention is required.”**
