# Landing with Nosewheels at 90 degrees

This article describes the outcomes of investigations into several events of aircraft landing with NLG wheels at 90° and shows why they are not related. It also recalls the corrective actions and existing operational recommendations to prevent any recurrence.

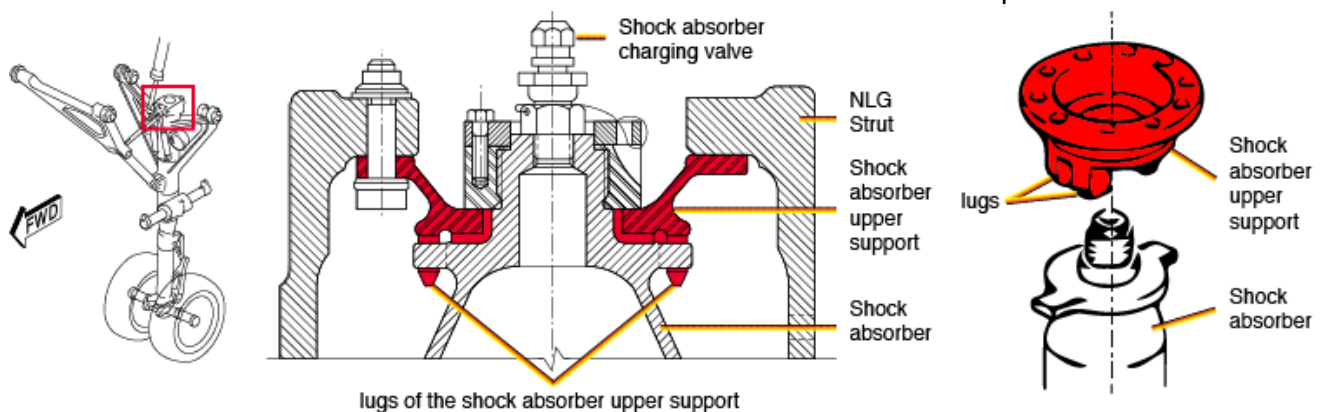
There are two lugs on the upper support of the NLG shock absorber that prevent it from rotating freely in its housing (**fig.1**). The investigation showed that both lugs had sheared off and this caused the NLG to lose its centered position. This condition was immediately detected by the Landing Gear Control Interface Unit (LGCIU), which triggered the **L/G SHOCK ABSORBER FAULT** ECAM alert. The Braking & Steering Control Unit (BSCU) also detected the rotation and deactivated the Nose Wheel Steering (NWS) system. This triggered the **WHEEL N/W STRG FAULT** ECAM alert. The absence of nosewheel steering, combined with the broken anti-rotation lugs and the aerodynamic loads, enabled the NLG wheels to turn at 90° from the centerline.

It was discovered that the BSCU standard fitted to the aircraft at the time performed a greater number of steering movements during the preland checks compared to previous BSCU standards. This caused more fatigue to the 2 lugs on the upper support of the shock absorber. The internal pressure of the shock absorber was also found to be too high due to incorrect servicing during maintenance. This resulted in additional friction being applied to the NLG self-centering mechanical device, which is connected to the upper support, and eventually caused the 2 lugs to shear.

(fig.1) Position of the 2 lugs on the upper support of the NLG shock absorber

BSCU Standard L4.9B was developed with a reduced number of steering movements during the preland tests. The retrofit of this new standard is complete. The BSCU standard responsible for the lug failure is no longer in service.

Before this event, it was possible to perform servicing of the shock absorber with weight on wheels but it was difficult to service the correct pressure. This led to a tendency to overpressure the shock absorber and caused increased fatigue on its upper support. NLG shock absorber servicing procedures were improved following the event to allow for easier servicing with weight off wheels using jacks on the NLG. If the shock absorber can only be serviced with weight on wheels, then the servicing task must be done again, and with weight off wheels, within the next 7 days.

Following another event that led to a landing with the NLG rotated to 90°, which had been caused by installation errors during maintenance, a new foolproof design of the NLG shock absorber was introduced (**fig.2**). This design prevents any lug rupture on the upper support of the shock absorber, and it is installed on all A320 family aircraft in production since 2004 and SB A320-32-1277 (Mod 34160) is available for retrofit.

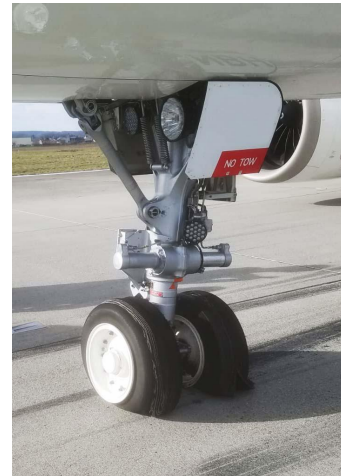
After NLG touchdown, both NLG tires burst and the aircraft stopped on the runway. There were no injuries. The NLG wheels were turned to 90° from the aircraft centerline and skid marks of more than 1200 m long were found on the runway (**fig.3**).

During inspection of the NLG after the event, water was found in the two Rotary Variable Differential Transformers (RVDTs). These two sensors provide the angle of the NWS position to the BSCU. Three days before the event, the aircraft was cleaned during a maintenance C check. The water ingress in the RVDTs most probably happened at this time.

A ferry flight was performed after the C check and cleaning. Analysis of the recorder data showed that one RVDT was blocked during this flight. It is likely that this was due to the water in the RVDT freezing at altitude but was probably unblocked as the ice broke up upon landing. A steering offset resulted from this flight and remained for the next 7 flights.

When the flight crew inappropriately cycled the A/SKID & N/W STRG switch, they reactivated the BSCU and hydraulic pressure was supplied to the steering actuator. During the preland test, the BSCU could not centre the nosewheels because of the faulty sensor and the angle of the NWS position was already too excessive. This resulted in the nosewheels rotating further toward 90° before landing.

(fig.3) View of the NLG after landing

AMM/MP tasks for NLG washing must be followed (12-21-11 "External Cleaning", which refers to AMM/MP 32-21-00 "Cleaning of the Nose Landing Gear"). These tasks clearly warn against the use of high-pressure hoses and provide details on protections to be used.

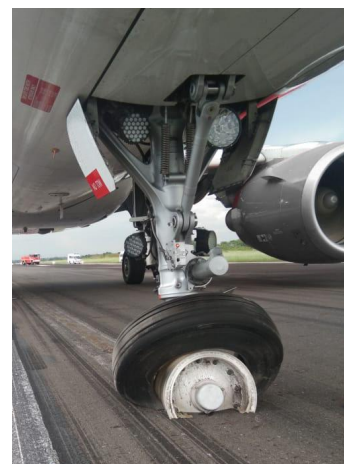
The MEL operational procedure states that the flight crew must avoid sharp turns when the NWS is inoperative. Differential braking and asymmetric thrust were used to steer the aircraft during the taxi-out. The flight crew then performed a sharp 180° turn to align the aircraft on the runway contrary to the conditions of the MEL. After liftoff, the **L/G SHOCK ABSORBER FAULT** ECAM alert was triggered and the landing gear lever was jammed in the DOWN position. The flight crew performed an In-Flight Turn Back (IFTB) and landed the aircraft. The NLG had rotated to 90° and both NLG tires burst (**fig.4**).

(fig.4) View of the NLG after landing

Even if the safety analysis shows that an acceptable level of safety is granted when dispatching the aircraft without an operative NWS system, the operational burden is significant. For that reason, and to avoid such an event occurring again, the Nose Wheel Steering Item 32-51-01 will be removed from the MMEL. It will no longer be possible to dispatch an aircraft with an inoperative NWS system. The updated Master MEL (MMEL) revision will be available in February 2022. An FOT will also be published to further explain the rationale for removing this MMEL item and to provide appropriate mitigation means in the case of inoperative NWS.

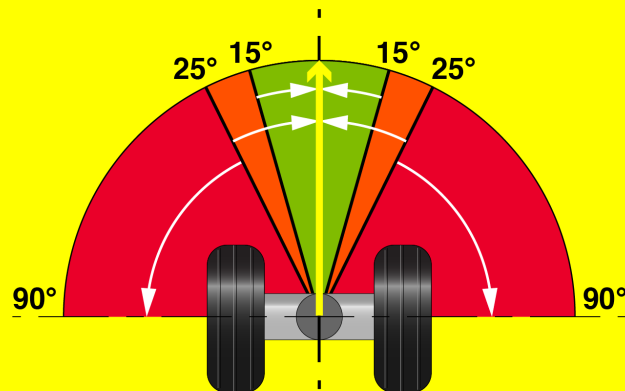
The NLG wheels were in free-to-castor mode **(fig.5)** because of the inoperative NWS.

In free-to-castor mode, the NLG wheels will return to 0° after up to 15° of steering due to the self-centering effect offered by the rake angle of the leg. Between 15° and 25°, the wheels will return to 0° but with more difficulty. If the NWS steering angle exceeds 25°, then NLG wheels will rotate toward 90°.

**(fig.5)** Ability of the NLG wheels to self-center when in free-to-castor mode

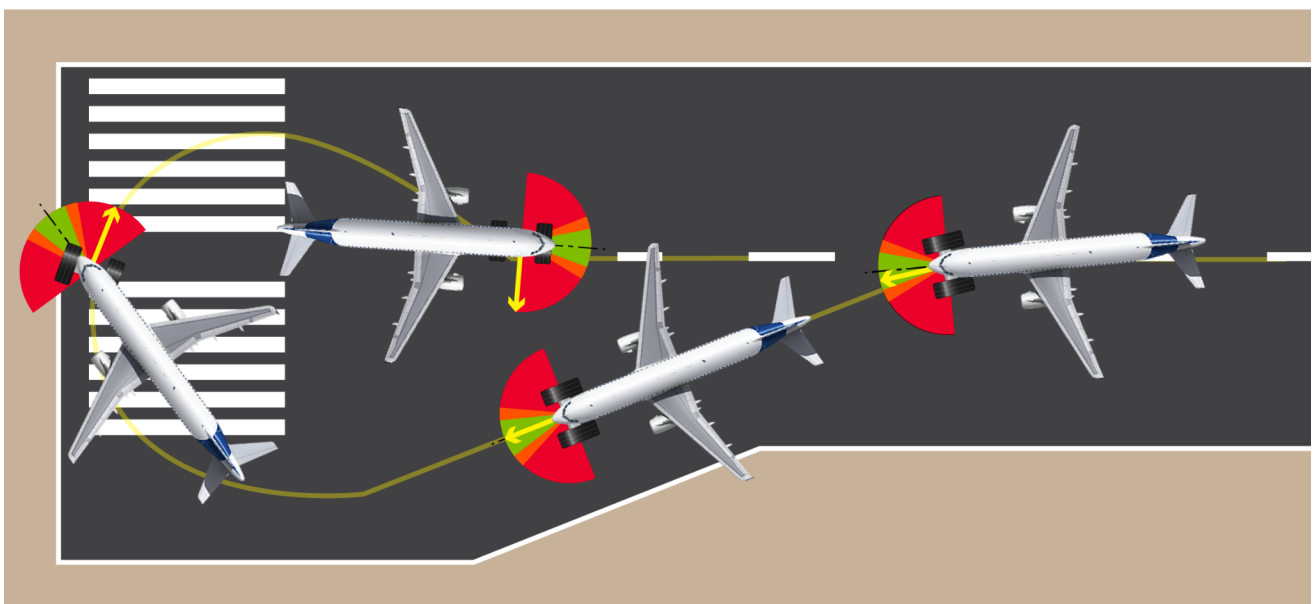
Analysis of recorder data showed the evolution of the NWS angle during the taxi-out, which resulted in a U-turn. The NLG wheels remained below 15° during the first left turn and naturally returned to the centered position. During the right turn, the angle of the wheels was more than 25°, which means they will continue rotation towards the 90° position at the end of the sharp 180° turn. The wheels remained in the 90° position during the takeoff roll and upon landing.

**(fig.6)** Illustration of the 180° turn performed during the event
