## Look out for Ice Ridges on the Lower Nose Fuselage

Ice ridges on the lower nose fuselage can cause Computed Airspeed (CAS) values delivered by the ADRs to be lower than the actual airspeed which may lead to unreliable airspeed events. This article describes the potential effect on the aircraft's systems from the takeoff phase and how to prevent such a situation.

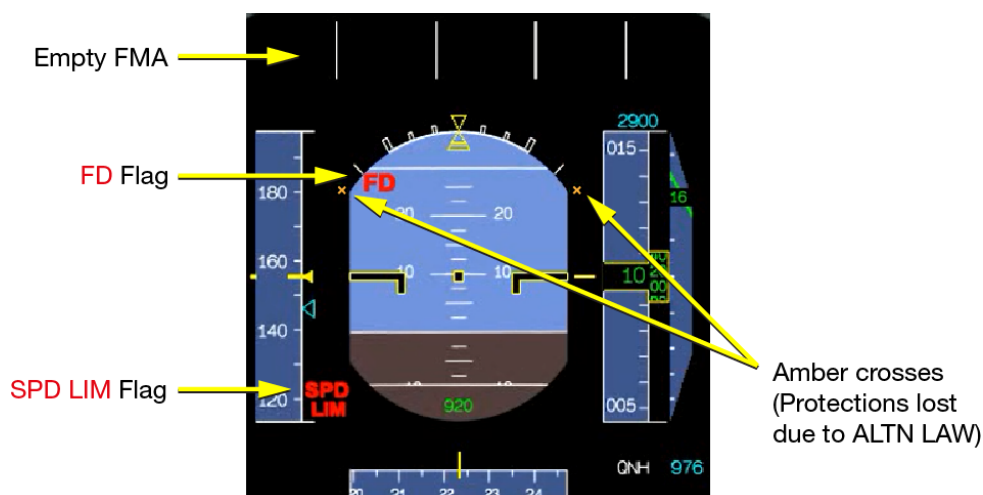
With the ground servicing complete, the flight crew proceeded to takeoff. At lift-off, the flight controls law reverted to alternate law and the **AUTO FLT A/THR OFF** ECAM caution triggered. 12 seconds later, the Flight Directors (FD), Characteristic Speeds, TLU function and Autopilot availability were also lost. The **FD** and **SPD LIM** red flags were displayed on both PFD (**fig.1**) and at the end of the ECAM take-off inhibition phase, when the aircraft reached 1500ft, three ECAM alerts were displayed:

- **NAV ADR DISAGREE**
- **F/CTL ALTN LAW**
- **AUTO FLT RUD TRV LIM SYS**

(fig.1) Impact on the PFD indications: **FD** and **SPD LIM** red flags, empty FMA and amber crosses of the alternate law.

The flight crew identified an airspeed discrepancy issue and then compared PFD1, PFD2 and the standby speed indications with the ground speed on the navigation display. They proceeded to switch off ADR 1+3 and performed an in-flight turn-back with the ADR2 ON.

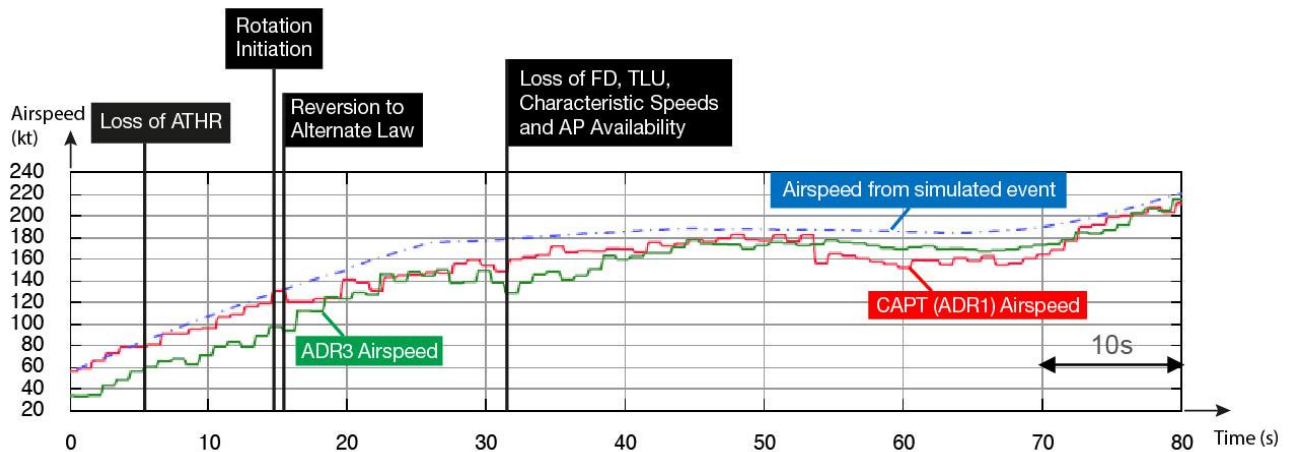
The resulting Computed Airspeed (CAS) from the simulation, representative of the actual airspeed, is shown in blue on the graph (**fig.2**). This was compared to the recorded CAPT CAS (from ADR1) shown in red and ADR3 CAS, which is shown in green on the graph (**fig.2**).

From the beginning of the take-off roll, ADR3 airspeed is perpetually underestimated up to 40kts and ADR1 airspeed is underestimated from take-off roll up to 10kts and from rotation up to 35kts. ■

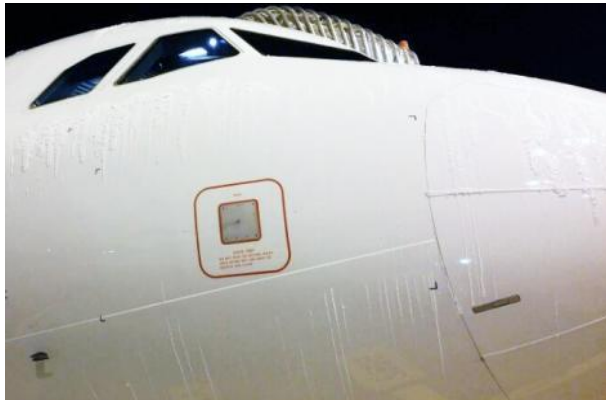
The main cause of ice ridges over the lower nose fuselage of the aircraft is ice accretion during a long stay on ground in cold conditions (**fig.3**). A review of in-service events from the last 6 years shows that a large majority of ice ridges related events occurred during the first flight of the day.

**(fig.3)** Example of thin ice ridges forward of the Pitot probes of an A320 family aircraft

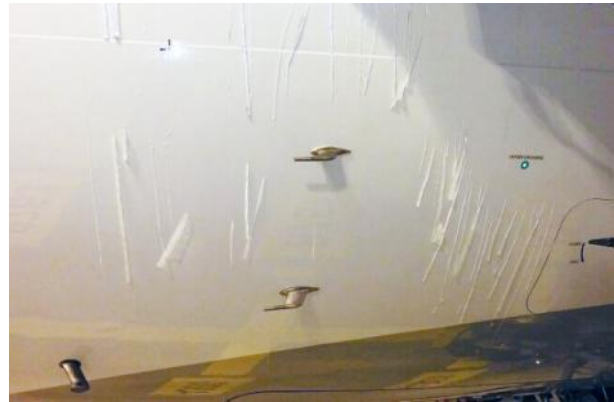
Reported events also show that ice ridges may be dislodged during the flight or may remain attached to the lower nose fuselage for the entire flight (**fig.4**).

**(fig.4)** Example of ice ridges that remain on the lower fuselage even after completing a flight

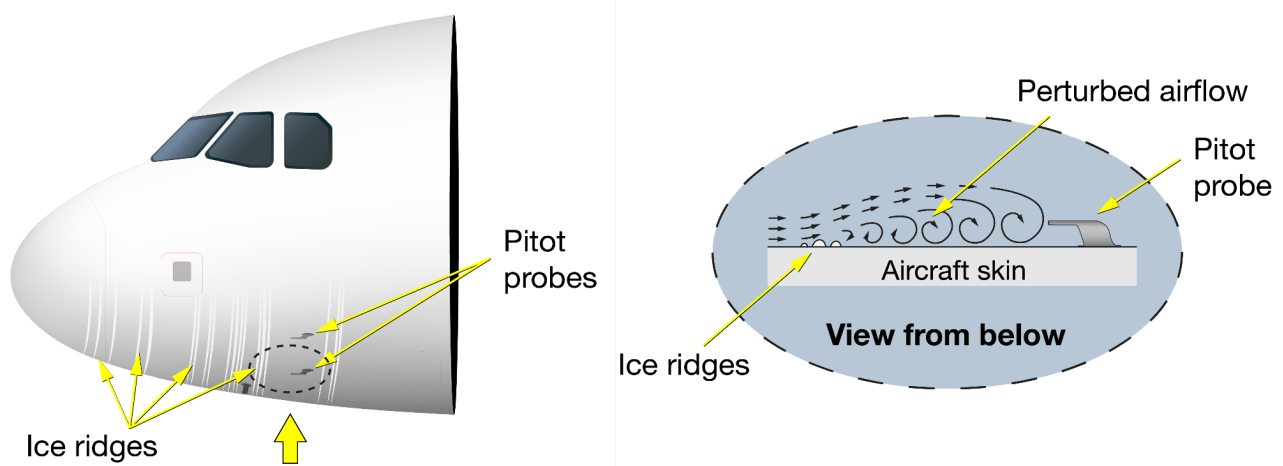
The presence of ice ridges located forward of the Pitot probes on the lower nose fuselage creates airflow perturbations **(fig.5)** and may lead to airspeed data from the ADR of the impacted probe(s) to be lower than the actual airspeed.

The effect of ice ridges on the measured airspeed value will depend on the location, shape and number of ice ridges present. A large ice ridge but also successive thin ice ridges can significantly impact the airspeed measurement.

**(fig.5)** Effects of the ice ridges on the airflow forward of the Pitot probes

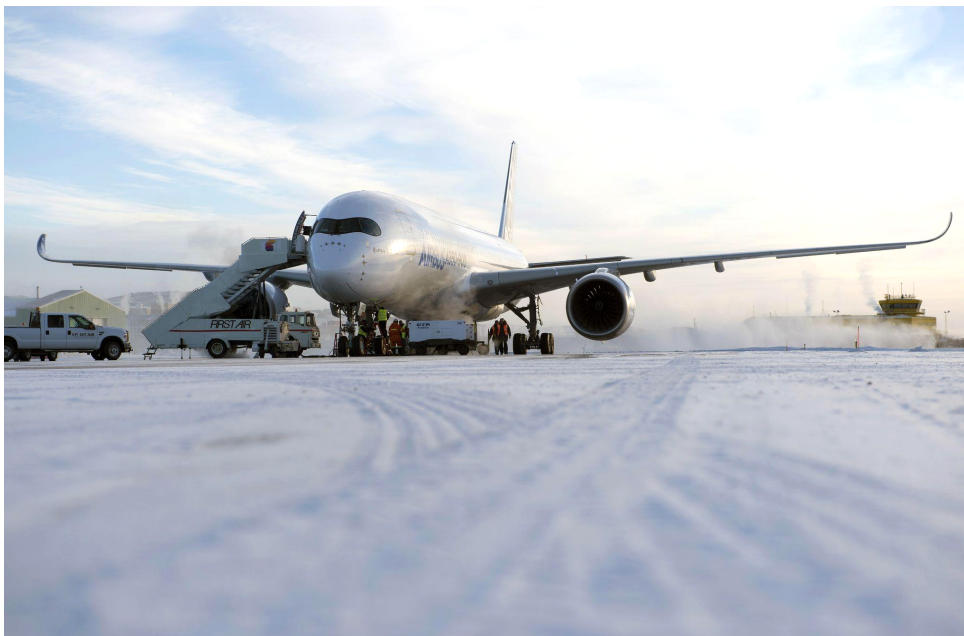
“ The lower nose fuselage must be clear of ice before departure to avoid unreliable airspeed situation due to ice ridges, and even thin ice ridges must be removed before departure. ”

While performing ice removal from lower nose fuselage it is recommended that:

The operator should spray the de-icing fluid from the rear to the front to avoid contaminating the Pitot tube

Never spray de-icing fluid directly on static probes and AOA probes to avoid contamination
