# Overspeed event with crew take-over and OEB49 application

While flying at FL380, an A340 aircraft encountered a strong and abrupt tailwind decrease that triggered significant  $M_{MO}$  overshoot and overspeed warning.

**Safety first, #28** June, 2019. Safety first is published by Airbus S.A.S. - 1, rond point Maurice Bellonte - 31707 Blagnac Cedex/France. Publisher and Editor: Yannick Malinge, Chief Product Safety Officer. Concept Design by Airbus Multi Media Studio 20190588. Reference: X00D16031905 Issue 28. Photos by Airbus.

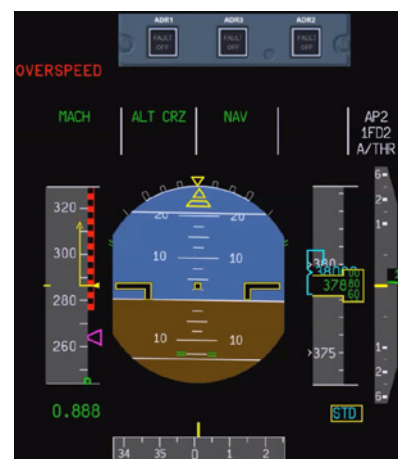
(fig.1)

An A340 aircraft was flying at FL380 with a managed Mach number of 0.82 and a tailwind of around 64 kt. Prior to reaching top of descent, a sudden drop in tailwind of 41 kt in 14 seconds caused a significant airspeed increase and triggered an OVERSPEED warning for 9s despite the thrust reduction commanded by the autothrust (A/THR) (**fig.1**).

View of the PFD at the time of the overspeed

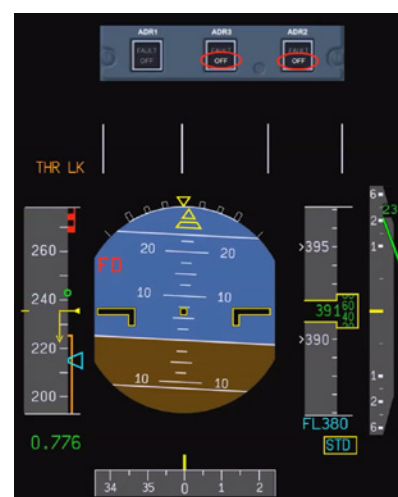
(fig.2)

The flight crew erroneously applied the OEB49 procedure and switched off the ADR 2 and ADR 3 about 15 seconds after the autopilot disconnection. This caused the aircraft to revert to Alternate law, with the loss of the FD bars and disconnection of autothrust. As a consequence, the thrust remained at the current value which was still idle at that time (**fig.2**). Indeed the THR LK function at autothrust disconnection maintains the thrust at its current value until the thrust levers are moved again. This is indicated by the associated “**ENG THRUST LOCKED**” ECAM alert that requests to move the thrust levers and the “**THR LOCK**” displayed on the FMA.

View of the PFD after switching off ADR2 and ADR3

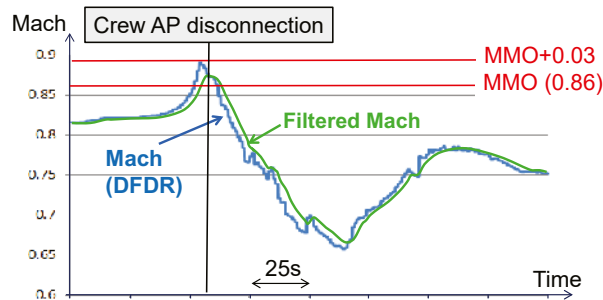
(fig.3)

During this event, the flight crew disconnected the autopilot following the OVERSPEED warning. However, the autopilot is robust to overspeed situations. The autopilot automatically disconnects only when the filtered Mach becomes higher than  $M_{MO} + \text{margin}$  ( $M_{MO} + 0.03$  on A330/A340 aircraft). The filtered Mach is a smoothed and slightly delayed Mach which dampens any abrupt variation of the current Mach and makes the autopilot even more robust against automatic disconnection.

Simulations show that if the autopilot had been left engaged, it would have remained engaged during this event (**fig.3**). As a result, the aircraft would have stayed on its trajectory.

Evolution of the filtered Mach versus the current Mach and versus the autopilot automatic disconnection threshold value ( $M_{MO} + 0.03$ )

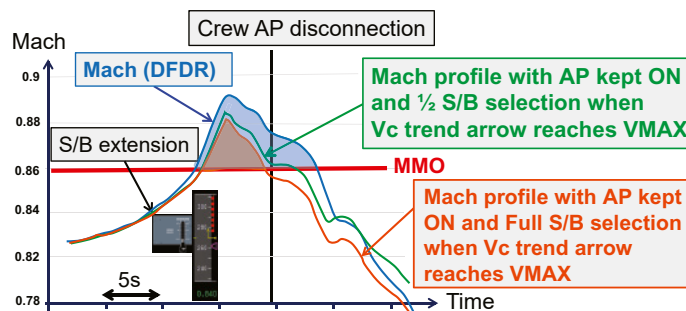
(fig.4)

In addition, the use of speedbrakes (S/B) is an efficient way to limit the  $V_{MO}/M_{MO}$  overshoot in cruise. This event has been simulated with autopilot kept ON and S/B selection at the time the Vctrend arrow reaches  $V_{MAX}$ . The comparison of the event Mach with the Mach resulting from these simulations shows that the use of AP combined with a S/B extension would have minimized the altitude excursion as well as the  $V_{MAX}$  overshoot and overshoot duration (**fig.4**).

Comparison of the recorded Mach evolution with the simulated Mach evolutions if AP was kept ON with the selection of half and full S/B when the Vc trend arrow reached  $V_{MAX}$

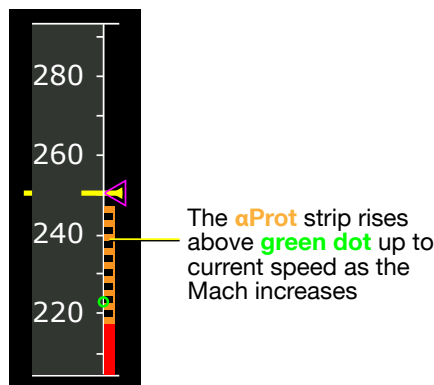
(fig.6)

Preventive entry conditions of the OEB49 for A330 and A340 aircraft

On A330 or A340 aircraft, the preventive entry condition is when the **αProt** strip continuously increases and exceeds Green Dot (GD) speed as the Mach increases in a stabilized wings-level flight path (typically during the climb phase) **(fig.6)**.

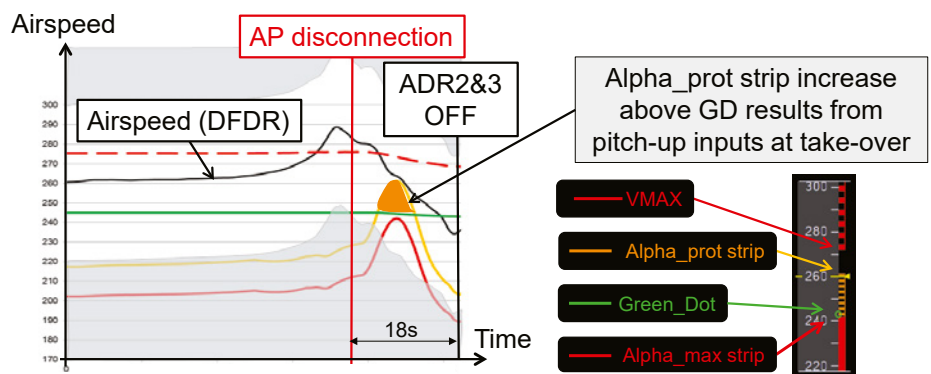
(fig.7)

In the event described, the flight crew of the A340 improperly applied OEB49. The **αProt** strip increase above green dot speed did not occur with Mach increasing and in stabilized wings-level flight, but instead resulted from sidestick pitch up inputs **(fig.7)**.

The preventive entry condition of the OEB49 was therefore not fulfilled. The reactive entry was not fulfilled either as the aircraft was climbing when the OEB was applied.

Plot of the recorded airspeed, green dot speed, Valpha prot, Valpha max and Vmax during the event

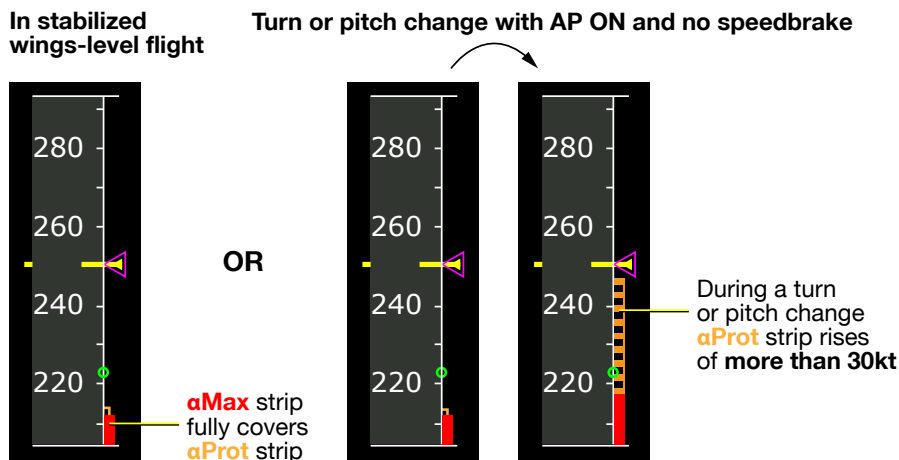
**(fig.8)**

On A320 family aircraft, by design, the **αProt** strip is limited by VLS out of g-load conditions, so that an abnormal **αProt** strip increase becomes visible only during manoeuvres (turn or pitch change)

- 1<sup>st</sup> preventive entry: The **αMax** strip completely hides the **αProt** strip in a stabilized wings-level flight path (without an increase in load factor)
- 2<sup>nd</sup> preventive entry: With the Auto Pilot (AP) engaged and the speed brakes in the retracted position, the **αProt** strip rapidly moves by more than 30 kt during flight manoeuvres with an increase in load factor, for example turns or pitch variations.

Preventive entry conditions of the OEB48 for A320 aircraft
