## Preventing Loss of Engine Generators on A320 Family, A330 and A340 Aircraft

Some cases of emergency electrical configurations on A320 aircraft were reported to Airbus where both Integrated Drive Generators (IDGs) failed in sequence due to worn components inside their Constant Speed Drive (CSD).

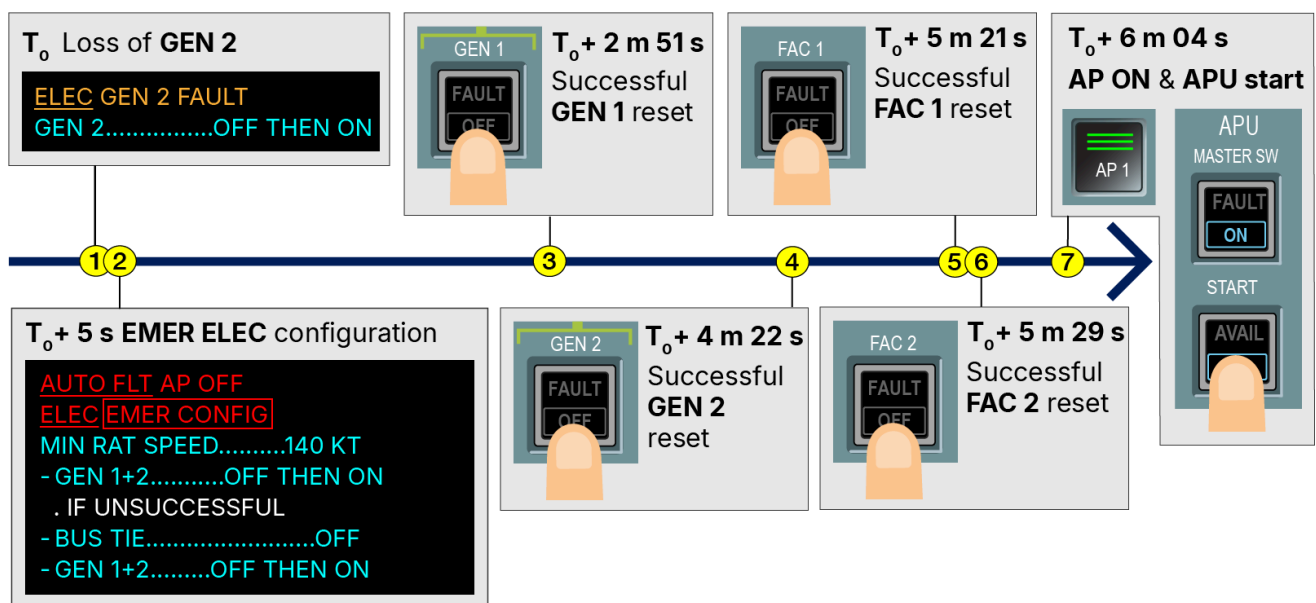
(fig.1) Sequence of actions during the event

① Crossing 31 500 ft, (fig.1) the **ELEC GEN 2 FAULT** ECAM alert triggered (**To**).

② 5 s later (**To+5s**), the aircraft switched to the emergency electrical configuration, and the Ram Air Turbine (RAT) deployed and activated accordingly. The autothrust and autopilot disconnected and the flight controls reverted to ALTERNATE law. Only the Captain's PFD and ND, and the upper ECAM displays remained ON. The **AUTO FLT AP OFF** and **ELEC EMER CONFIG** triggered.

During the next 2 minutes and 46 seconds, the flight crew attempted to reset both generators. ③ At **To+2m51s**, GEN 1 was successfully reset and electrical power restored to the network. The **ELEC GEN 2 FAULT** and **ELEC IDG 2 OIL LO PR** ECAM alerts were displayed on the ECAM.

④ 1 m 31 s later (**To+4m22s**), GEN 2 was also successfully reset.

⑤ 59 s later (**To+5m21s**), the flight crew successfully reset FAC 1, enabling the recovery of the normal flight control law. ⑥ 8 s later (**To+5m29s**), FAC 2 was also successfully reset.

⑦ 43 s later (**To+6m04s**), the flight crew re-engaged the autopilot and started the APU as a safety precaution. The aircraft continued its descent and safely landed at its destination airport (**To+19m38s**).

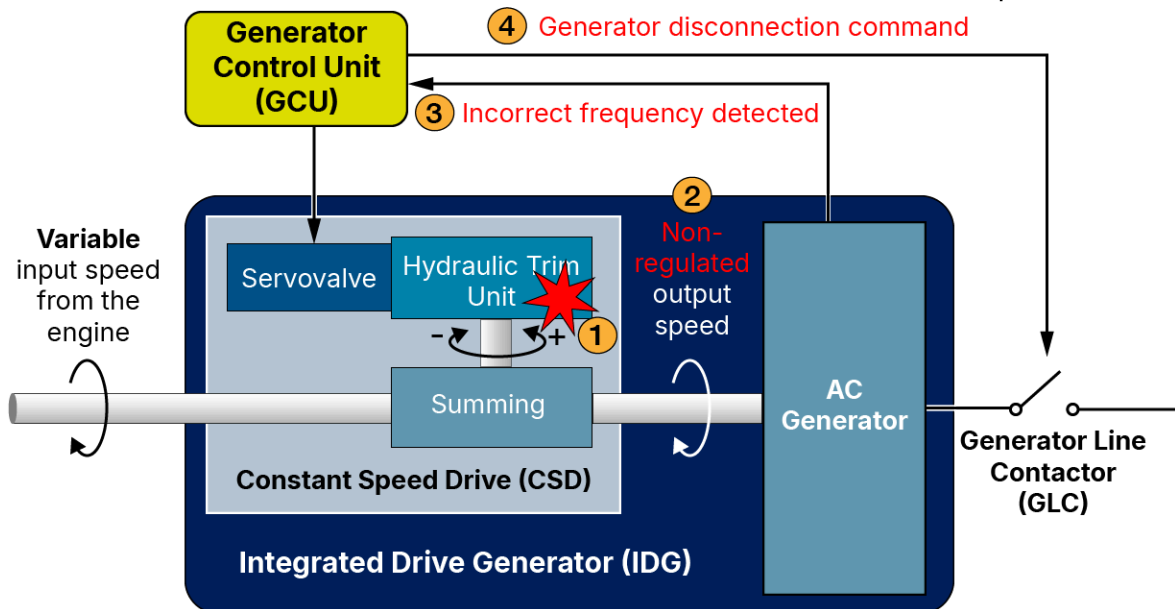
(fig.4) Frequency regulation issue due to worn IDG

Both generators were removed from the aircraft and sent to the manufacturer for examination. It was confirmed that they both failed due to frequency regulation issues, which originated from worn hydraulic blocks inside their Constant Speed Drive (CSD) module.

Analysis showed (fig.4) that the generators suffered from ① worn hydraulic blocks inside its CSD causing ② an incorrect regulation of the CSD output speed. ③ This resulted in electrical frequency fluctuations that were detected by the GCU, which ④ disconnected the generator from the electrical network to protect the aircraft's systems.

## Introduction of a MPD task for early detection of worn generators

In shop maintenance, maintenance organizations should replace CSD hydraulic blocks if wear is found out of allowable limit or, as a preventive measure, if the wear is considered as close to the limit or excessive. ■
