# Preventing Tailstrike During Go-around near the Ground

The focus of this article is go-around near the ground, sometimes called, “rejected landing”. This follows our previous article: “A Focus on the Landing Flare” article published September 2020 and “A Focus on the Takeoff Rotation” published January 2021. Those articles provided recommendations for avoiding tailstrikes when performing landing flare and takeoff rotation.

There is also a higher risk of tailstrike when a go-around is required near the ground. This article provides additional recommendations and observations for flight crews to help them avoid tailstrike events during this phase.

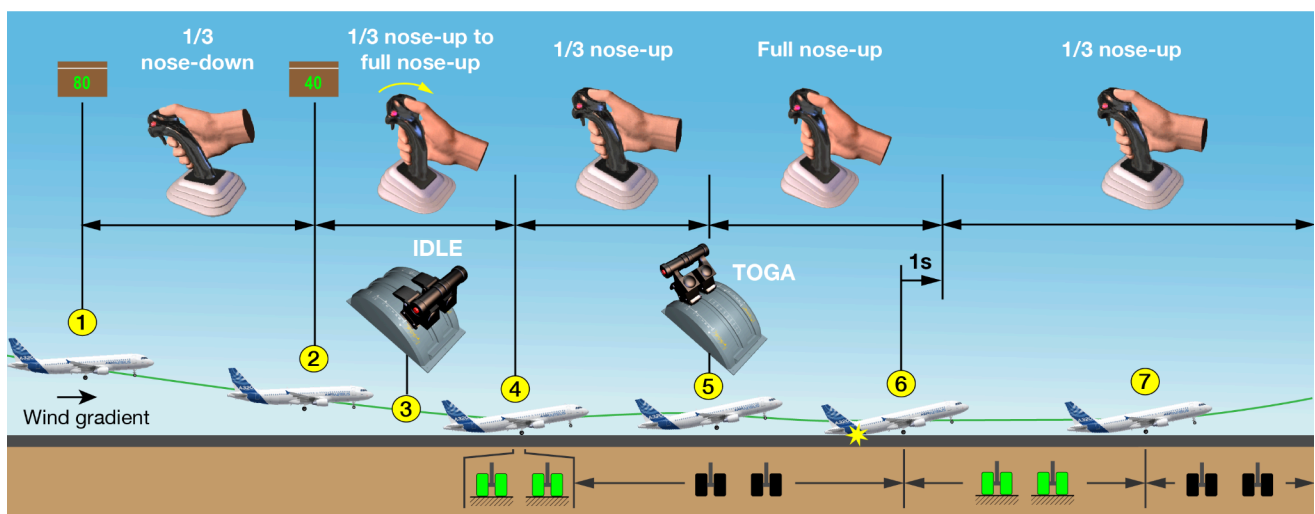
(fig.1) Illustration of the event: Case Study 1

① At 80 ft RA, the PF applied  $\frac{1}{3}$  of full nose-down input (**fig.1**). Simultaneously, the wind, which was about 5 kt headwind, suddenly changed to a 3 kt tailwind. The aircraft pitch reduced from  $+3.5^\circ$  at 80 ft to ②  $+2.5^\circ$  at 40 ft.

From 40 ft RA, the PF started the flare with a progressive nose-up input up to a full nose-up input in the last 10 ft. ③ Thrust levers were retarded to idle at 10 ft RA. The pitch increased from  $+2.5^\circ$  up to ④  $+9^\circ$  up at touchdown.

The aircraft slightly bounced while the ground spoilers started to extend, and the PF maintained an average  $\frac{1}{3}$  nose-up input during 2 s. ⑤ The pitch reached  $+12^\circ$  when the PF applied TOGA thrust and applied a full nose-up input.

⑥ The aircraft touched down a second time during the engine spool-up and ground spoilers retraction. A tailstrike occurred with a pitch of  $+12.7^\circ$  at a speed of 127 kt (VAPP - 10kt). The PF maintained the full nose-up input for 1 more second. The aircraft speed at that point was 122 kt (VAPP - 15 kt). The PF then partially released the nose-up input to  $\frac{1}{3}$  of full nose-up input. ⑦ The pitch reduced to  $+11^\circ$  and the aircraft achieved lift-off when the speed reached 128 kt.

Both the wind gradient and PF input at 80 ft RA created a lift reduction that led the aircraft vertical speed to increase to -800 ft/min at 40 ft RA. The flare reduced the vertical speed, which was still -350 ft/min at the first touchdown. The energy returned through the main landing gear shock absorbers, combined with the lift provided by the high pitch at touchdown ( $+9^\circ$ ), caused the aircraft to bounce.

The ground spoilers extension during the bounce reduced the lift, and caused the second touchdown. The continuous nose-up input of the PF after the first touchdown, in addition to the full nose-up input when TOGA was selected, led to the pitch increase from  $+9^\circ$  to  $+12.7^\circ$ , which caused the tailstrike on the second touchdown. ■

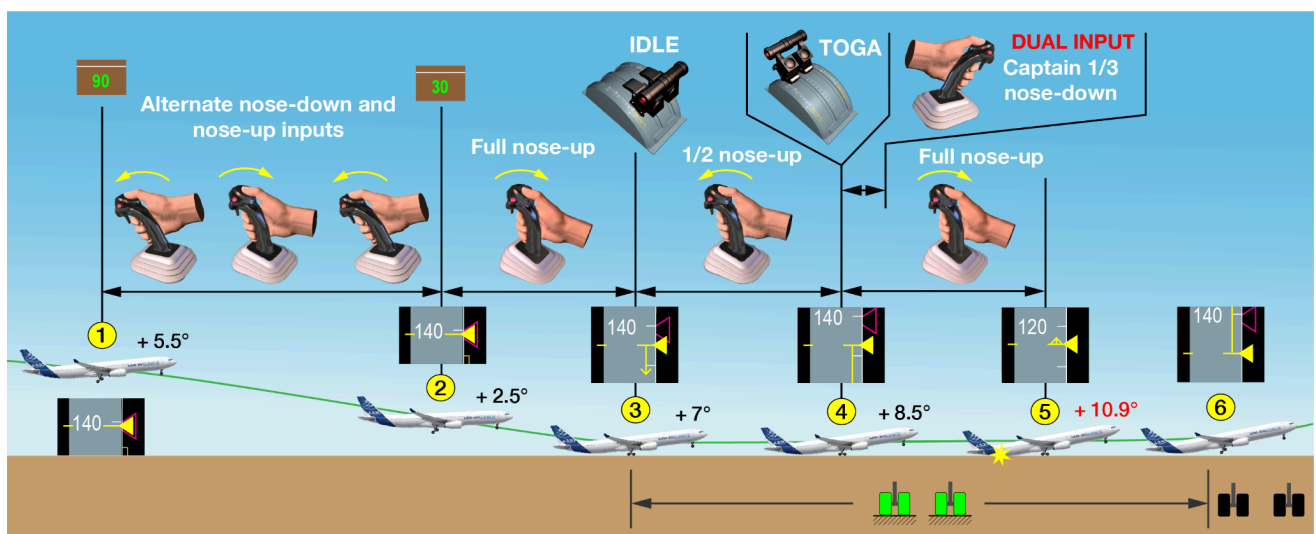
(fig.2) Illustration of the event: Case Study 2

① From 90 ft RA, the PF alternated nose-down and nose-up inputs, leading to a nose-down tendency. The pitch reduced from  $+5.5^\circ$  to ②  $+2.5^\circ$  at 30 ft. The flare was initiated at 30 ft by application of a close to full nose-up input, which was partially released and then followed by another full nose-up input just prior to touchdown. ③ The thrust levers were retarded to IDLE simultaneously at the point of the hard touchdown. The pitch was  $+7^\circ$  and the speed was 135 kt (VAPP - 4 kt) decreasing.

The PF maintained  $\frac{1}{2}$  full nose-up input for 2s and then ④ set the thrust levers to the TOGA detent combined with a full nose-up input. The Captain simultaneously applied  $\frac{1}{3}$  nose down input briefly, which led to a "DUAL INPUT" callout. The engines began spool up to TOGA thrust, but the speed was still decreasing and the pitch increasing due to the full nose-up inputs applied by the PF. ⑤ A tailstrike occurred and the pitch reached  $10.9^\circ$  at a speed of 116 kt (VAPP - 23 kt).

The alternate nose-up and nose-down inputs, between 90 ft and 30 ft, led to a vertical speed increase from -550 ft/min at 90 ft up to -850 ft/min at 30 ft when the PF started the flare. This late flare, combined with the high vertical speed, led to the hard landing.

The PF maintained a nose-up input after touchdown, leading the pitch to increase from 7° to 8.5° when the go-around was initiated. The PF then applied full nose-up input simultaneously with the TOGA thrust selection while the aircraft speed was as low as 116 kt (VAPP -23 kt). This led to the tailstrike.

The brief nose-down input performed by the Captain, without pressing the sidestick priority pushbutton when the go-around was initiated, was not sufficient to counteract the full nose-up demand by the First Officer. ■

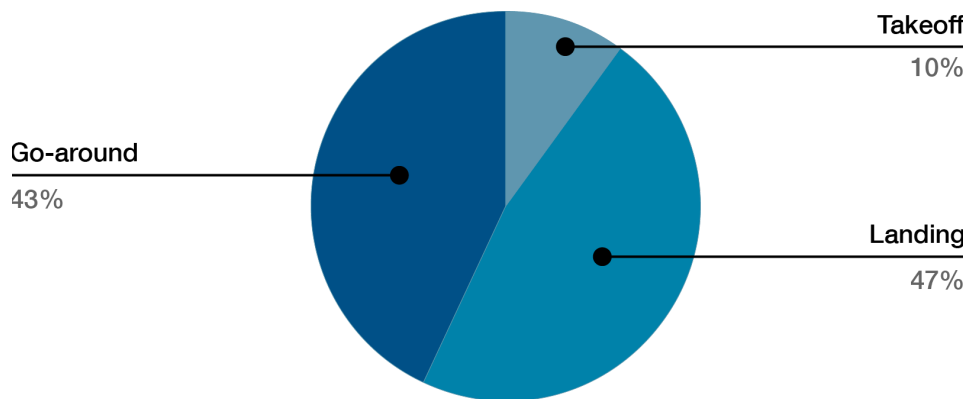
**(fig.3)** Percentage of tailstrike events per flight phase

Between January 2022 and September 2024, 49 tailstrike events were reported to Airbus with 5 (10 %) during takeoff, 23 (47 %) during landing and 21 (43 %) during a go-around near the ground **(fig.3)**.

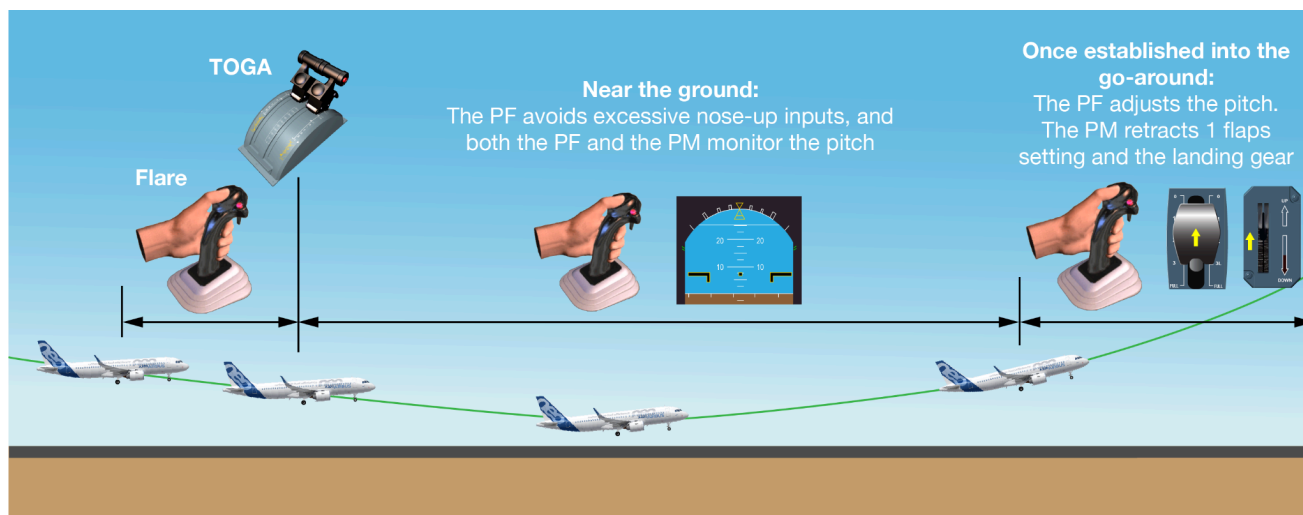
(fig.4) Management of a go-around near the ground

The application of full back stick by the flight crew was reported in many of the tailstrikes during go-around near to the ground events. This was a common contributor to these events as this action led to a high rate of rotation.

When performing a go-around near the ground, the PF and PM must monitor the pitch and the PF must avoid excessive nose-up input (**fig.4**).

During a go-around near the ground, the flight crew must delay the flaps and landing gear retraction until the aircraft is established on its go-around trajectory (**fig.4**). Delaying the flaps retraction prevents the need for higher pitch in the early stage of the maneuver, when the aircraft is closer to the ground.

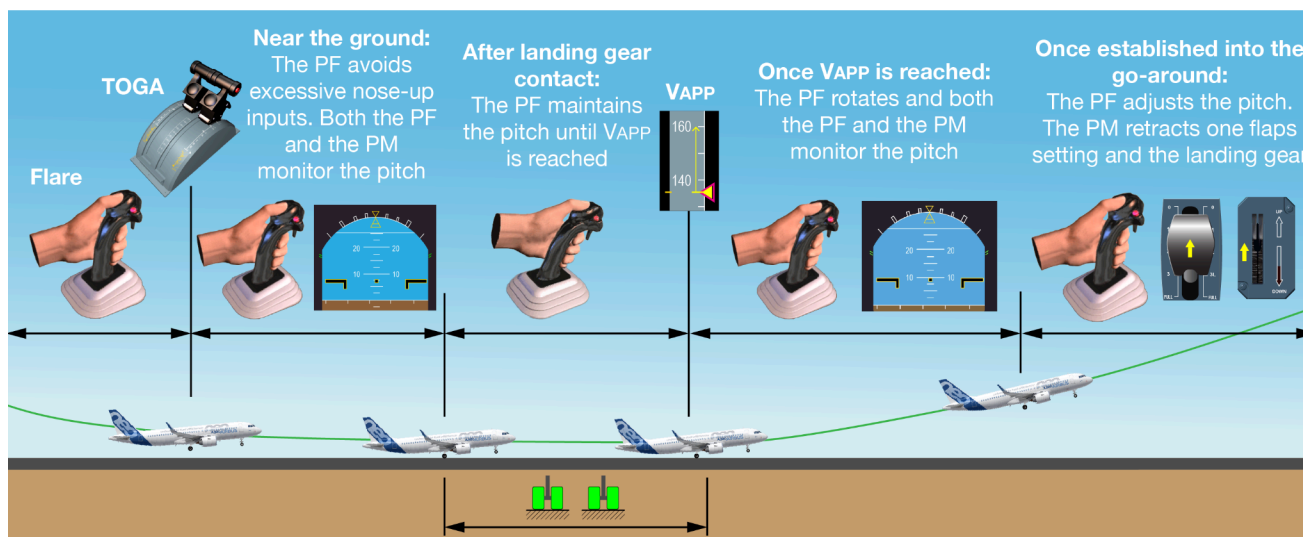
(fig.5) Management of energy after landing gear contact

In many reported cases of tailstrike during go-around, the high nose-up demand applied when the aircraft was on ground, and at low speed, led to the tailstrike.

If engines are at idle when the go-around is initiated, they can take a few seconds to spool up. The flight crew should wait until the aircraft speed reaches at least  $V_{APP}$  to rotate the aircraft (**fig.5**).
