# Safe Aircraft Parking

This article provides an overview of the parking brake architecture and explains the importance of checking accumulator pressure before applying the park brake, and then confirming there is sufficient hydraulic pressure at the brake unit. It also describes the safety enhancement available on A320 family and A330/A340 aircraft and gives recommendations for chock design and placement.

This article applies to A300/A310/A320/A330/A340/A350/A380 aircraft. It does not apply to A220 aircraft as they are equipped with electric brakes.

**Safety first, #29** January, 2020. Safety first is published by Airbus S.A.S. - 1, rond point Maurice Bellonte - 31707 Blagnac Cedex/France. Publisher and Editor: Yannick Malinge, Chief Product Safety Officer. Concept Design by Airbus MultiMedia Studio 20192534. Reference: X00D16031905 Issue 29. Photo by H. Goussé.

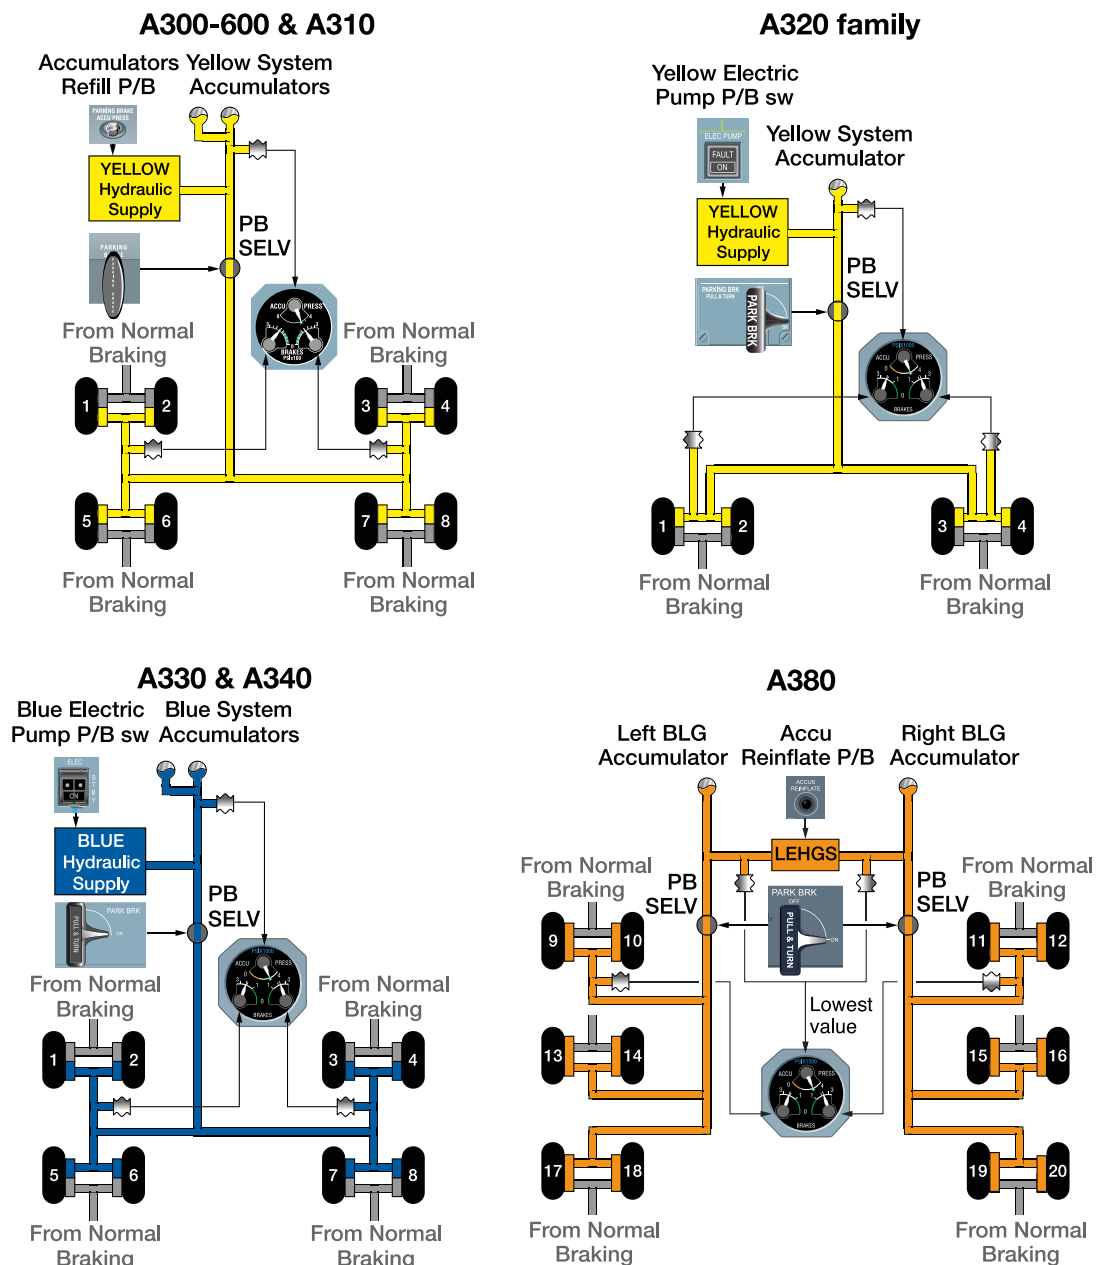
**(fig.1)**

On A300-600, A310, A320 family, A330, A340 and A380 aircraft, the BRAKES and ACCU pressure indicator located on the center instrument panel enables the flight crew to quickly check the available accumulator pressure on its upper part and the actual pressure applied to the brakes on its lower part **(fig.1)**.

Functional schematics of the parking brake system

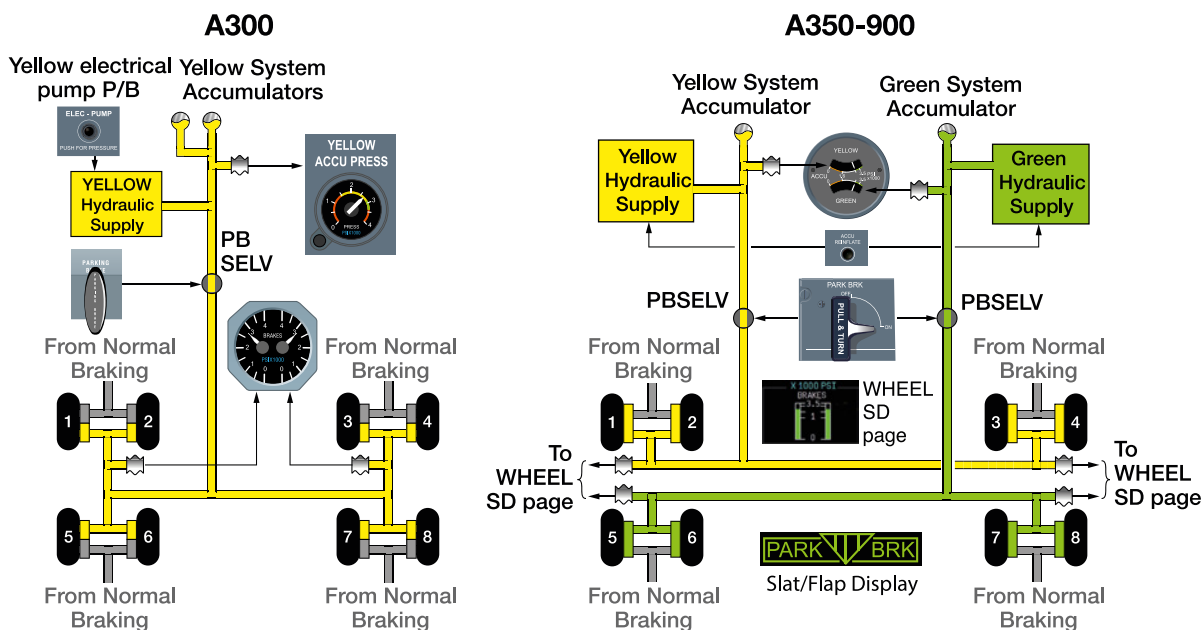
**(fig.2)**

On A300 aircraft, the YELLOW ACCU PRESS indicator located on the overhead panel provides yellow accumulator pressure indication to the flight crew. The brake pressure indicator located on the center instrument panel provides measurement of the actual pressure applied to the brakes **(fig.2)**.

On A350 aircraft, the ACCU pressure indicator provides pressure indication from both green and yellow accumulators. The flight crew can check the pressure applied to the brakes on the SD WHEEL page or check that the PBSELV is open and that sufficient pressure is applied to the brakes when the Slat/Flap display shows the green **PARK BRK** indication **(fig.2)**.

Functional schematics of the parking brake system for A300 and A350 aircraft (A350-1000 not represented)

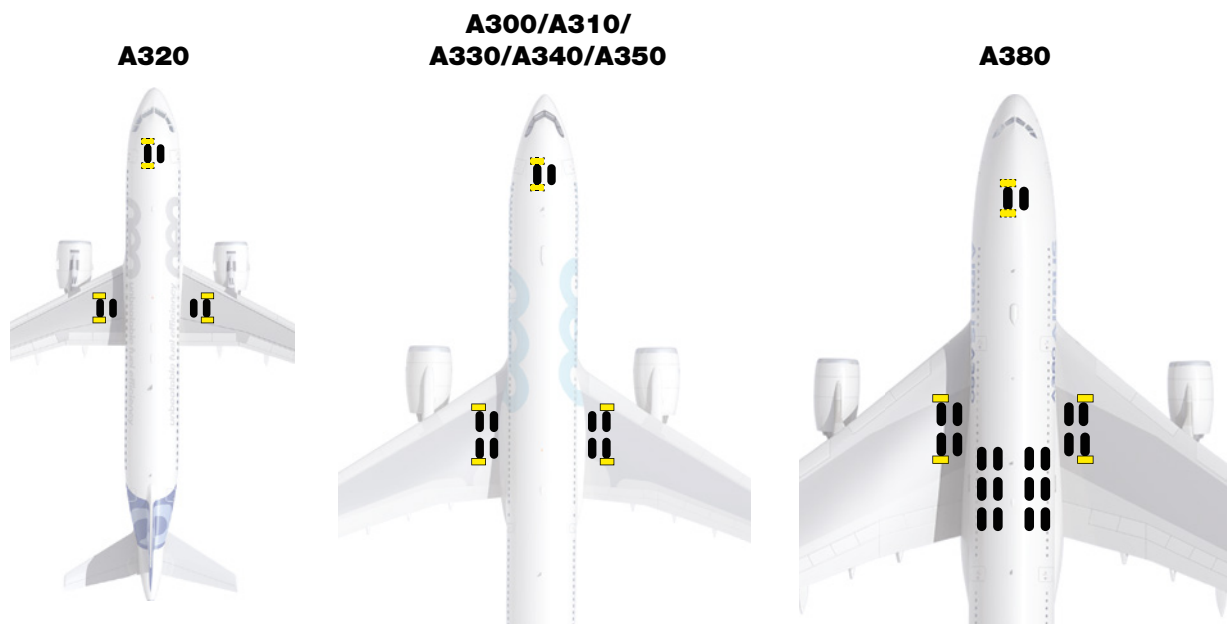
**(fig.5)**

Recommended location  
of chocks during transit

Airbus recommends to first place a set of chocks on one wheel of the nose landing gear as soon as the aircraft comes to a stop. Then two sets of chocks should be placed on the outboard wheels of the main landing gear only when the engines are switched off and spooling down. Chocks on the NLG can now be removed if it is required **(fig.5)**. The ground operator must notify the flight crew that the chocks are in place.

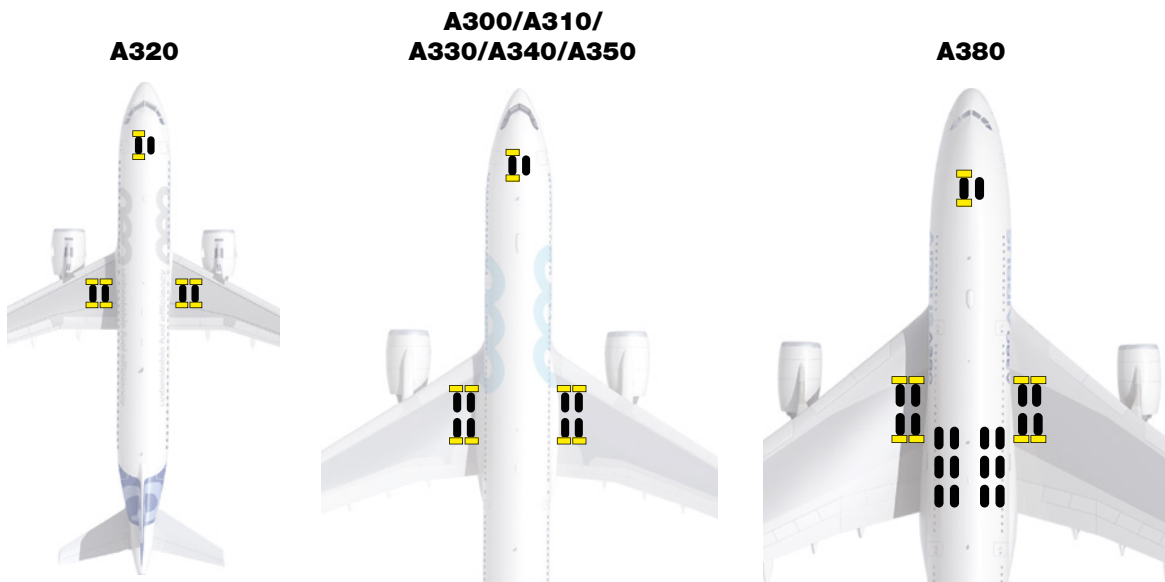
**(fig.6)**

Recommended location of chocks during night stop, long stay or in strong wind conditions

For a night stop, a long stay or in the case of strong wind, Airbus recommends to keep the nose landing gear chocks in place and also secure the inboard wheels of the main landing gear with additional sets of chocks **(fig.6)**.

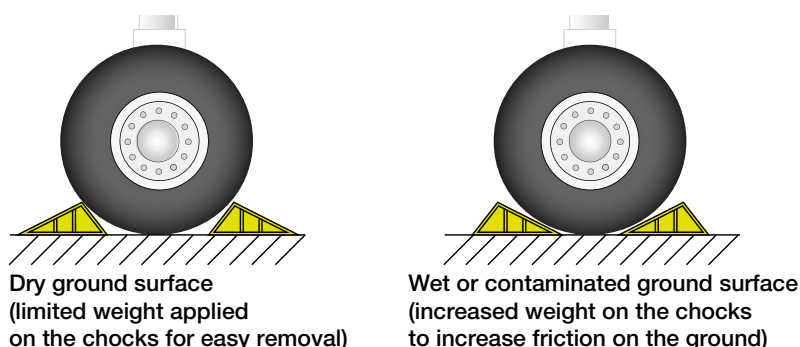
**(fig.7)**

Example of chocks with asymmetric design adapted to apron state

The recommended chocks are made of urethane type material and have an asymmetric design enabling optimum efficiency depending on if the apron is dry or wet/contaminated **(fig.7)**.
