# The importance of the pre-flight, flight controls check

**By: Albert Urdiroz**  
*Flight Safety Manager*

# 01 January 2005

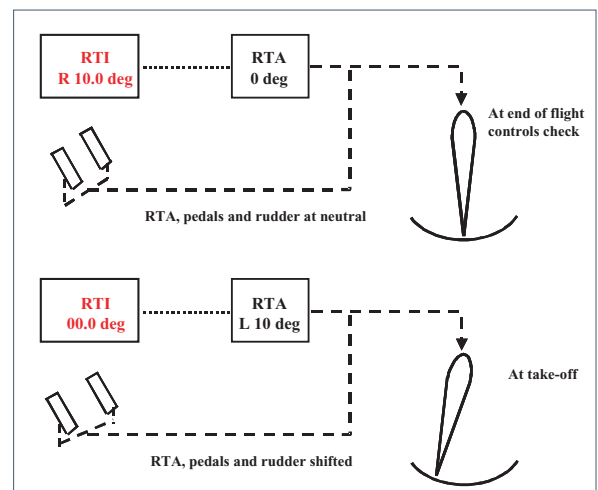
At the end of the F/CTL check, rudder trim indicator (RTI) was showing some rudder trim input. However rudder and rudder pedals were at neutral. Pedals and rudder trim are linked.

Rudder trim indication was manually brought back to neutral with no further check. This shifted the rudder, the rudder trim actuator and the pedals out of neutral.

Take-off was performed with the shift first compensated by inputs on the pedals and then by the autopilot yaw actuator once autopilot was engaged. But the rudder moved sharply to the rudder trim position once the autopilot declutched and the aircraft experienced an unexpected and sudden bank.

Such an event is covered with criteria 3, rudder at neutral with controls (what includes rudder trim) at neutral. There was no warning triggered to the crew, but it could have been detected by carefully performing the existing Standard Operating Procedures (SOP) F/CTL Check.

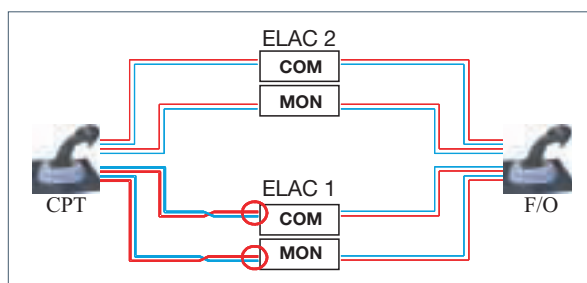
Figure 3: Cross connection of sidestick roll signals to F/CTL computer

Upon troubleshooting, a maintenance error was found. A wiring inversion had been made between the transducer unit of Captain roll sidestick and ELAC 1, on both the COMMAND & MONITOR channel. With this double inversion, ELAC 1 was receiving consistent signals, and thus could not detect the anomaly and could not trigger a warning to the crew (Figure 3).

The functional check required after performing AMM tasks had partially been performed on the F/O side only, and thus the anomaly was not detected by mechanics. Crew missed the last opportunity to detect it by not carefully performing the existing SOP F/CTL Check.

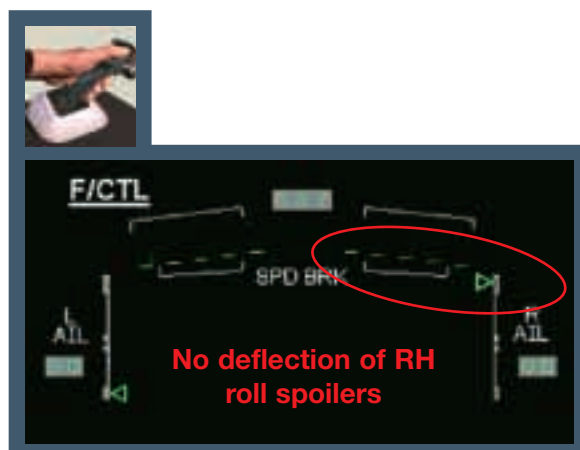
Figure 4: Lack of response from RH spoilers to sidestick inputs

Another example is an in-flight turn back due to reduced ability to turn left experienced just after taking off with an A320. Almost full left sidestick inputs were required in order to laterally control the aircraft. At 1500ft, ECAM warning "F/CTL SPLR FAULT" came up with all right hand roll spoilers shown inoperative.

During a previous maintenance task, R/H spoilers 2 to 5 were left in the maintenance position. After lift-off, they deployed to the zero hinge moment positions and would not respond to inputs.

Preventive instructions have been added in AMM, and monitoring has been improved to trigger an ECAM warning in such condition. But it could also have been detected by carefully performing the existing SOP F/CTL Check (Figure 4).

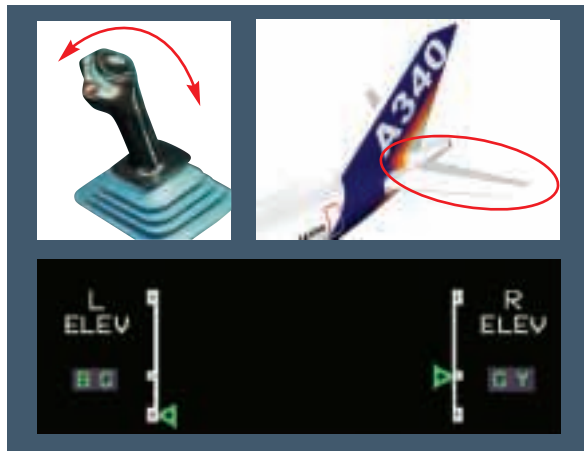
■ Figure 5

A few events of this kind have been experienced with aircraft of the A340 family. The crew detected during the pre-flight F/CTL check that one elevator was stuck down (Figure 5). The loss of the elevator control was not indicated to the crew by any warning.

These events resulted from failure of the servo-control in damping mode failed. Investigating these events has allowed definition of modifications to both the servocontrols and the F/CTL computers in order to prevent similar events. Appropriate ECAM warnings are triggered for crew annunciation. For these events, detection was ensured by carefully performing the existing SOP F/CTL Check only. Additional information about these event is available with

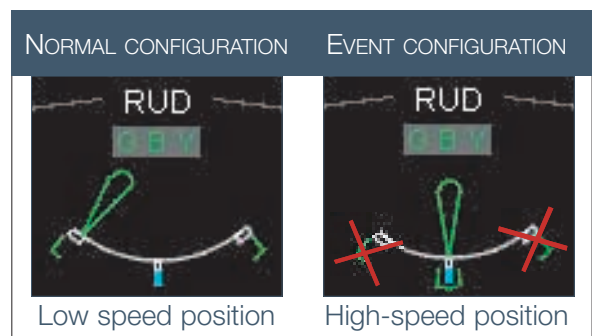
■ Figure 6: Full rudder deflection not achieved

The Rudder Travel Limitation Unit (RTL) had failed closed in the high-speed configuration. The ECAM warning “F/CTL TRAVEL LIM FAULT” dedicated to the monitoring of the RTL position was not displayed.

Indeed, at that time, FCSC which is the computer that controls the RTL and PTLU did not monitor their behaviour during phases when they are not electrically supplied and thus not supposed to move. However the RTL system failed and RTL closed during such a phase of no monitoring on ground. Monitoring has since been reviewed.

The failure was thus detected only by performing the existing SOP F/CTL Check, and the right decision to return to the gate could be taken.
