# Thrust Reverser Selection is a Decision to Stop

This article describes an event where the flight crew performed a go-around after they had selected thrust reversers on an A320 aircraft. The reverser on one engine remained deployed until the end of the flight.

# CASE STUDY

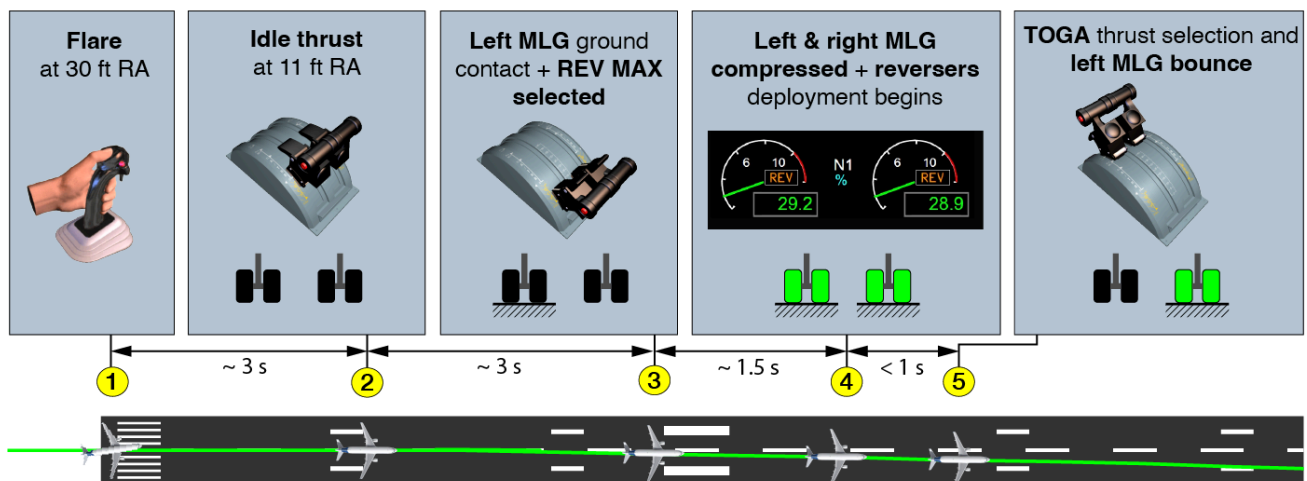
An A320 aircraft fitted with CFM56 engines was on an ILS approach in FLAP 3 configuration with good visibility conditions. There was a 25 kt crosswind and wind gusts from the left side (fig.1).

① The PF initiated the flare slightly above 30 ft RA, started the decrab maneuver at 24 ft RA, and ② set the thrust levers to idle at 11 ft RA. ③ The left Main Landing Gear (MLG) briefly touched the runway, but was not fully compressed when the flight crew set the thrust lever to maximum reverse.

④ When both the left and right MLG touched the runway and were compressed, the thrust reversers began to deploy. ⑤ The flight crew then decided to perform a go-around. The left MLG was briefly uncompressed when the PF applied TOGA thrust. They selected CONF2 and applied nose-up inputs.

(fig.1) Sequences of the event from landing flare to the application of TOGA thrust for go-around

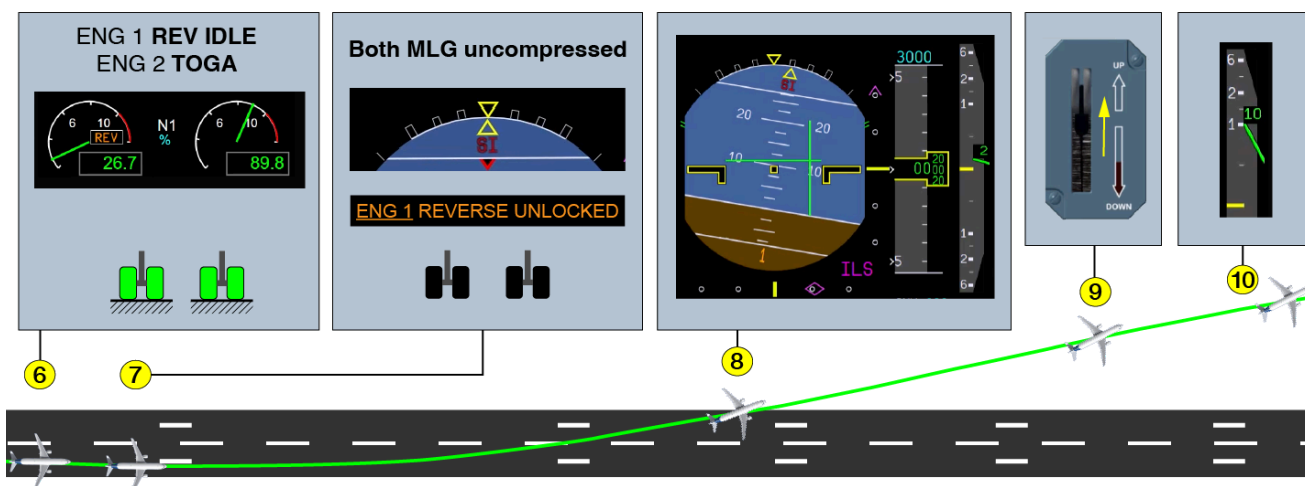
⑥ ENG 2 spooled up to reach TOGA thrust, but ENG 1 remained at idle with the **REV** indication still displayed on the Engine Warning Display (EWD) (fig.2). The aircraft began to veer to the left. The PF reacted and applied a half of maximum right rudder input. Both the left and right MLG were briefly compressed again. ⑦ The aircraft continued to veer to the left and the **ENG 1 REVERSE UNLOCKED** ECAM alert triggered when the left and right MLG were uncompressed. The beta target symbol on the PFD was flagged. ⑧ The aircraft overflowed the left runway edge by 1 ft.

⑨ The flight crew commanded the landing gear up and the aircraft started to climb on a trajectory that was shifted by approximately 20° to the left of the runway axis. When the landing gear was retracted and the pitch was set close to 12.5°, corresponding to the target for go-around with one engine inoperative, ⑩ the vertical speed reached 1 000 ft/min.

(fig.2) Sequences of the event after TOGA thrust selection

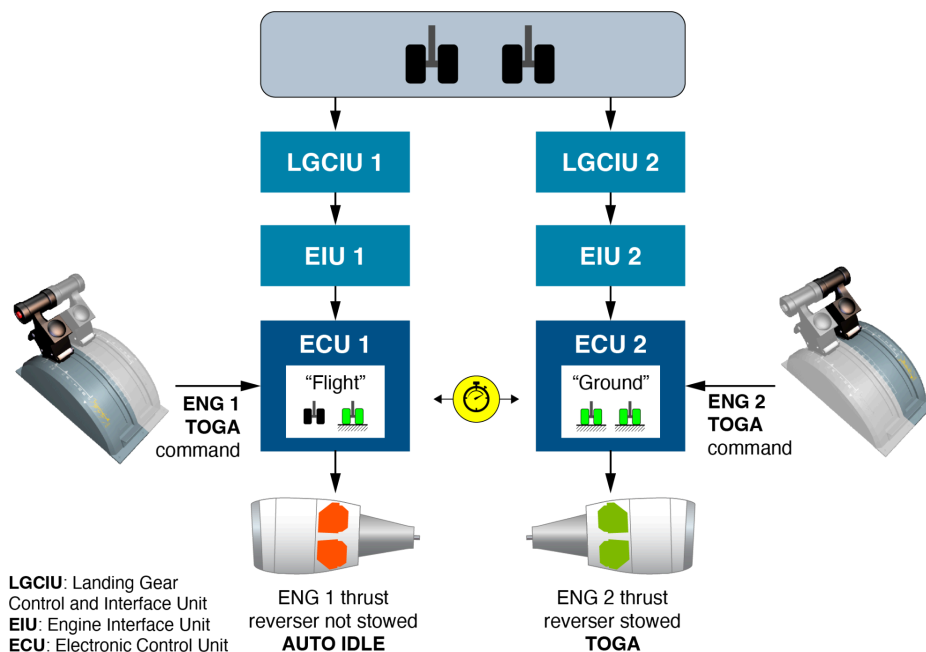
When the PF set TOGA thrust, ECU 1 computed the "flight" status using information from LGCIU 1. ECU 1 did not send a stow command to the ENG 1 reverser and its

blocker doors remained deployed. The automatic idle protection activated and sent a signal to prevent ENG 1 increasing thrust. What caused the difference between ENG 1 and ENG 2

A short asynchronism between the computation of the ground/flight status by both ECUs, combined with a bounce of the left landing gear, explains the different behaviors of the ECUs. This timing difference can be explained by the fact that thrust levers may not be closely aligned when the flight crew moves them from the REV sector to idle or forward thrust sector. In addition, a very slight delay may appear between the signals and computation chain of LGCIU-EIU-ECU, which are independent for the left and right sides (**fig.4**).

**(fig.4)** A short delay between the computation of the “ground” or “flight” status by ECU 1 and ECU 2, combined with a left MLG “bounce” condition caused the ENG 1 thrust reverser blocker doors to remain deployed and ENG 1 set at AUTO IDLE

An update of the ECU software for CFM56 engines is under development. It includes an enhanced stow logic in the case of a rejected landing with reversers already selected, which will prevent recurrence of the event described in this article. The ECU software update is planned to be available in 2025 for CFM56-5B engines and is under review for CFM56-5A and -5C.

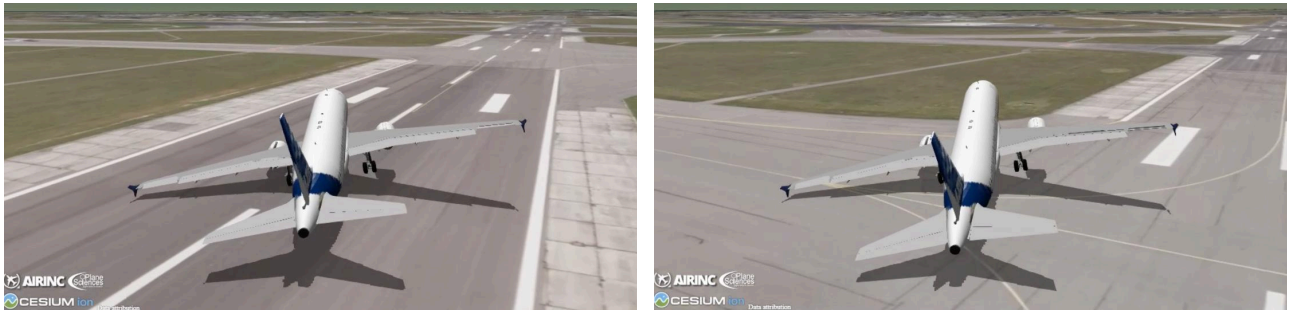
In the initial phase of the go-around, the aircraft attitude went close to wing tip and tailstrike conditions (**fig.5**) but remained within the ground clearance limits. ■

(fig.5) Screen captures from the video reconstruction of the event showing the aircraft attitude in the early stage of the go-around phase (Flight Animation System from APS Aerospace)
