## Use the Correct BARO Setting for Approach

Using an erroneous barometric reference setting during approach may cause the aircraft to fly lower than the published approach path, when the vertical guidance and trajectory deviations use the barometric reference. This can lead to a risk of controlled flight into terrain in poor visibility conditions or at night.

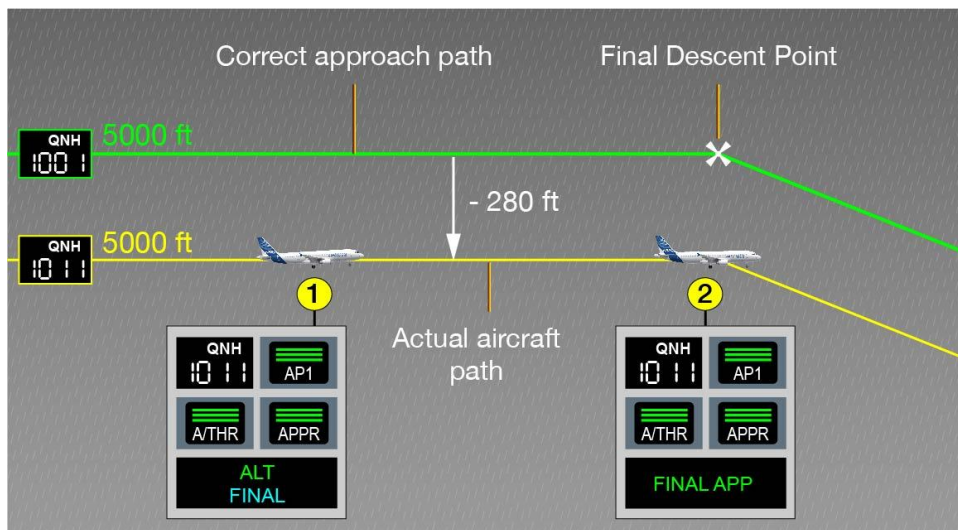
① The aircraft leveled off at 5000 ft QNH 1011 hPa (**fig.1**). This placed it approximately 280 ft below the intended altitude of 5000 ft with a correct QNH of 1001 hPa. With autopilot and autothrust ON, the A320 reached its Final Descent Point and ② commenced its final descent using **FINAL APP** guidance mode. The aircraft was flying with no visual reference and light turbulence through a rain shower.

(fig.1) The aircraft commenced its approach 280 ft below the published approach

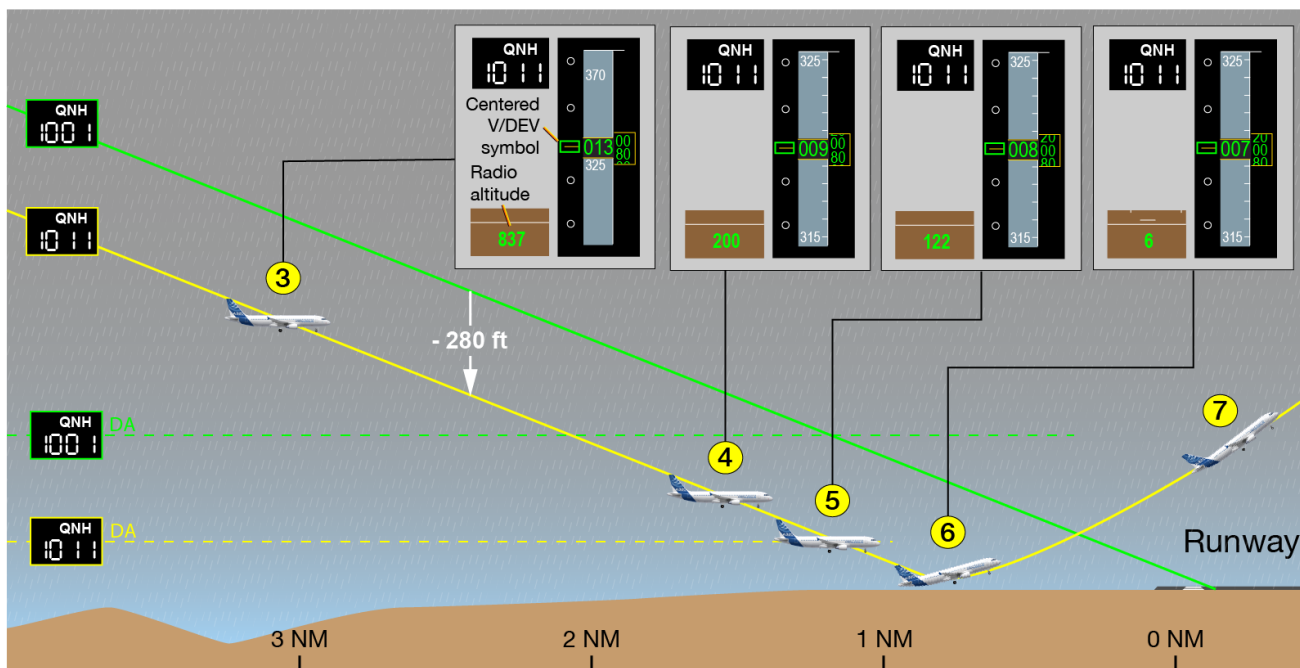
③ At 1392 ft indicated altitude (1000 ft above the airfield altitude), the aircraft was stabilized in CONF FULL at Vapp and the ND and PFD indicated that it was on its expected horizontal and vertical flight path (**fig.2**).

④ ATC received a Minimum Safety Altitude Warning (MSAW) when the aircraft was 1.53 NM from the runway threshold and had an indicated altitude of 891 ft.

⑤ The aircraft passed an 802 ft indicated altitude, corresponding to the Decision Altitude (DA) of the published approach plus 50 ft as per the airline policy. ATC transmitted a warning to the flight crew stating that they had an MSAW and asked the flight crew to confirm they had the runway in sight. The PF initiated a go-around 6 seconds after crossing the DA, at 735 ft indicated altitude.

⑥ The aircraft radio altitude indicated a descent to 6ft during the go-around maneuver. ⑦ The flight crew announced the go-around seconds later and were vectored for a second approach.

**(fig.2)** After the initiation of the go-around, the aircraft descended as low as 6ft radio altitude before climbing

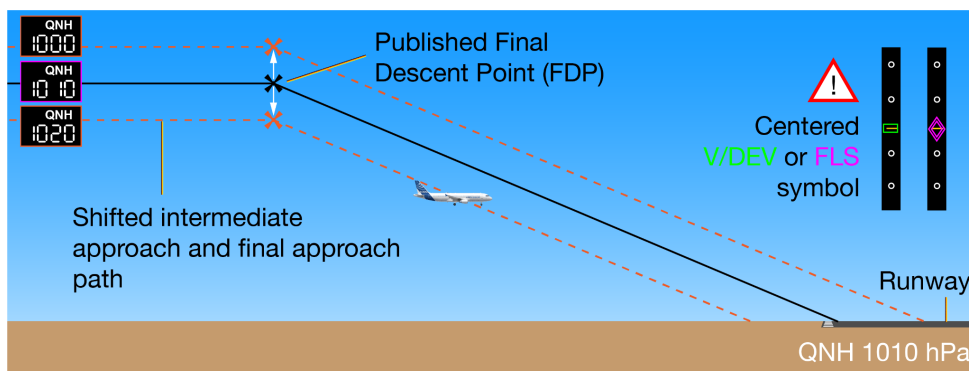
The FMS uses the aircraft barometric altitude to compute the deviation of the aircraft trajectory with the computed final descent path. If an erroneous barometric altitude is used, the aircraft will follow a flight path that is parallel to the published path but is shifted either above or below it **(fig.3)**. The vertical deviation symbol, or the FLS symbol, will indicate that the aircraft is on the correct flight path even if it is not the case.

**(fig.3)** Example of the effects of an incorrect BARO setting on A320 family aircraft

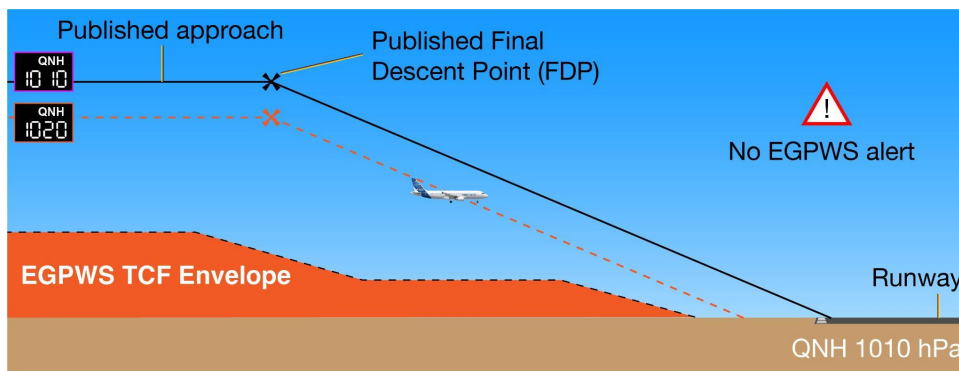
The relative proximity of the actual flight path to the published path prevents the **TOO LOW TERRAIN** EGPWS alert from triggering, because the path remains outside of the Terrain Clearance Floor (TCF) alert envelope (fig.4).

(fig.4) The TAWS may not detect a too low flight path

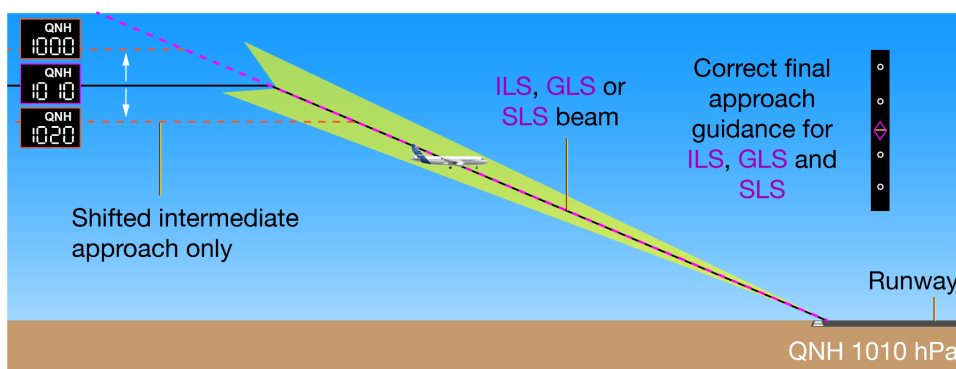
The final approach path of approaches using ILS, GLS, or SLS guidance are not affected, because the **G/S** guidance mode uses the ILS signal or a beam computed with an augmented GPS altitude. The final approach path will remain aligned with the correct ILS/GLS/SLS beam even if the intermediate approach segment shifts due to the erroneous barometric setting (fig.5).

(fig.5) The final descent path of ILS, GLS, and SLS modes is not affected by an erroneous barometric setting
