# Use of Non-Certified Equipment on Cockpit Windows

The use of non-certified equipment, like sunshades or suction cup mounted devices, on the inner surface of cockpit windows may create risks to the windows integrity and therefore aircraft safety.

This document highlights the risks associated with non-certified equipment used on cockpit windows. It provides operational recommendations to flight crews and recalls that certified tablet holders, mounted on the windows' frame, are available as a safe alternative.

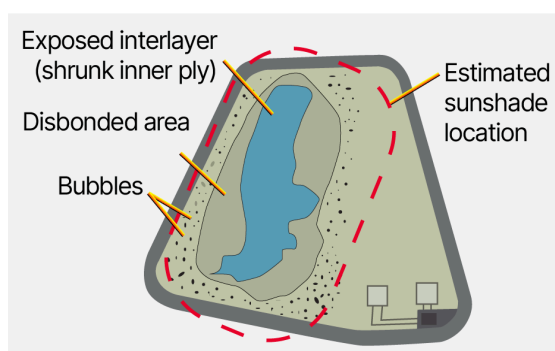
Detailed inspection by the manufacturer revealed that "the window experienced excessive temperature at the inner ply. The excessive temperatures had caused thermal relaxation of the inner ply to such an extent that the inner ply had fully relaxed back to expose the interlayer over a large area."

**(fig.2)** Mapping of the damage of the sliding window

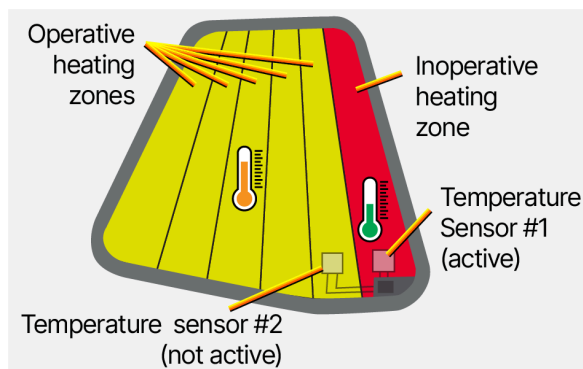
The heating film adjacent to the active(\*) temperature sensor was found to be inoperative. This failure on this type of window can cause the window heating system to incorrectly estimate the temperature of the window, resulting in an increase in temperature of the window areas with a functional heating film.

(fig.3) An inoperative heating zone caused a dysfunction of the window temperature regulation

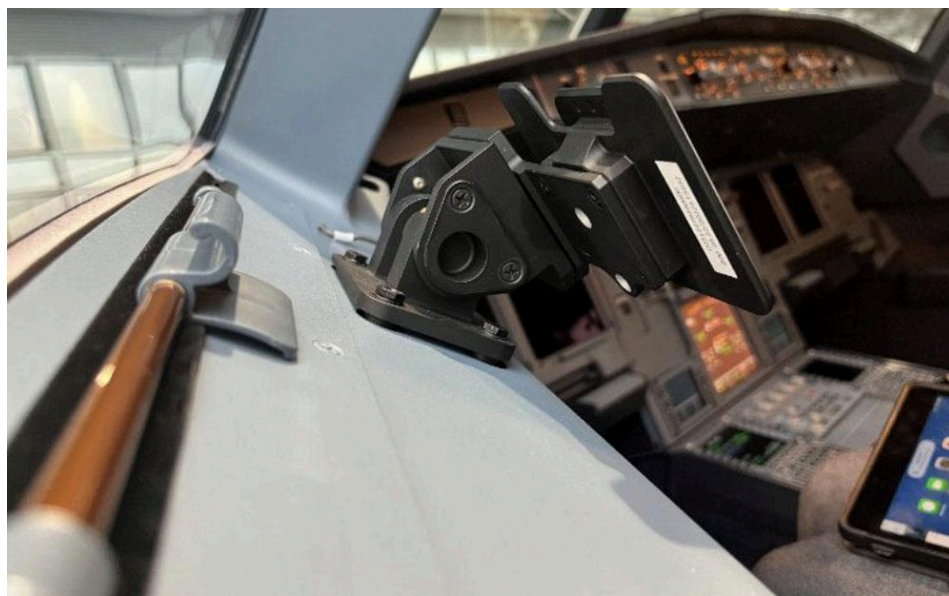
**(fig.10)** Example of a cockpit mount for tablets recommended as an option on A320 family aircraft

Airbus developed specific cockpit mounts for A320 family, A330, A340, A350 and A380 aircraft. These mounts can be installed as an option on newly built aircraft or in retrofit on in-service aircraft **(fig.10)**. They are **attached to the window's frame** and were tested to safely hold tablets in position in every condition. They are EASA and FAA approved, and designed taking into account their integration in the cockpit, and ensuring compatibility with normal and emergency operations (use of oxygen masks, accessibility to flashlight, emergency evacuation, etc...).

Operators wishing to install these mounts should contact their Customer Support Director.
