*Flight Operations Support - Customer Services Directorate*

# **GETTING HANDS-ON EXPERIENCE**

## **WITH AERODYNAMIC DETERIORATION**

### **A PERFORMANCE AUDIT VIEW**

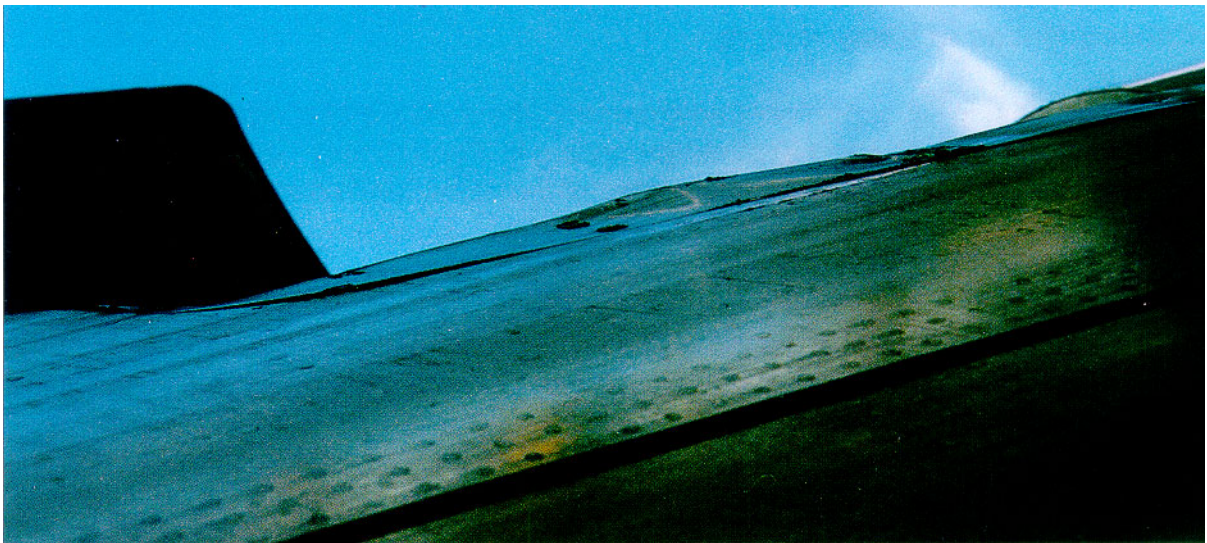
With repeated «loaders' assaults», scuff plates are frequently dented and generally present a step, generating high fuel penalties, but corrective actions are not particularly time-consuming.

Dented scuff plate

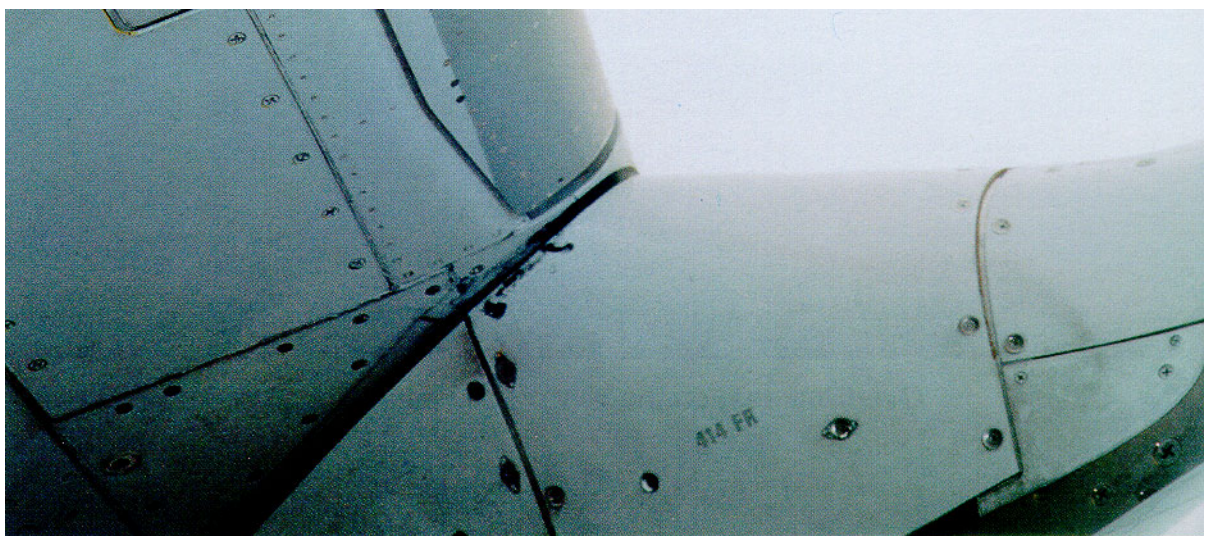
Missing seal on the wing / pylon junction

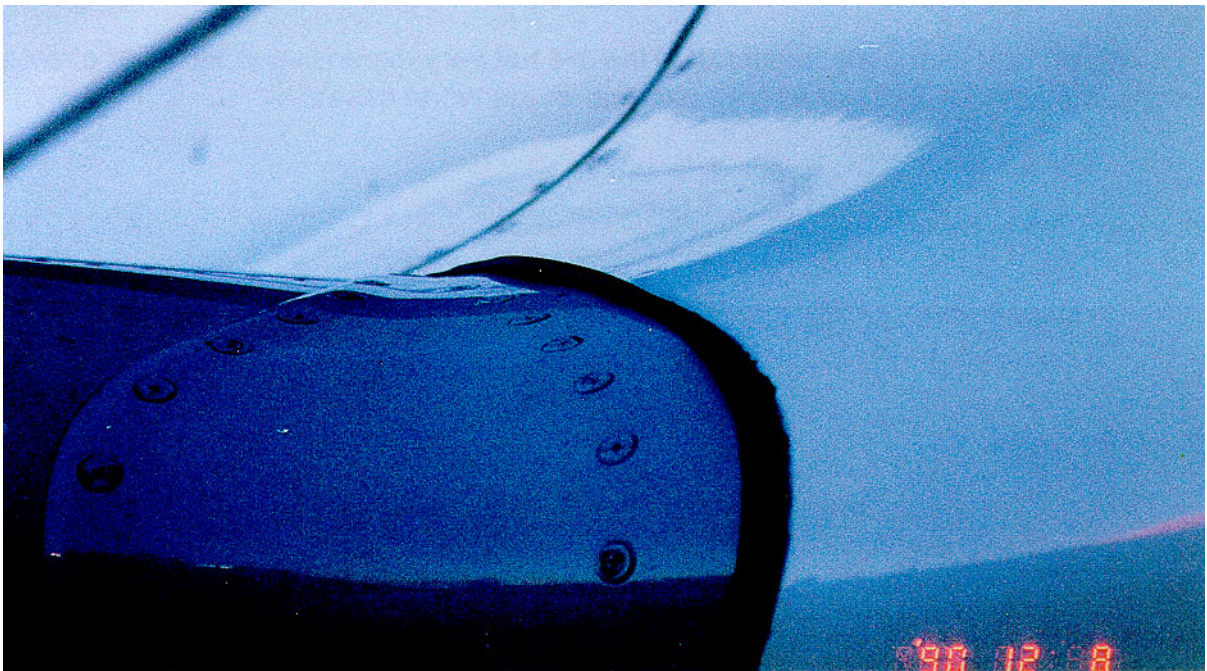
If a butt joint gap is overfilled, the penalty can be significant on the wing upper surface ( US\$330 ). The tables, corresponding to each aircraft type, show that a repair which is not properly carried out can lead to a heavier fuel penalty than existed prior to the repair (from US\$14 per aircraft per year for an unfilled butt joint gap to US\$500 for an overfilled gap on the upperwing in the sensitive «Zone 1»).

Overfilled seal on the wing / belly fairing junction

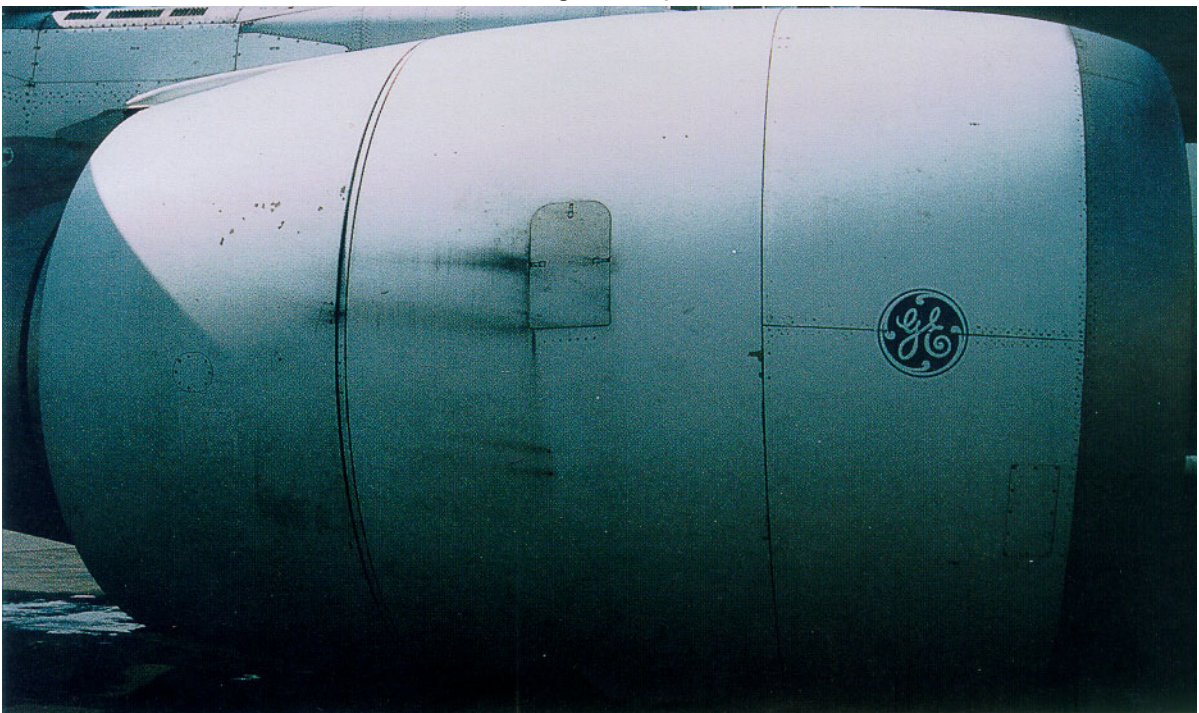
Another item, which is less obvious because it is hidden, is reverser air bleed. The associated fuel penalty is very large. Nevertheless, it can be observed by leakages on the engine cowling.

leakage traces

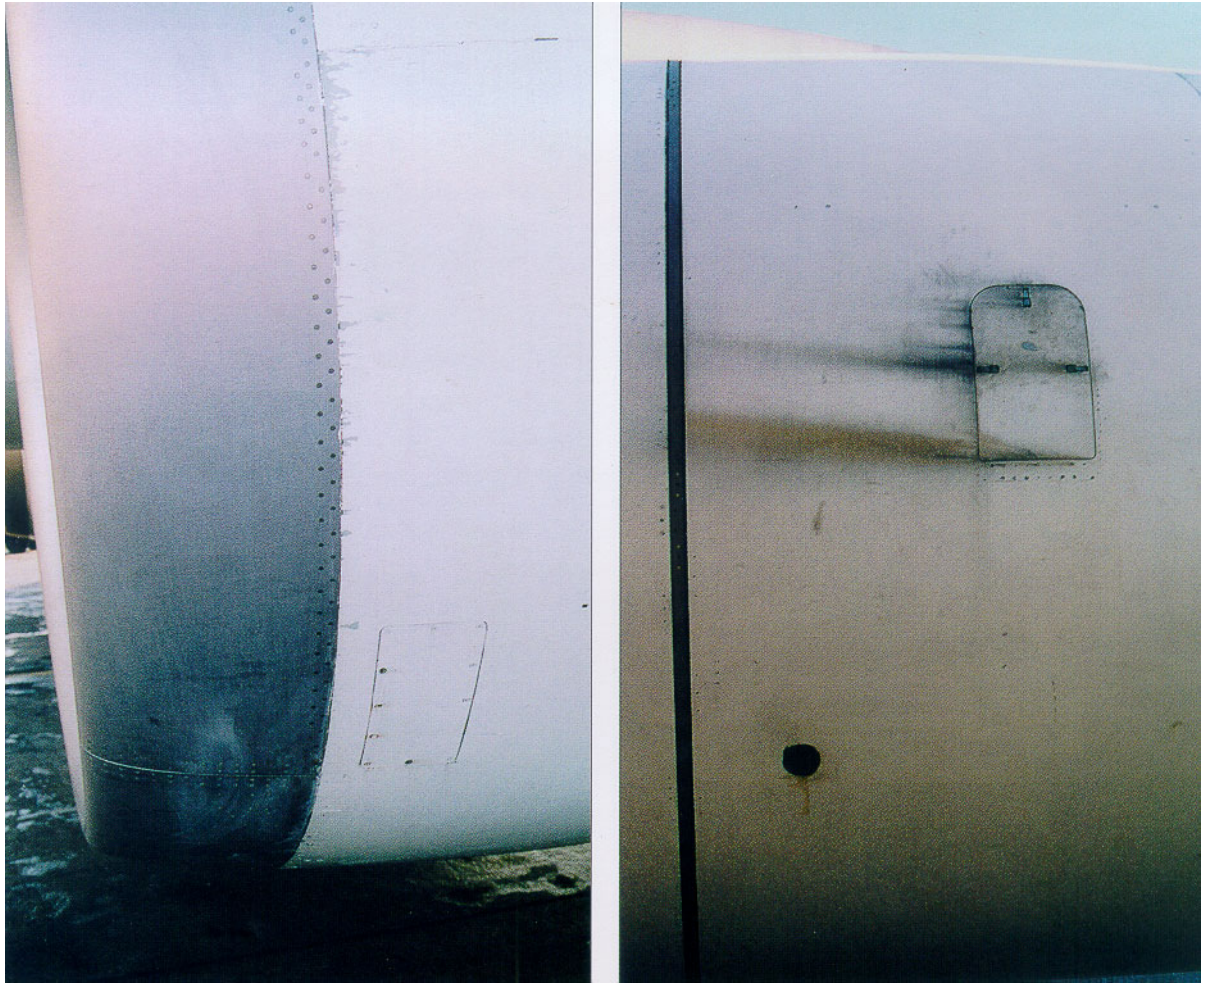
Distance due to leakage

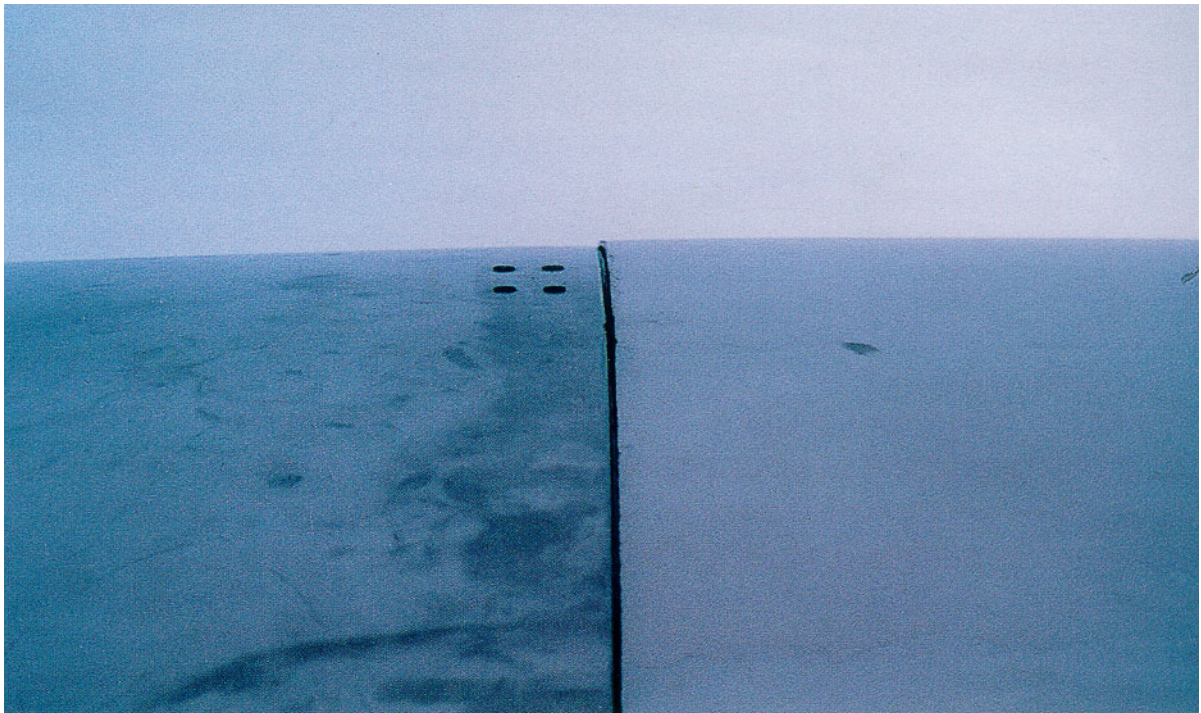
The engine cowling, due to its location in a very sensitive zone, has to be observed with great care during the Aerodynamic Inspection. All surface discrepancies incur considerable drag.

Step on engine cowl

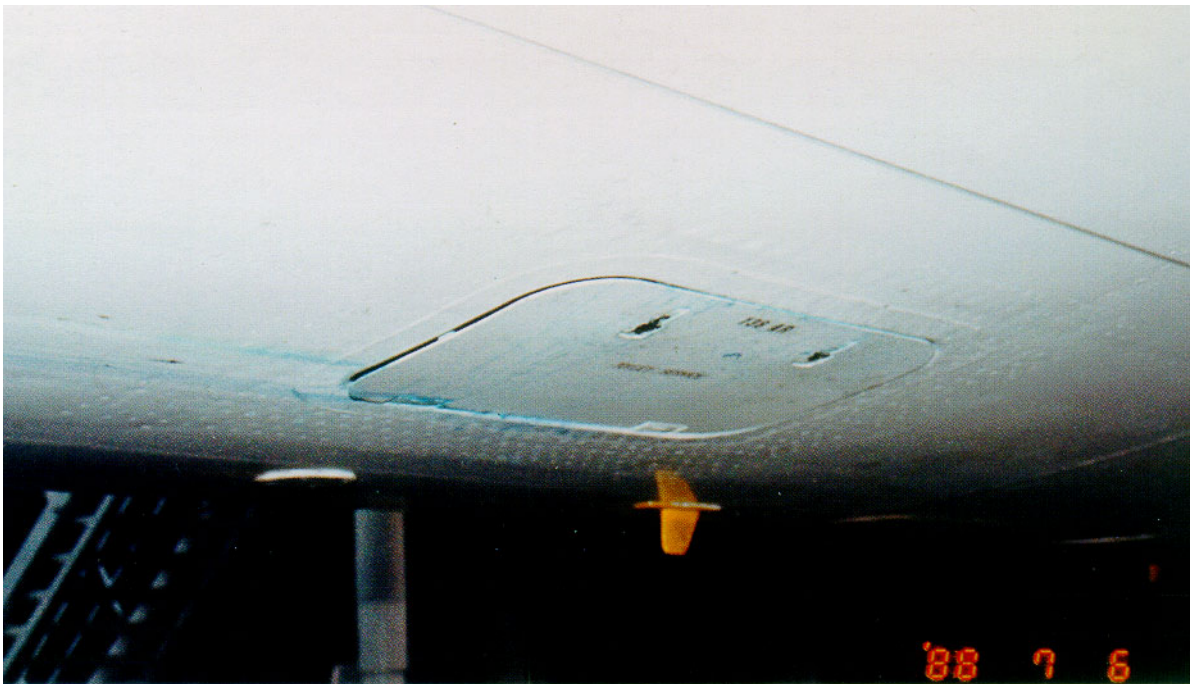
Mismatched access doors

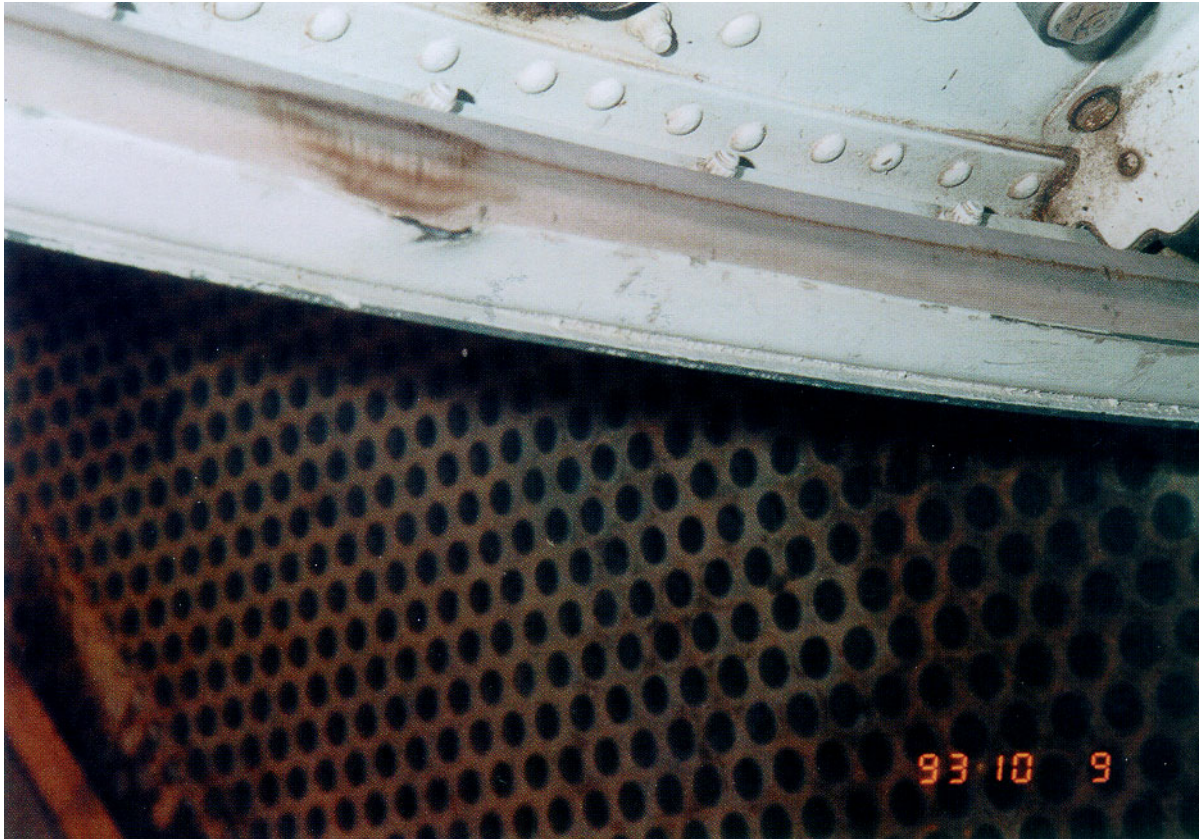
Damaged door

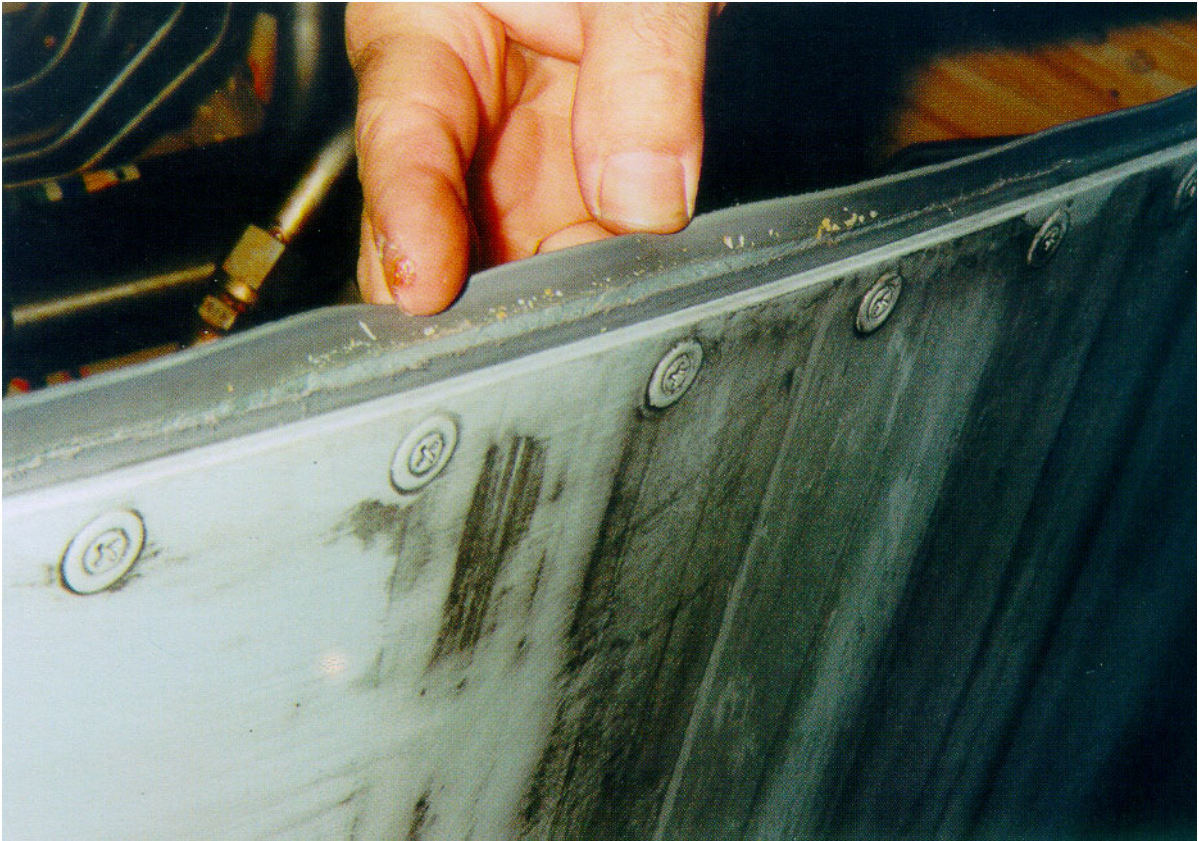
Damaged seal

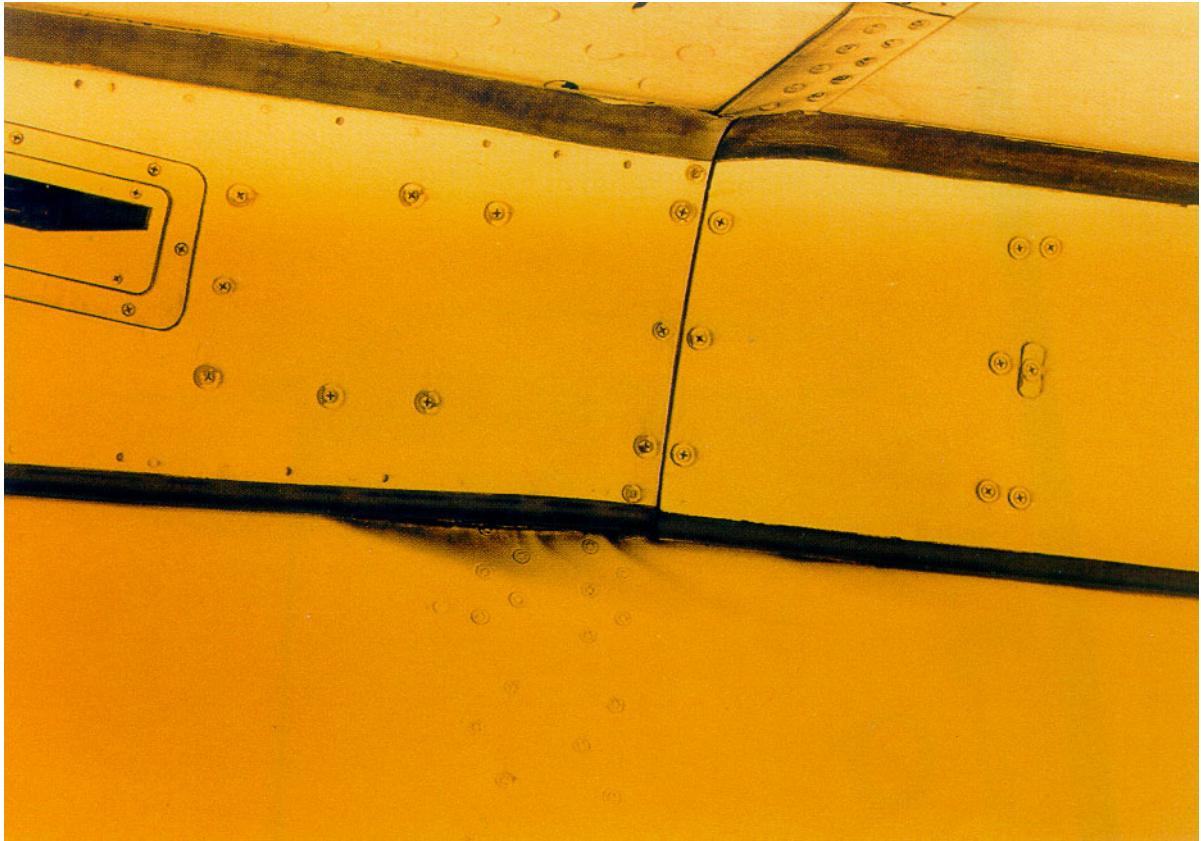
Damaged seals and leakage traces

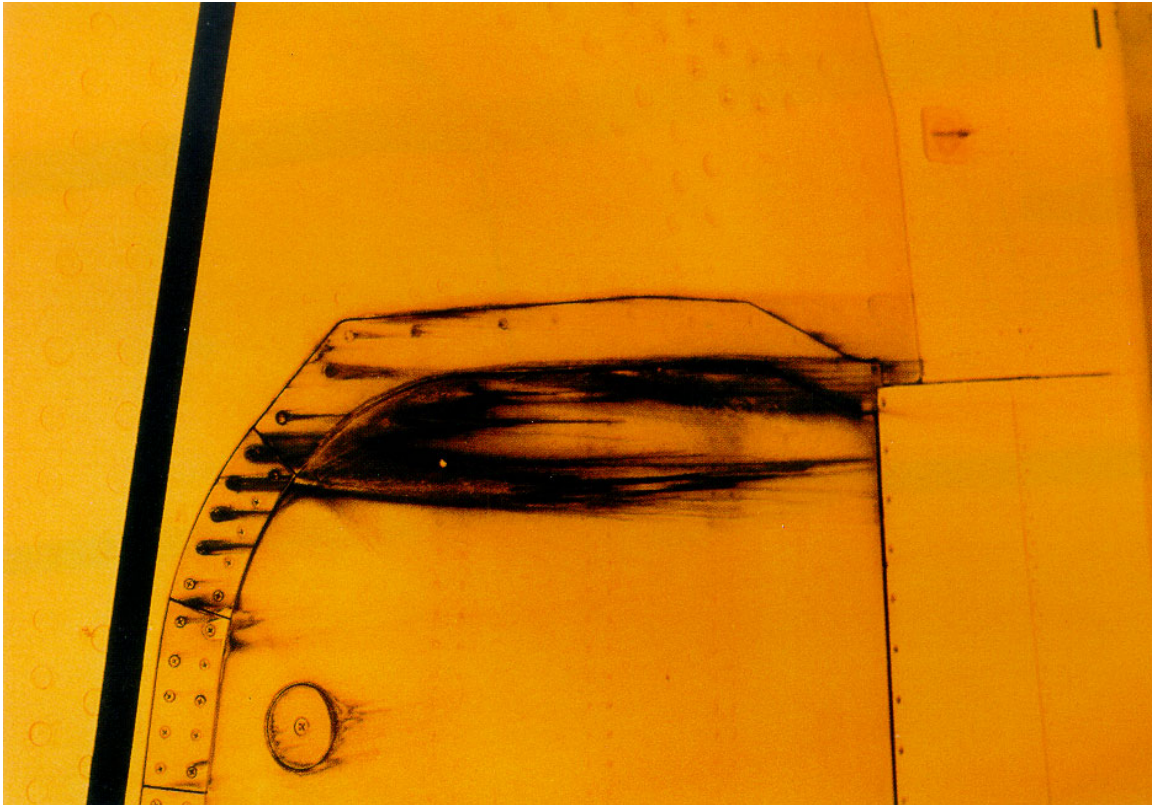
Leakage traces due to damaged seal

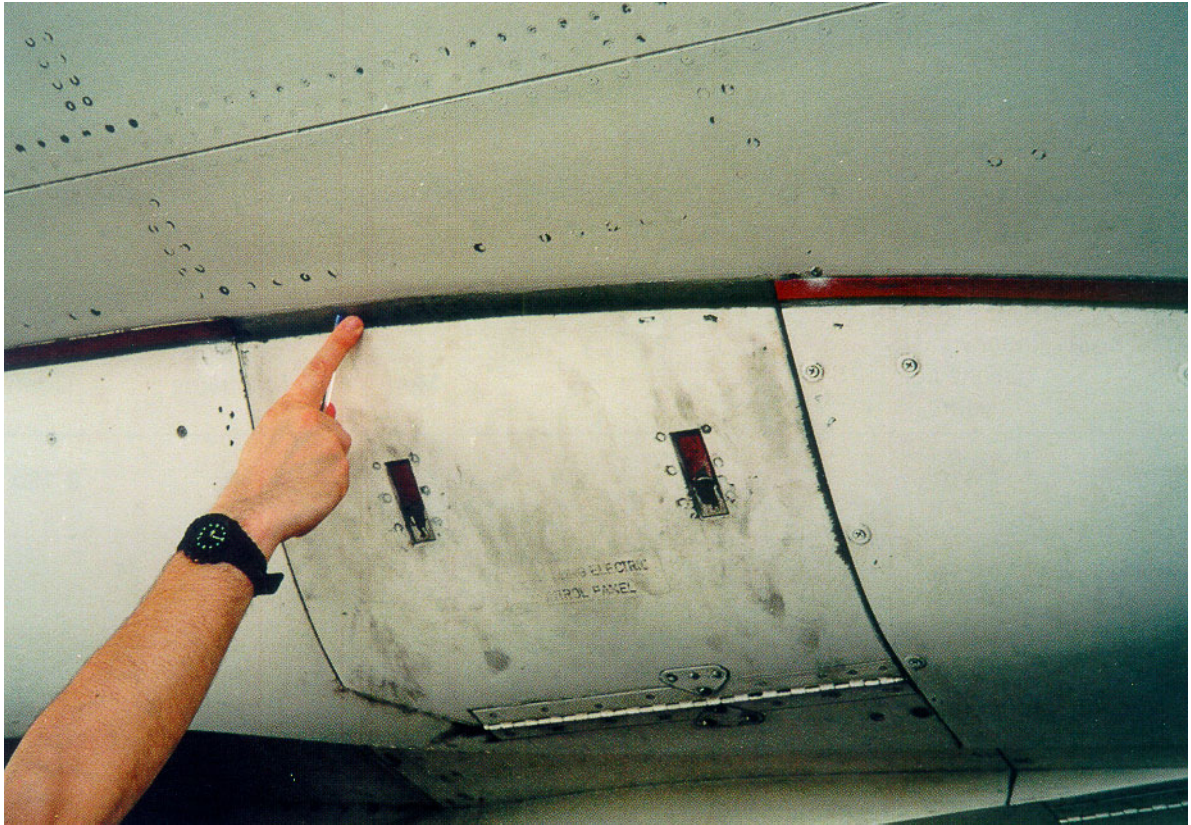
Missing service door seal

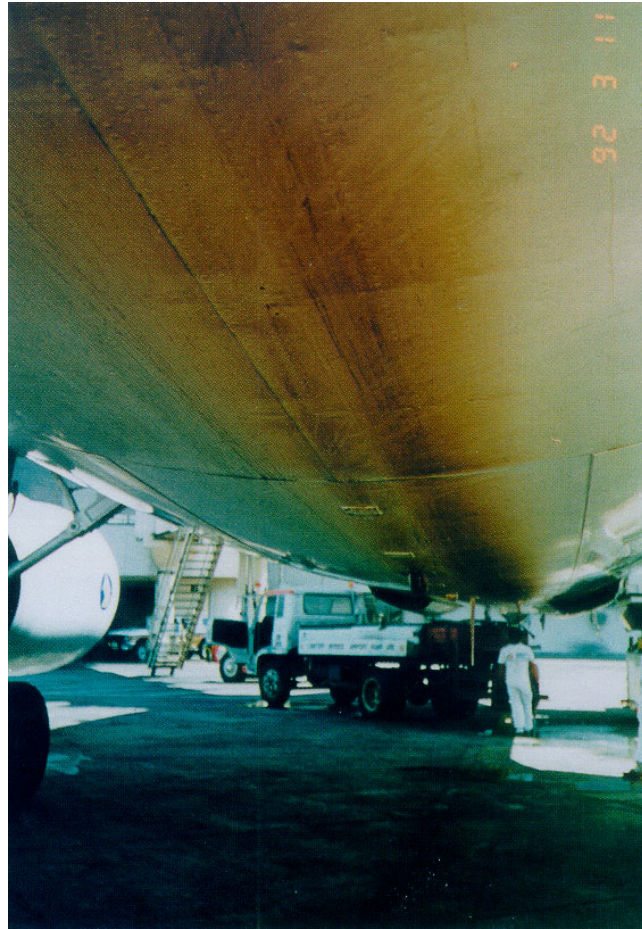
Roughness surface due to skydrol leakage on the belly fairing

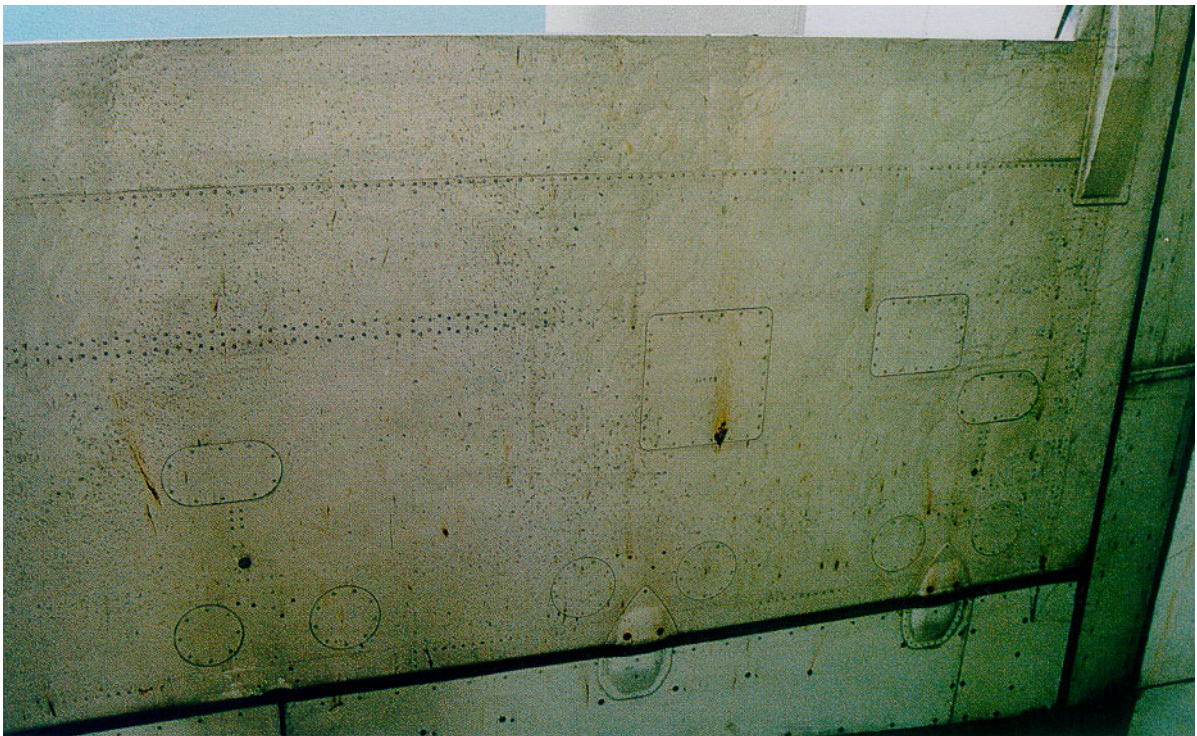
Skin roughness on lower-flap

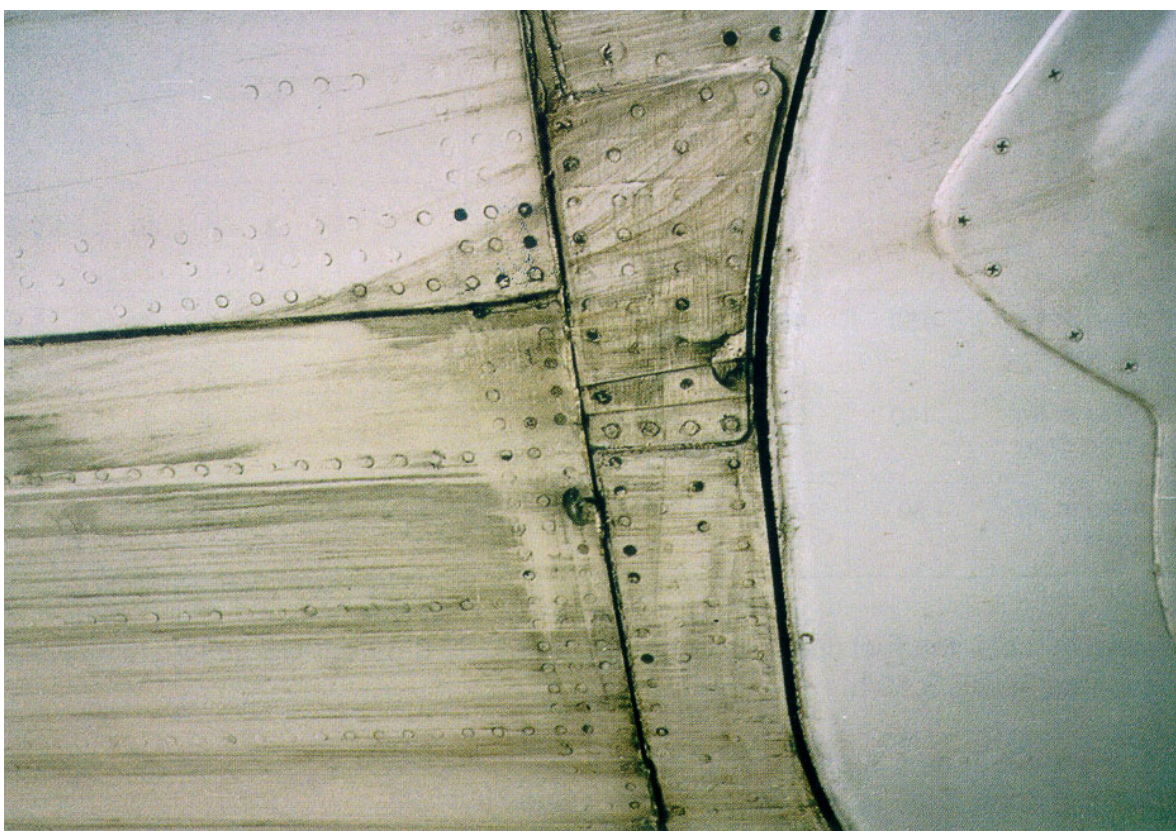
Leakage traces

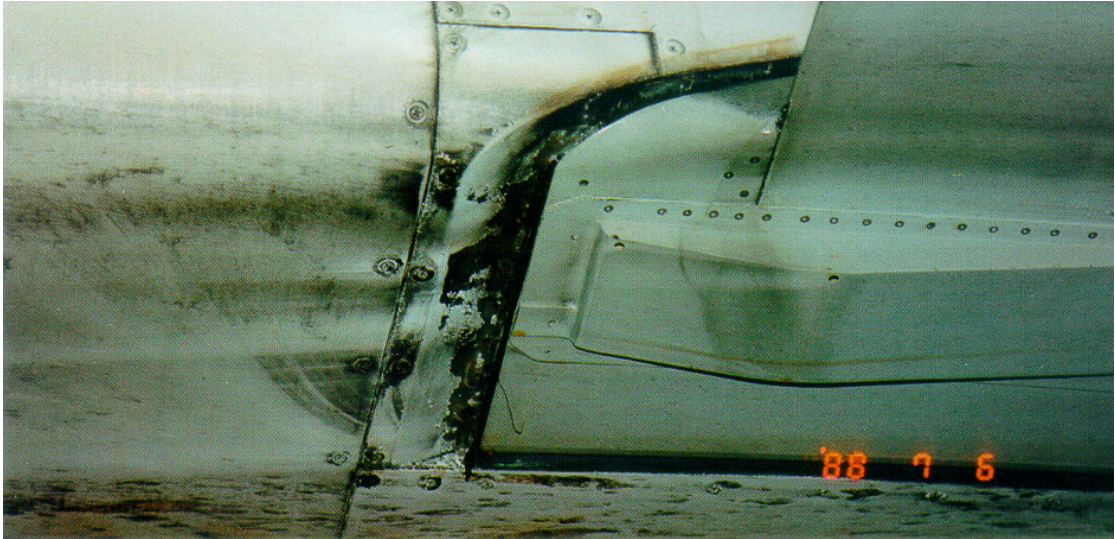
Damaged seal

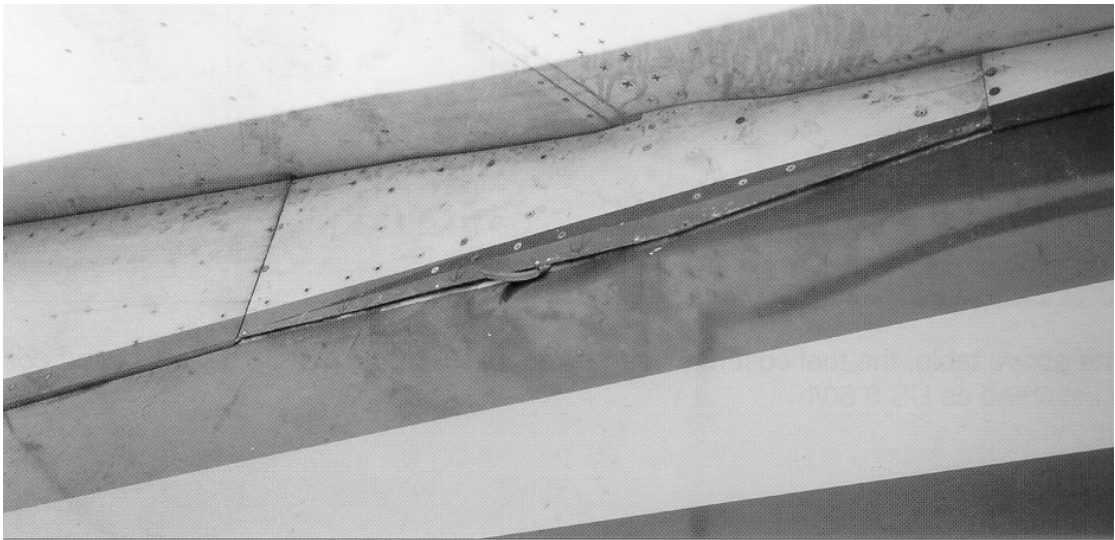
Missing seal

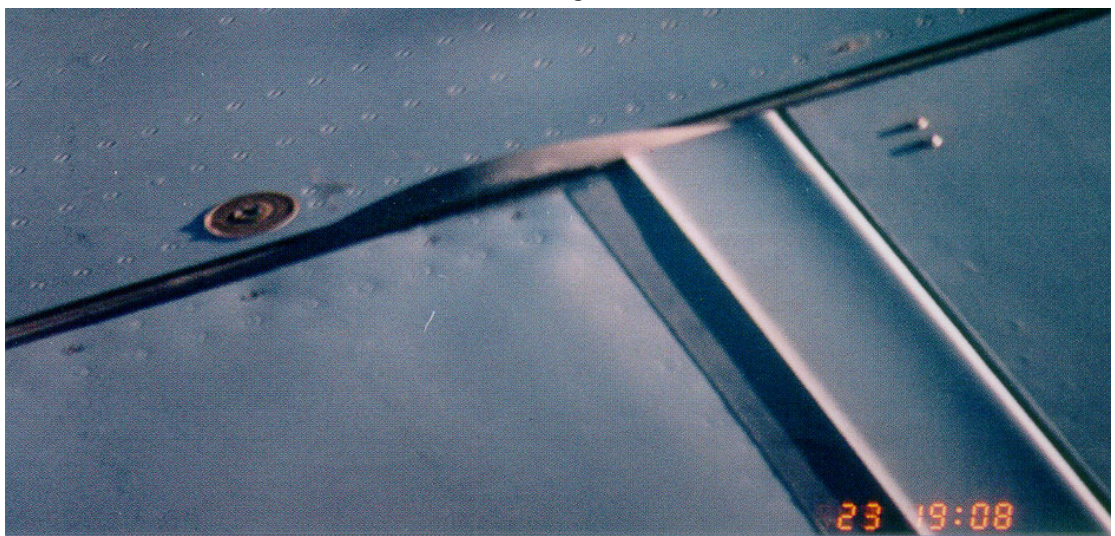
Missing seal

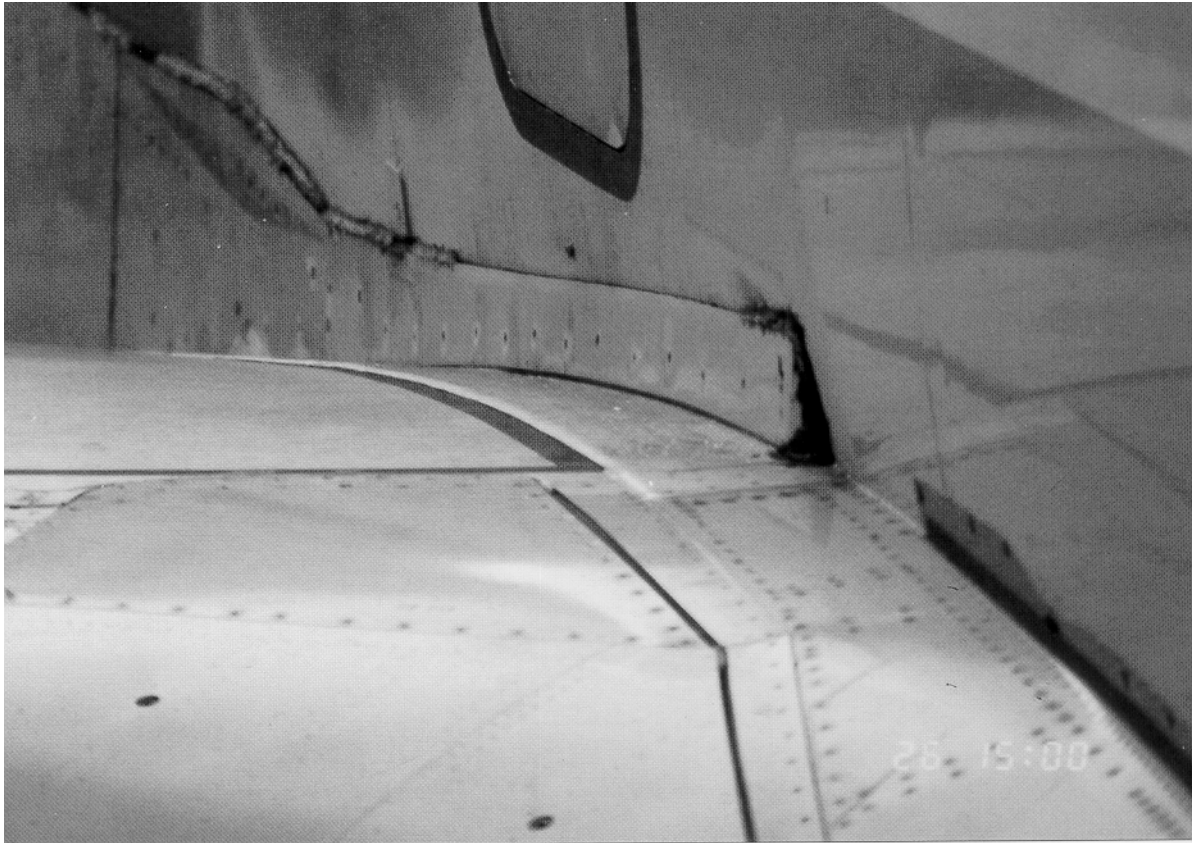
Overfilled belly fairing butt joint gaps

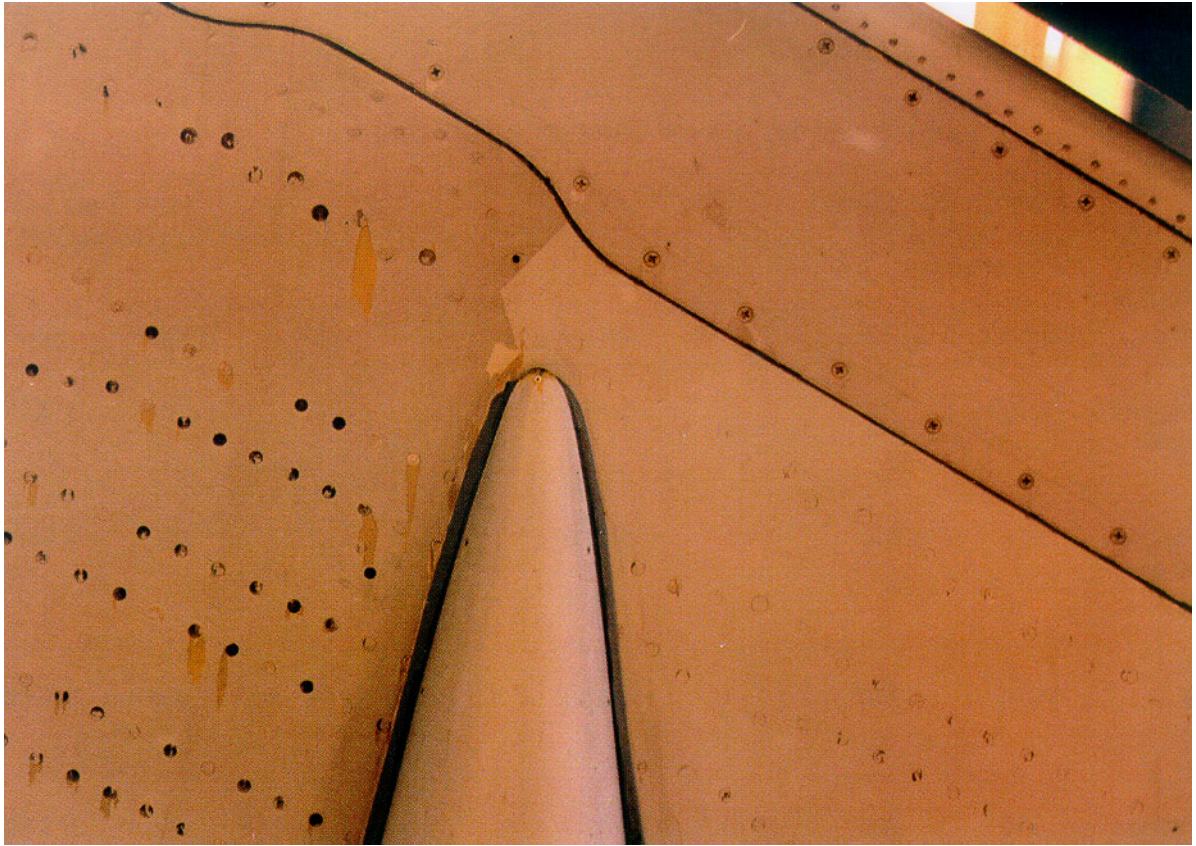
Damaged seals

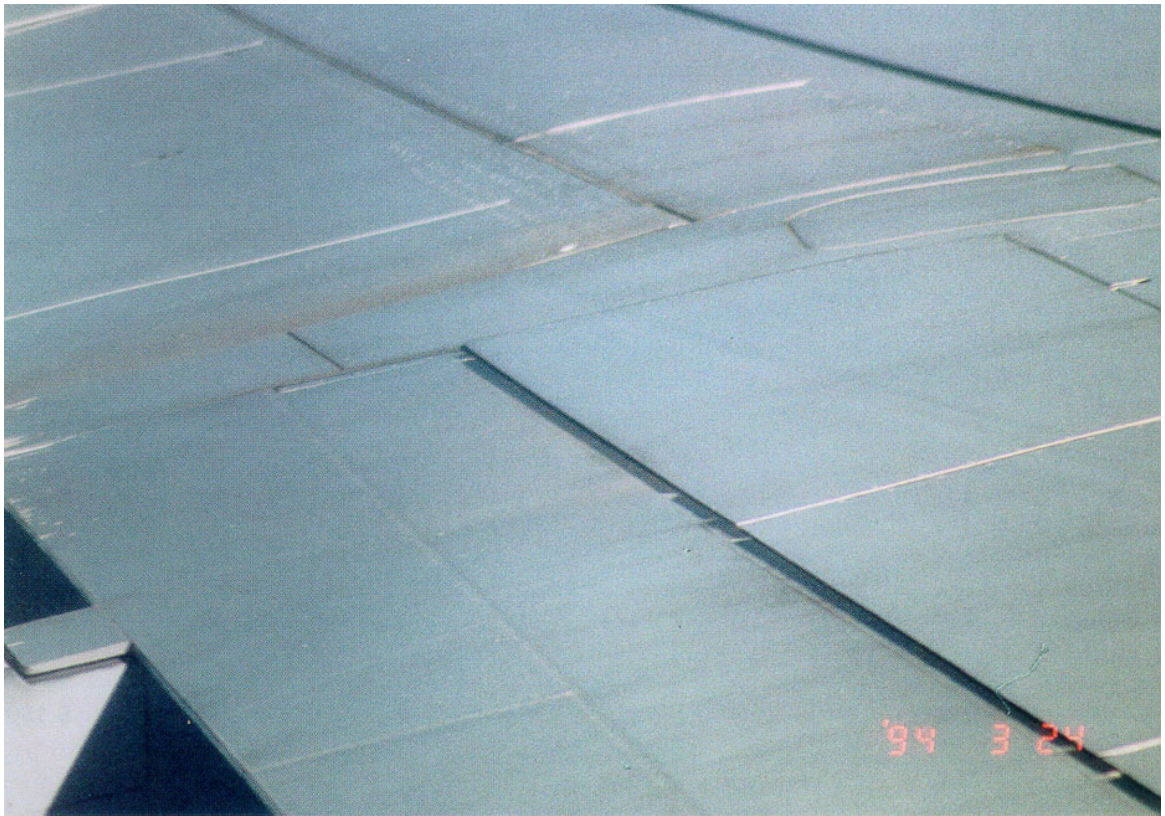
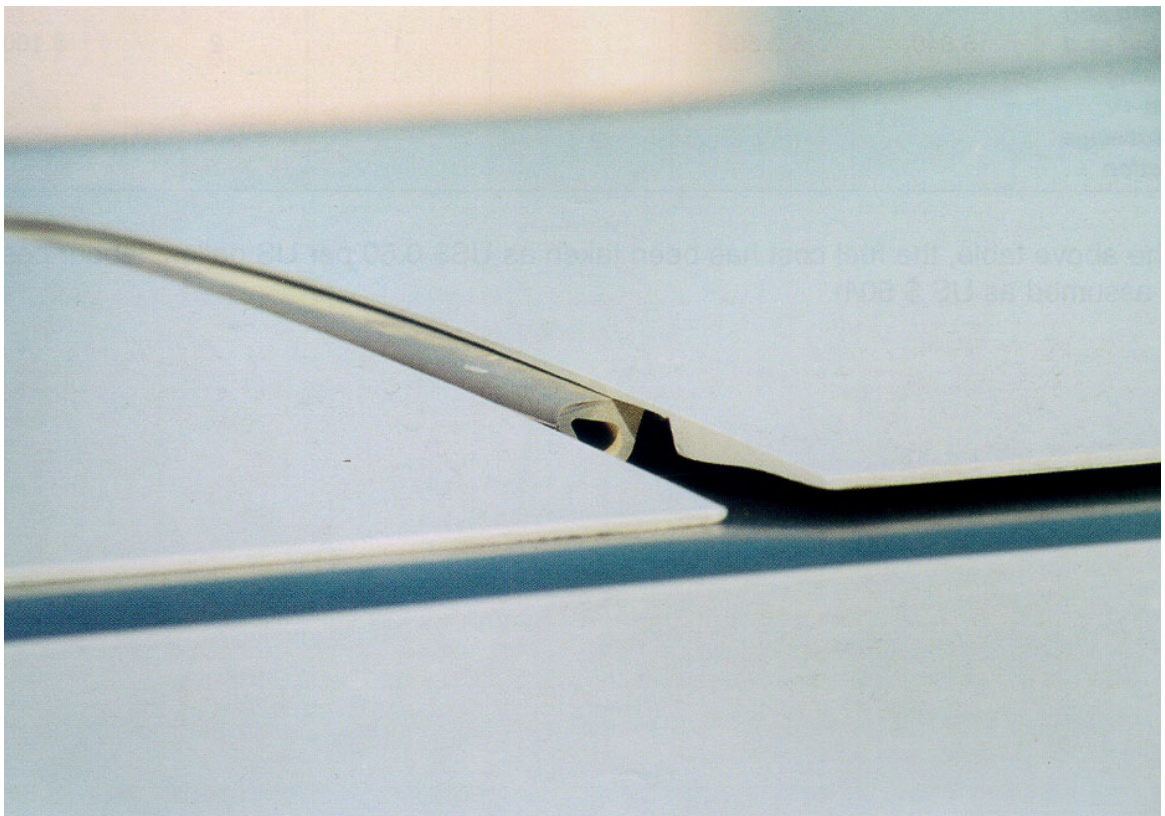
Misrigged spoilers

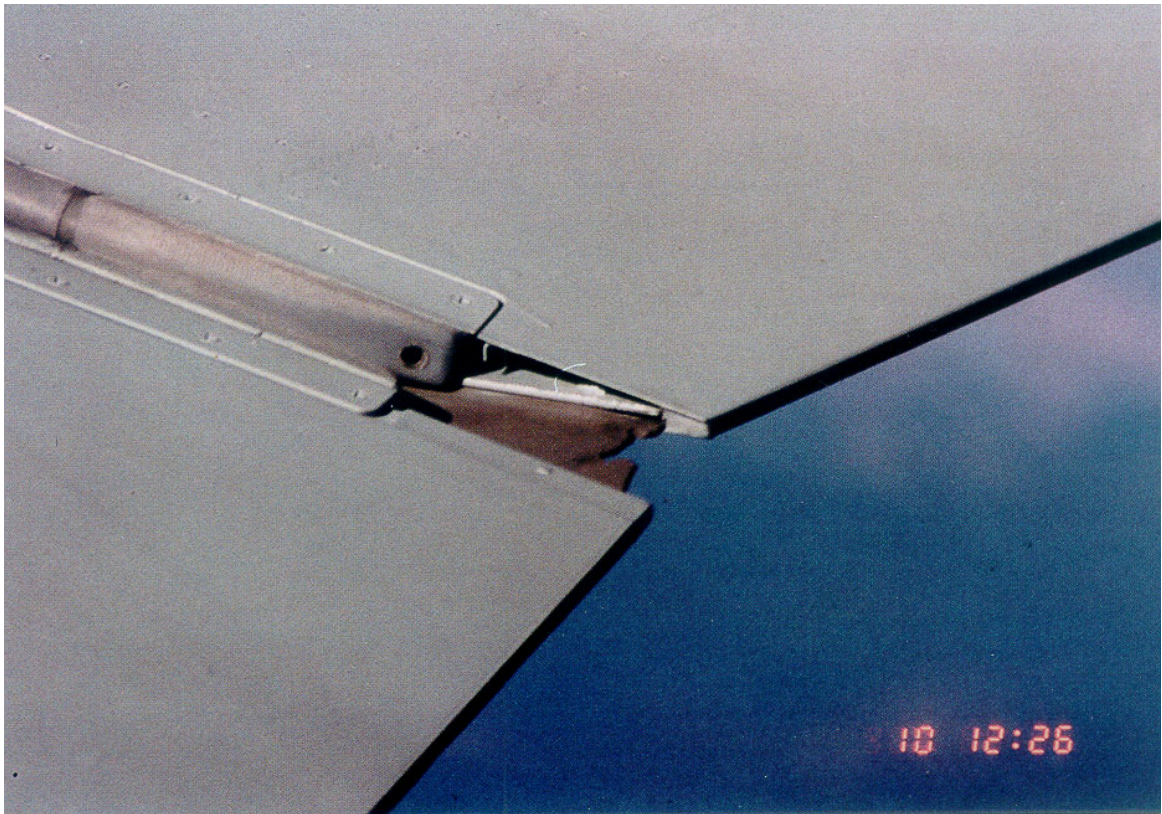
Damaged chordwise flap seal

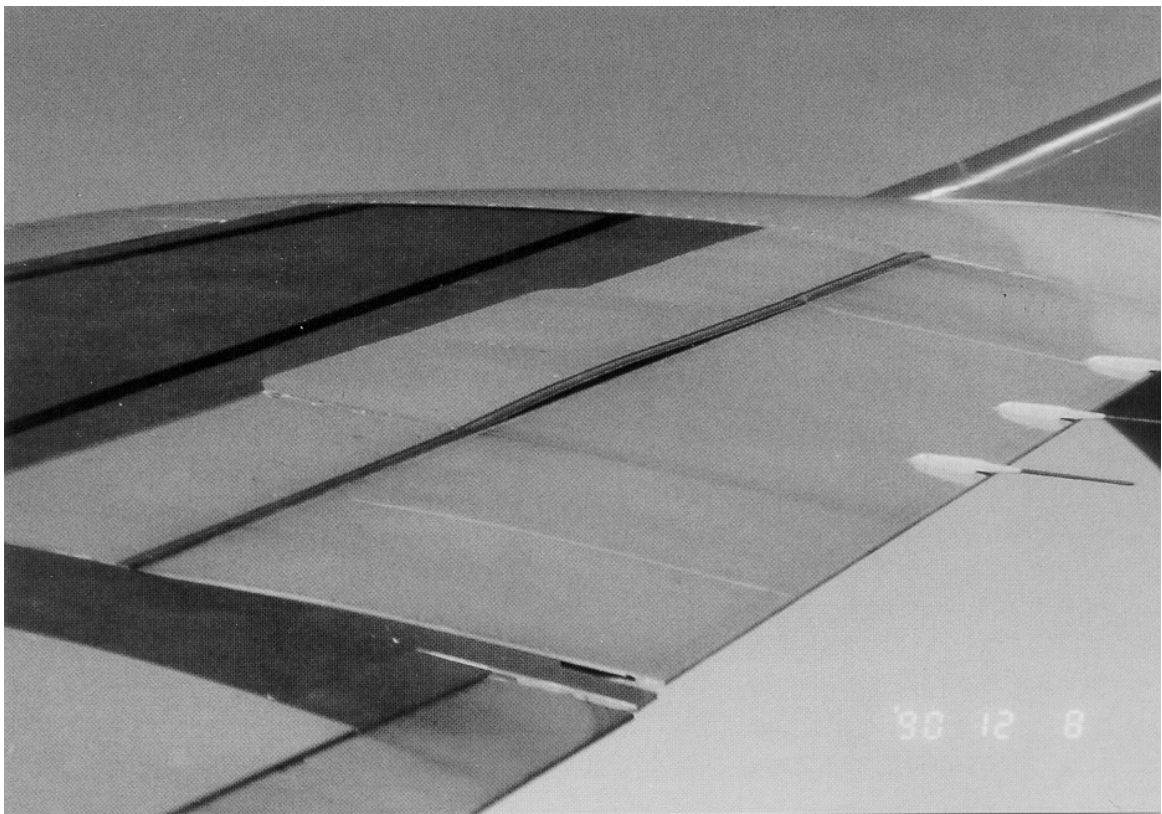
Damaged spanwise aileron seal

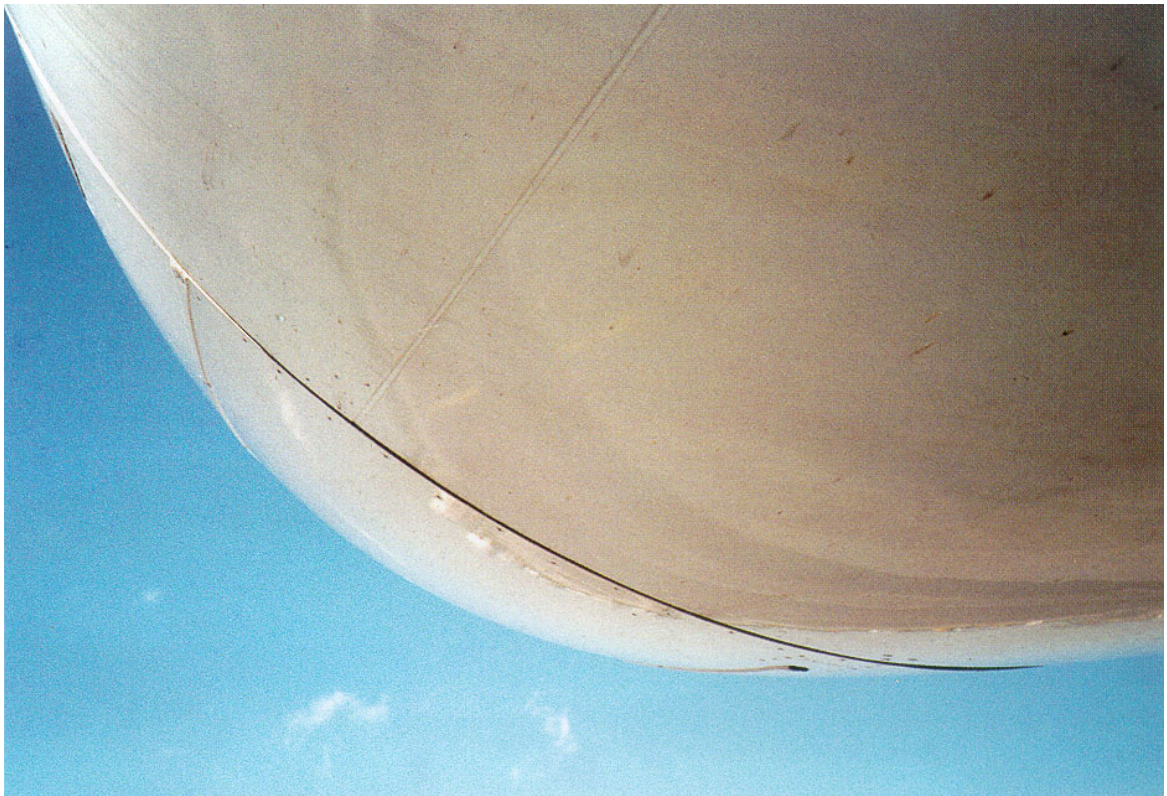
Radome misfit
