*Flight Operations Support - Customer Services Directorate*

# **GETTING HANDS-ON EXPERIENCE**

## **WITH AERODYNAMIC DETERIORATION**

### **A PERFORMANCE AUDIT VIEW**

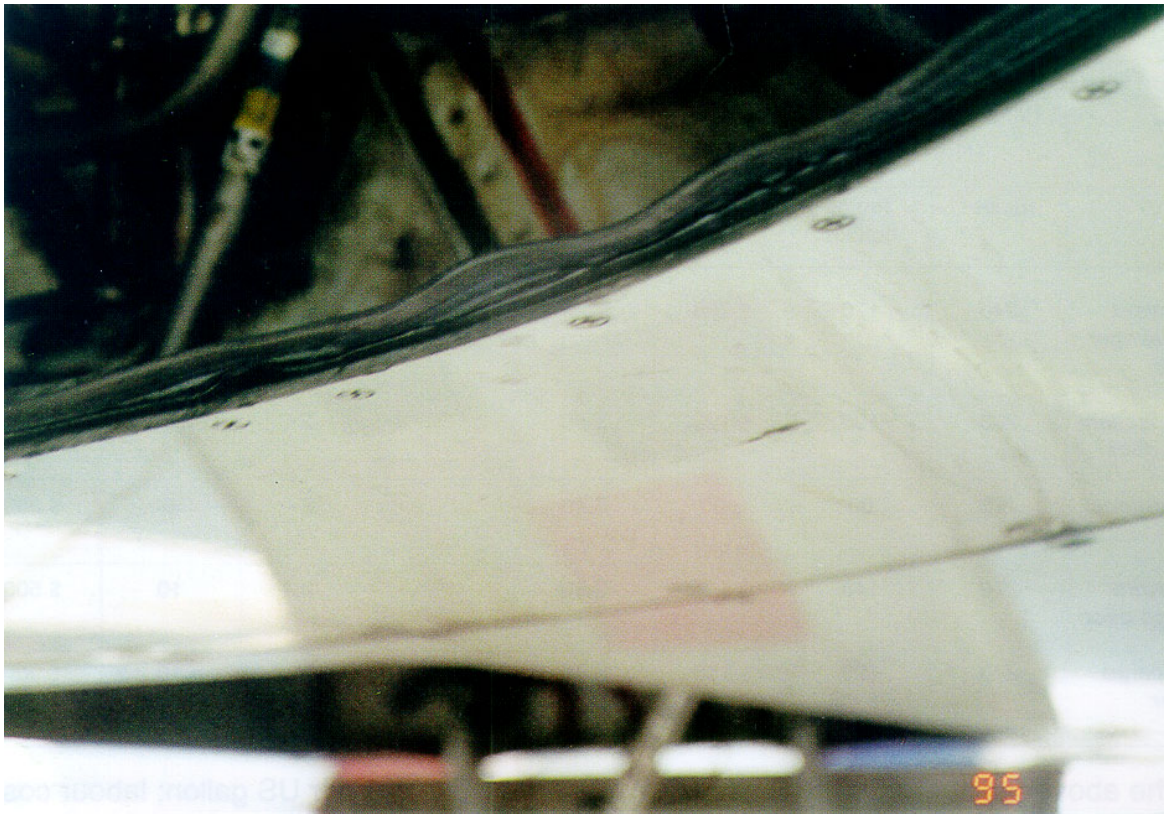
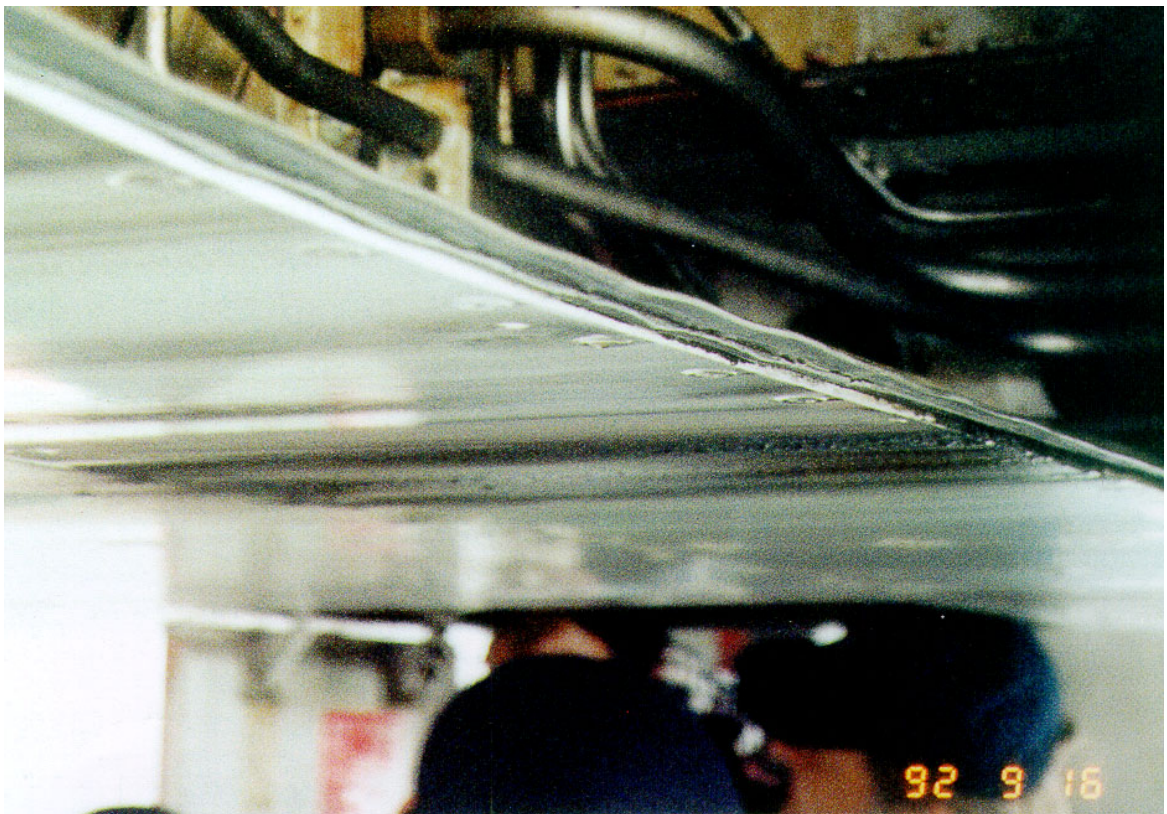
Damaged seal

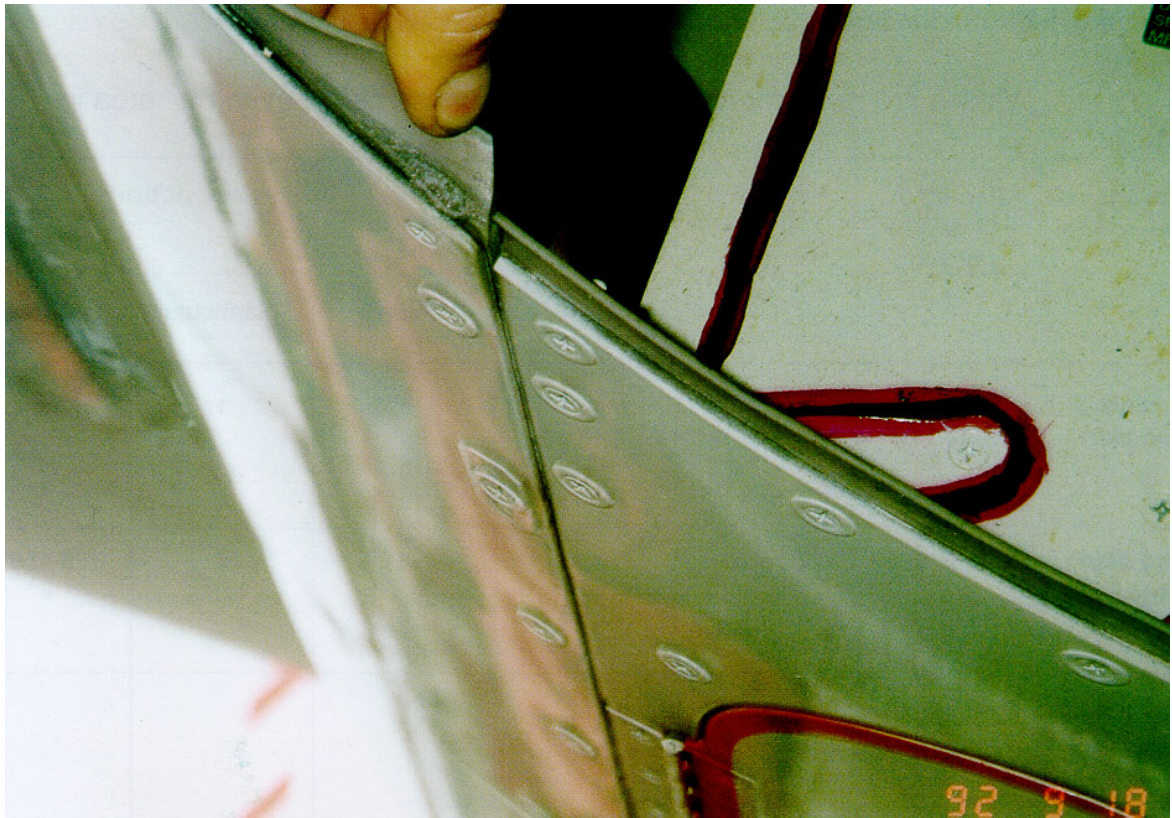
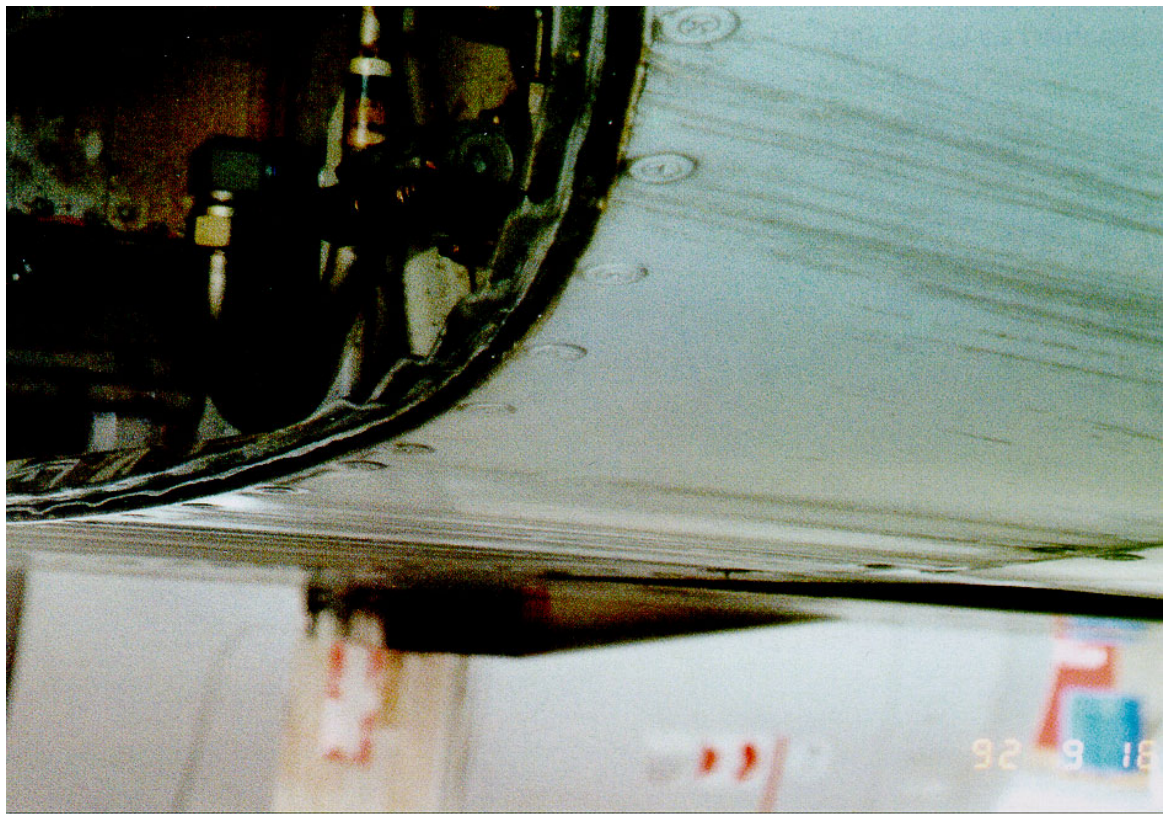
Damaged seal

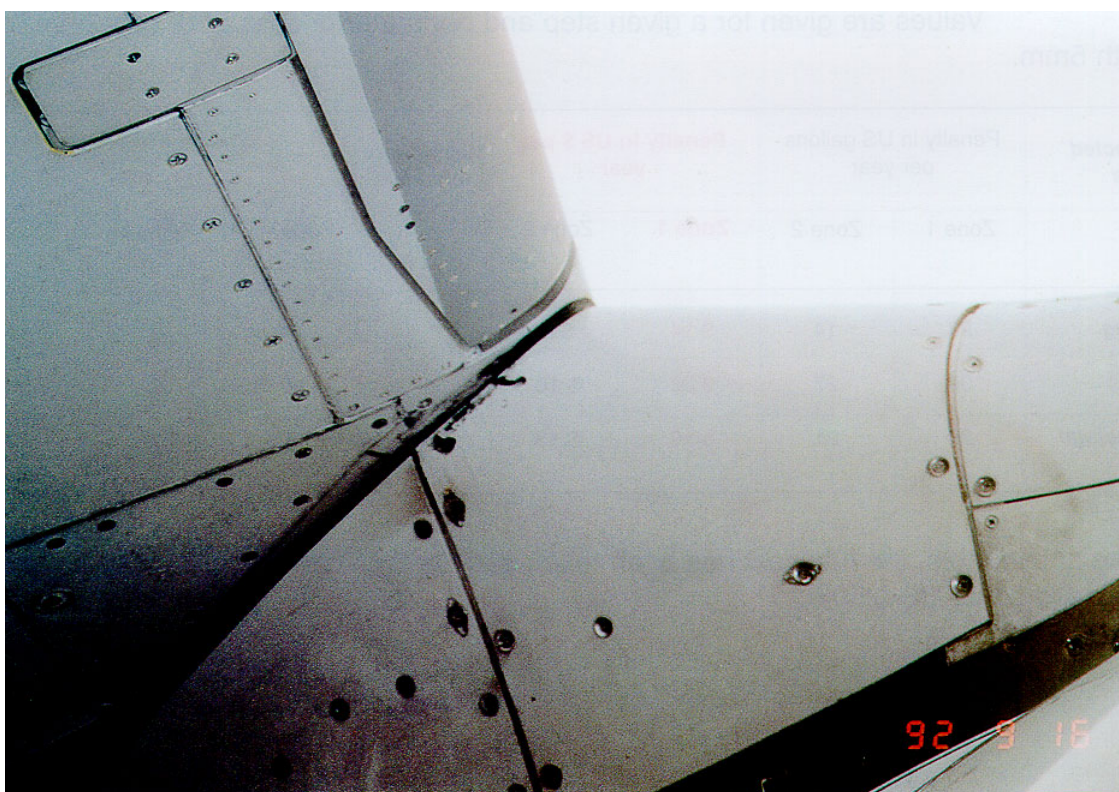
Seal missing

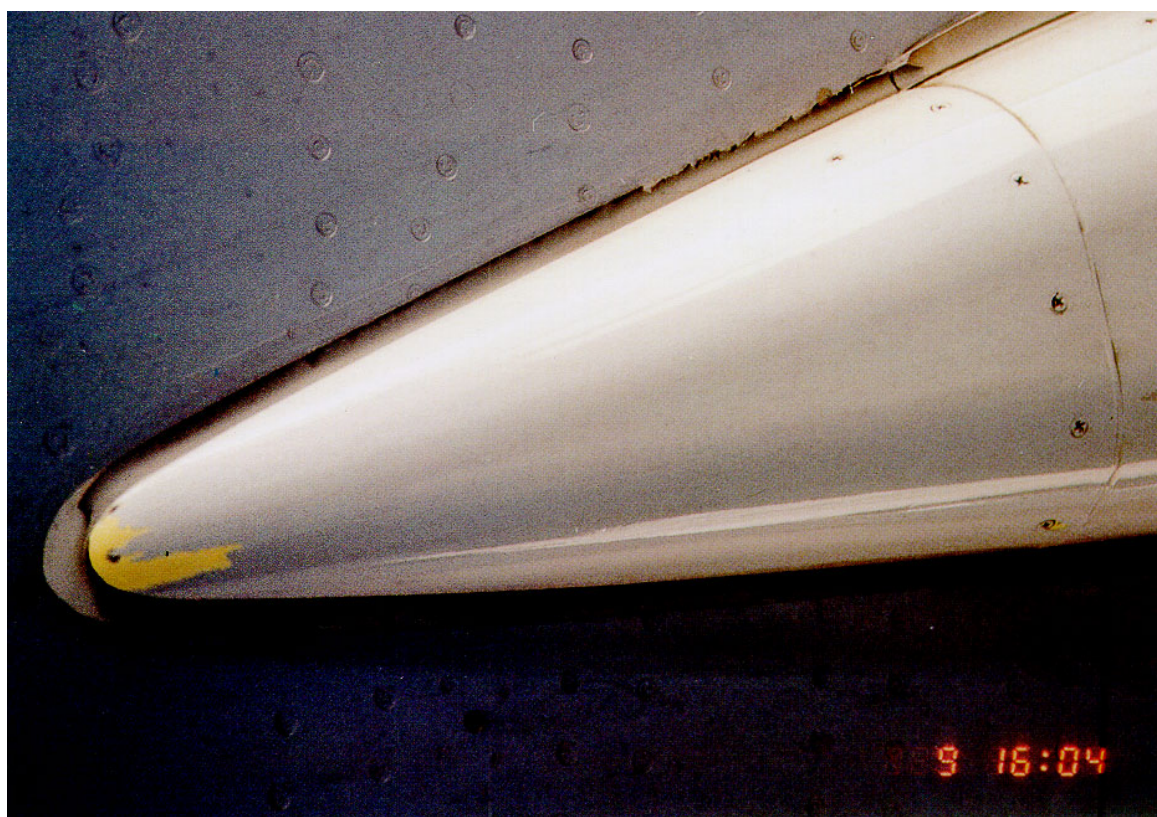
Seal missing

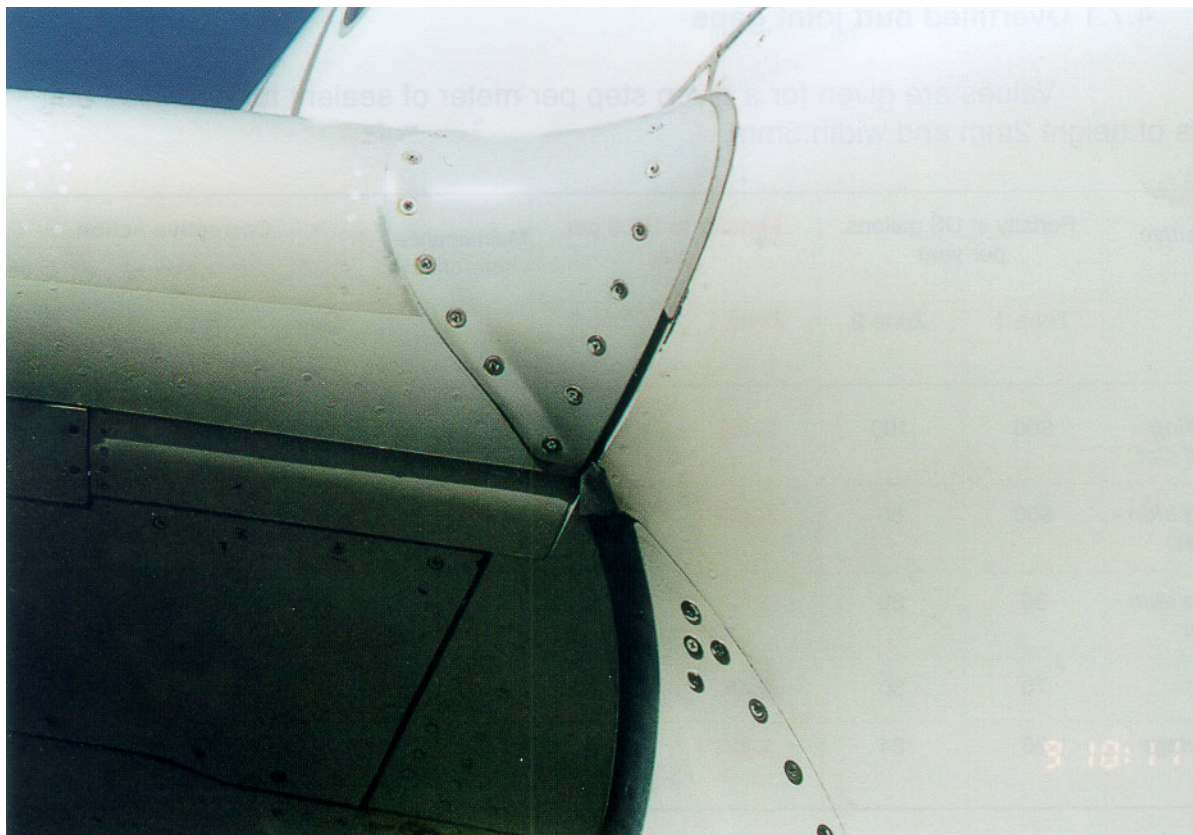
Seal missing

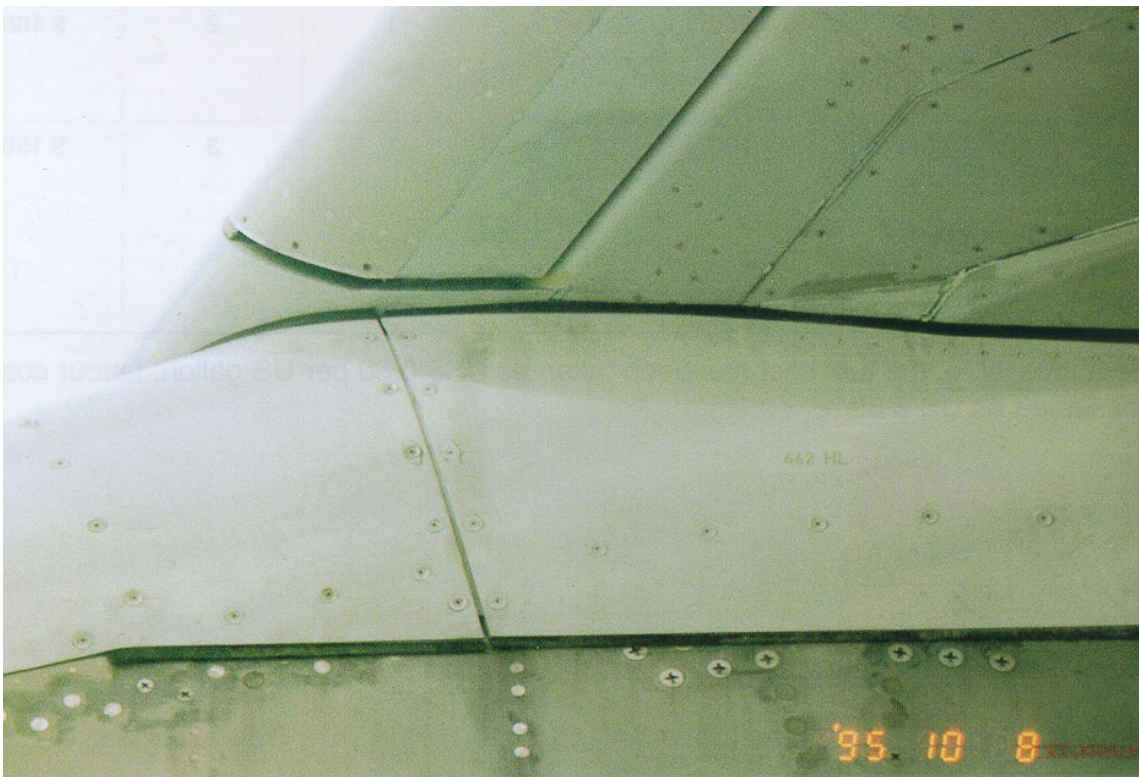
Missing chordwise slat seal

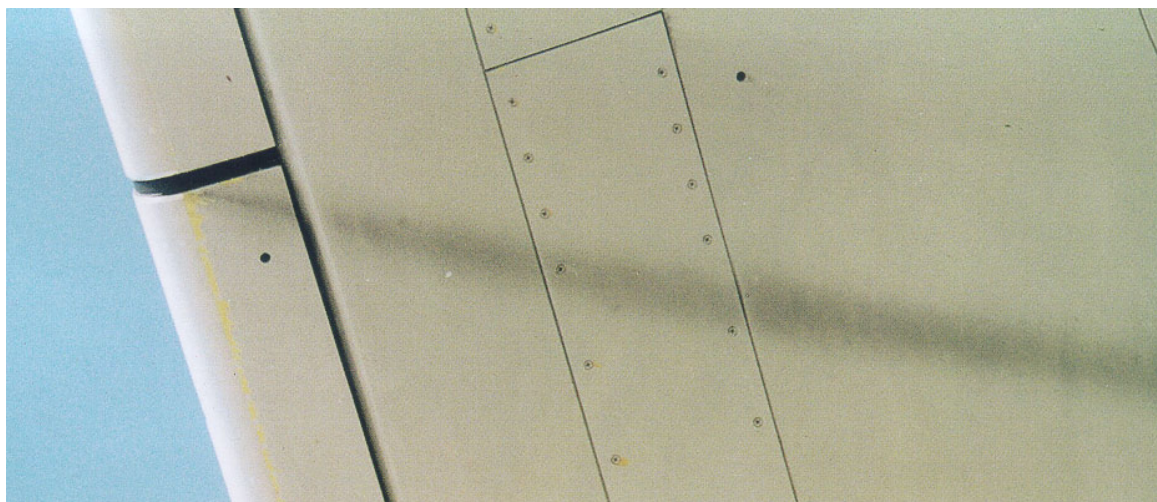
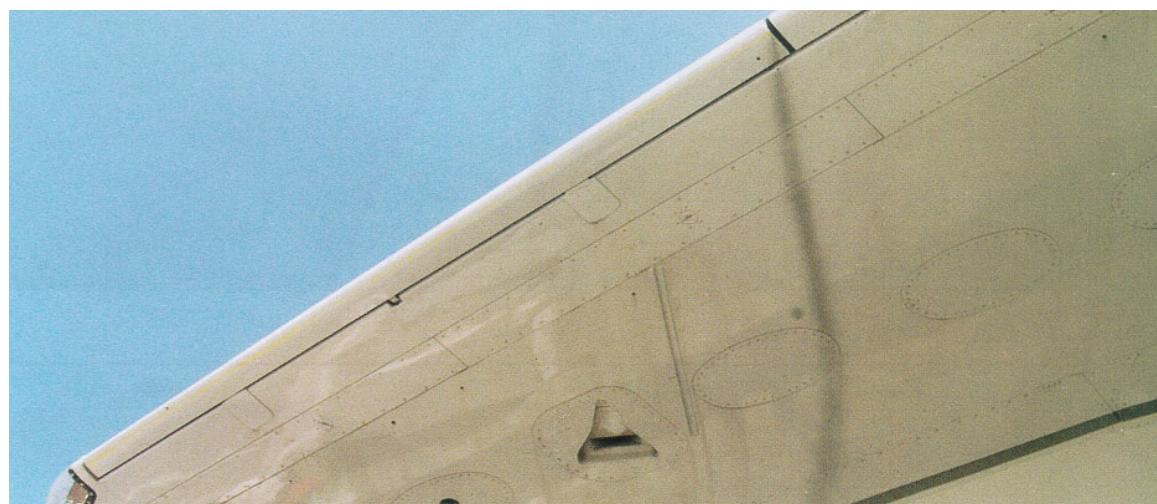
Missing spanwise slat seal

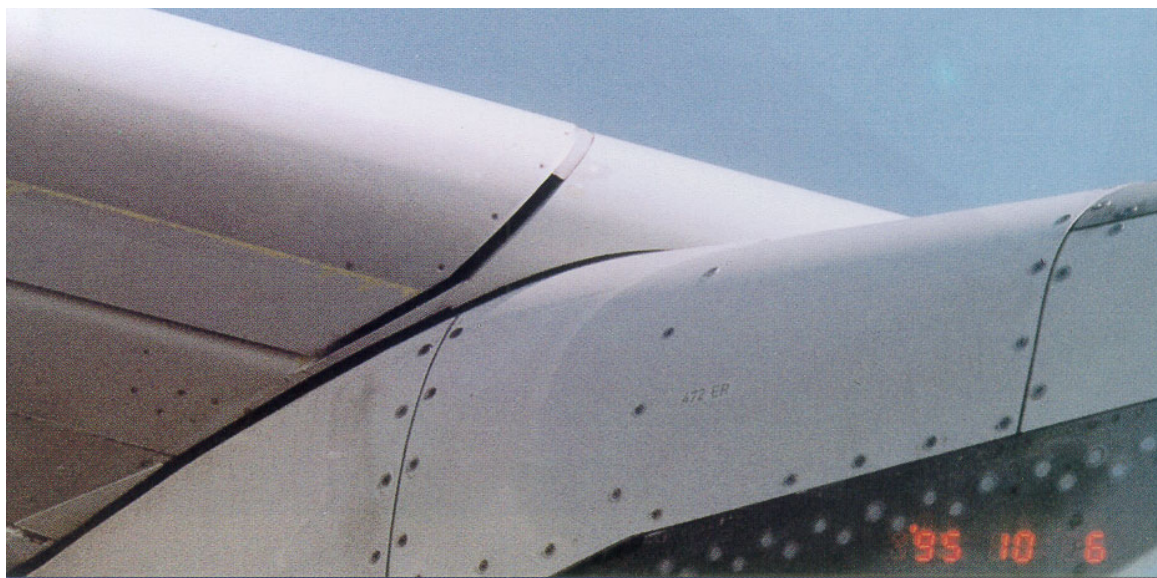
Missing chordwise seal

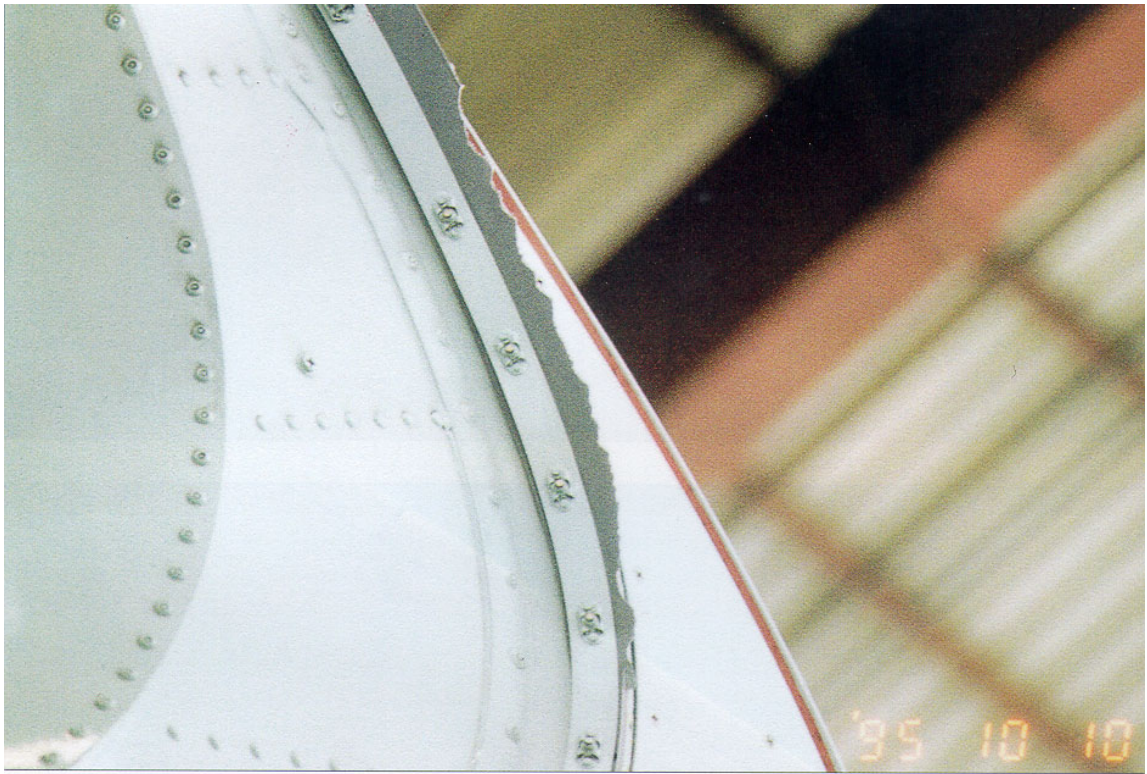
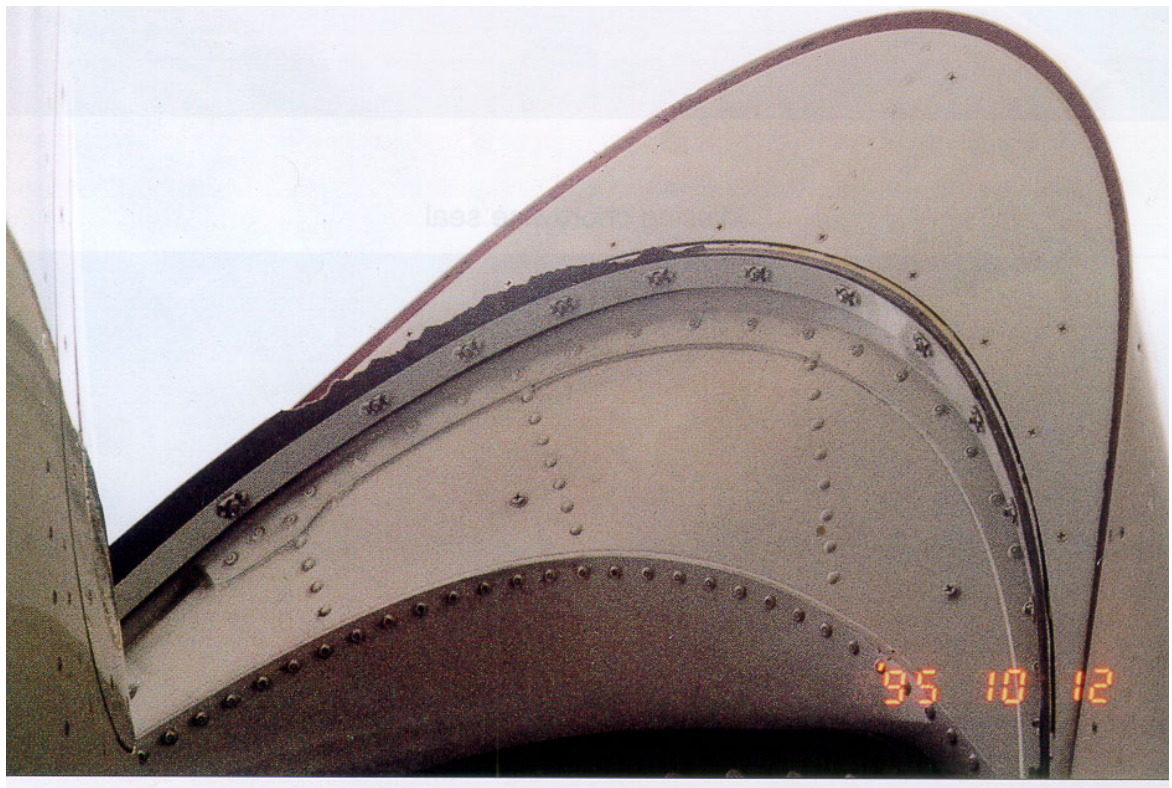
Damaged chordwise slat seal

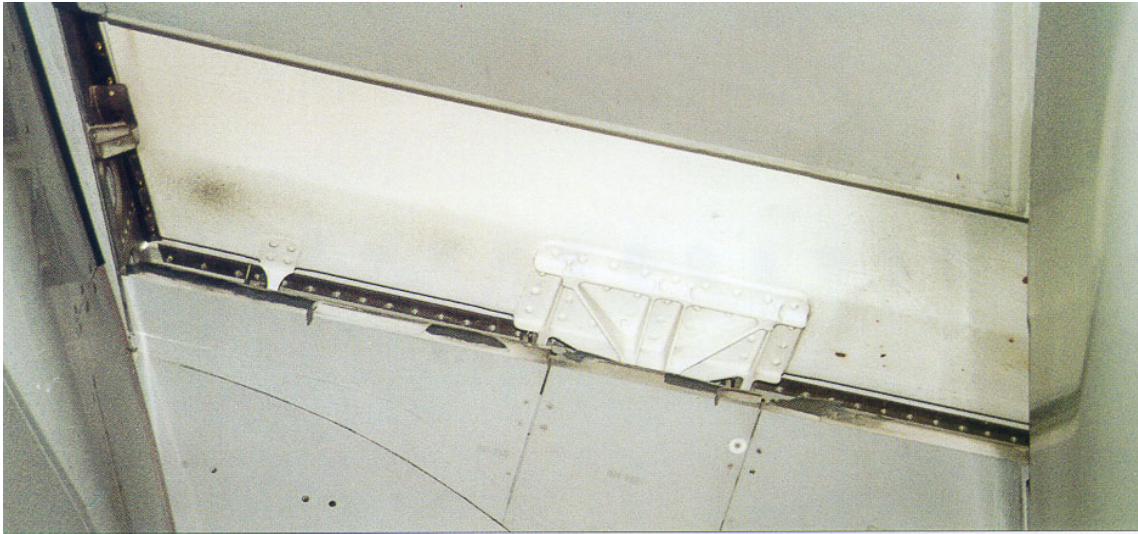
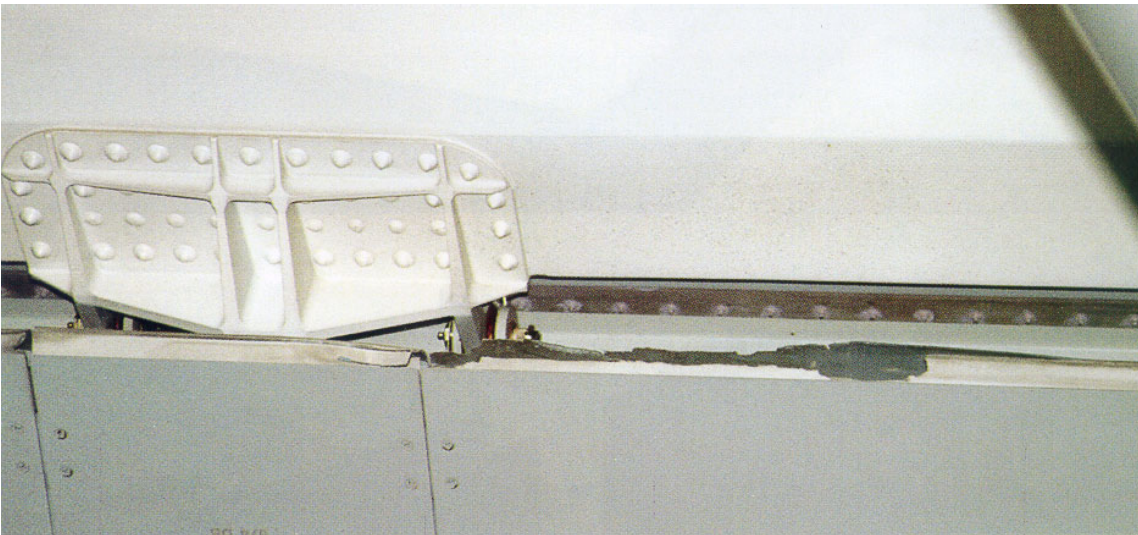
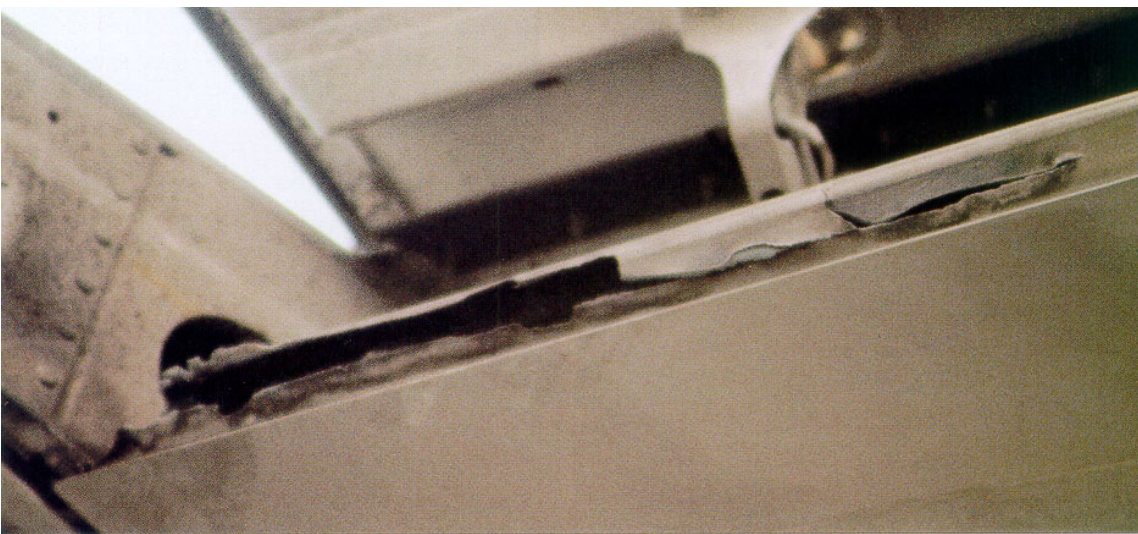
Damaged wing lower-surface-to-flap seals

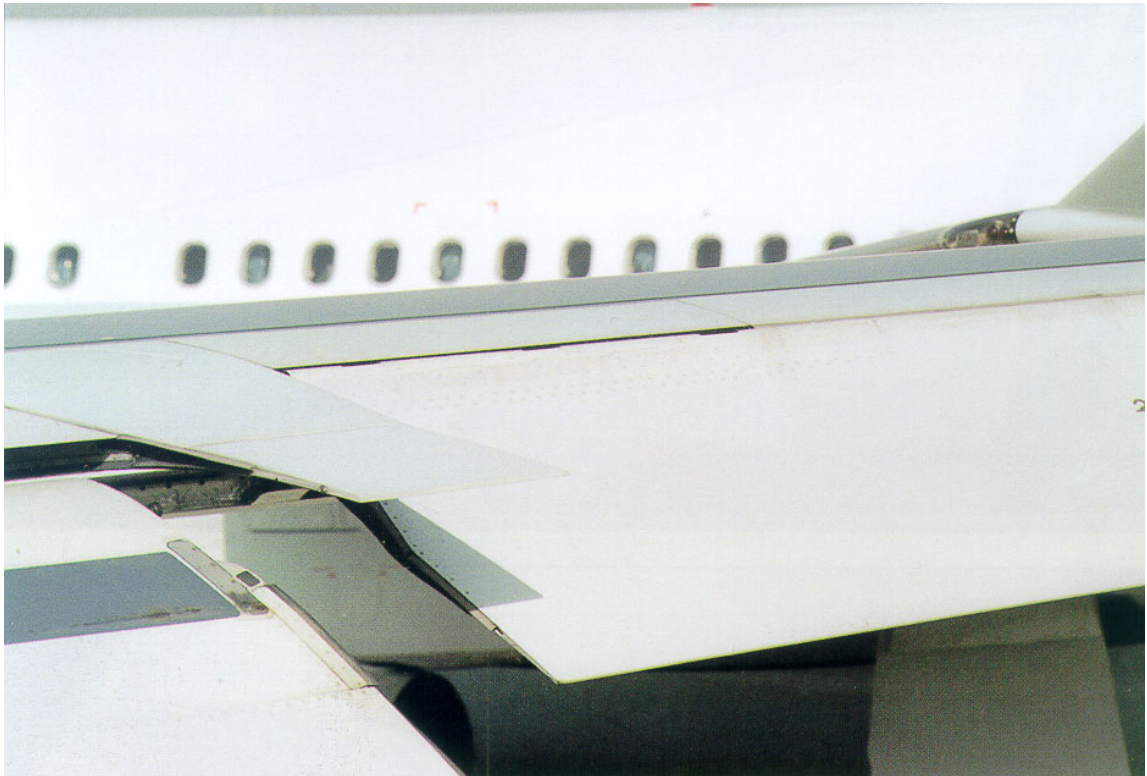
Missing aileron  
spanwise seal

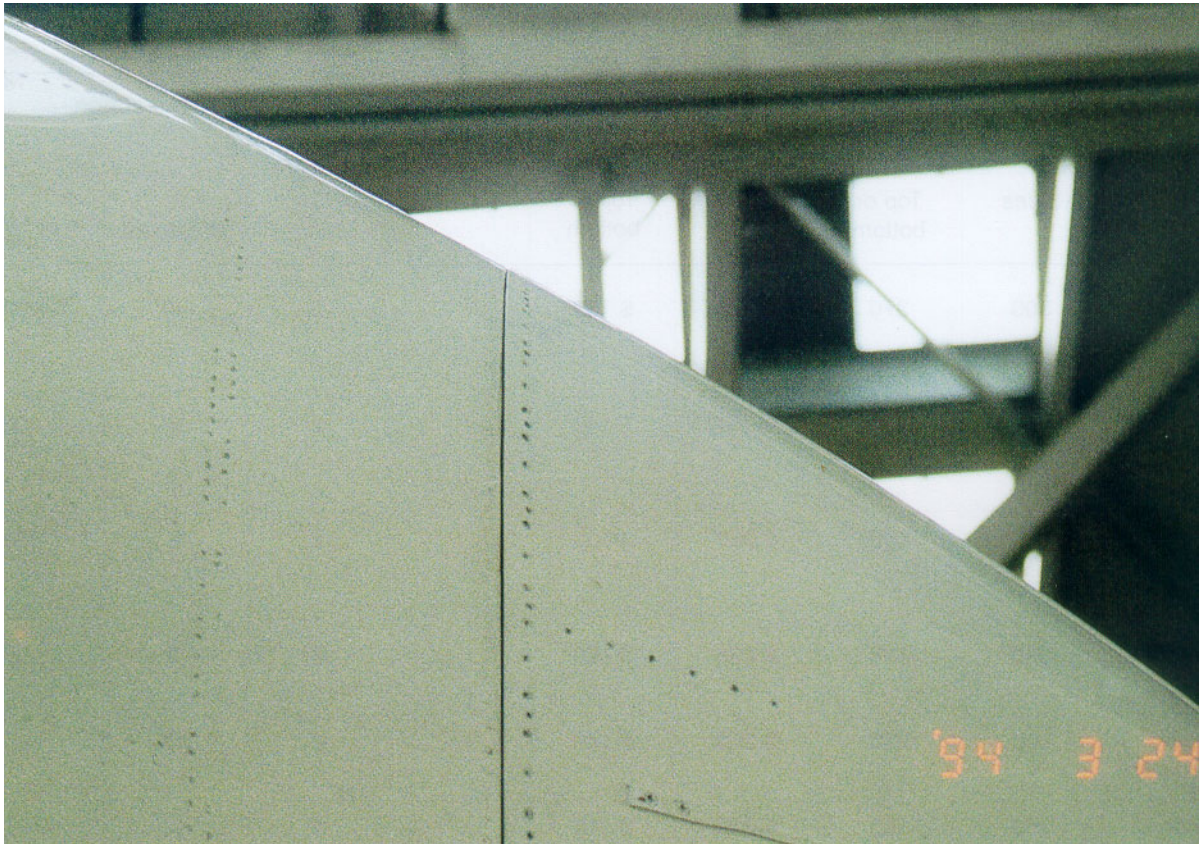
## Radome misfit

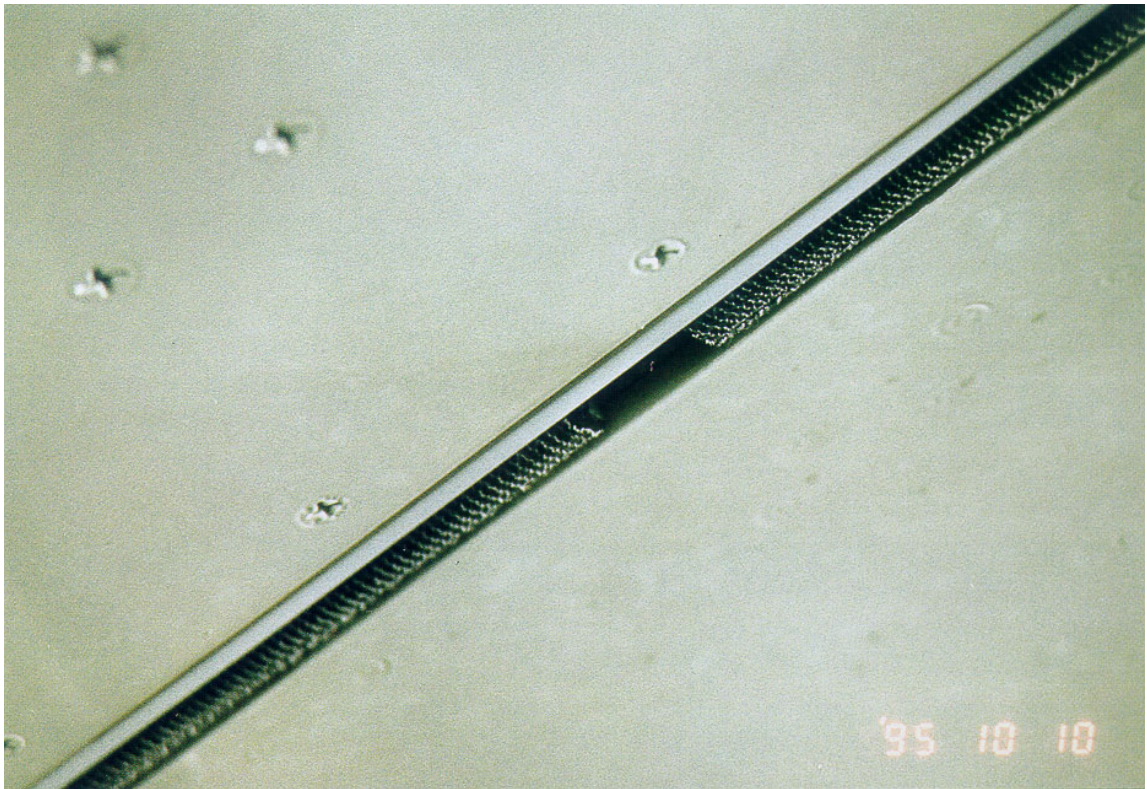
Missing door seal

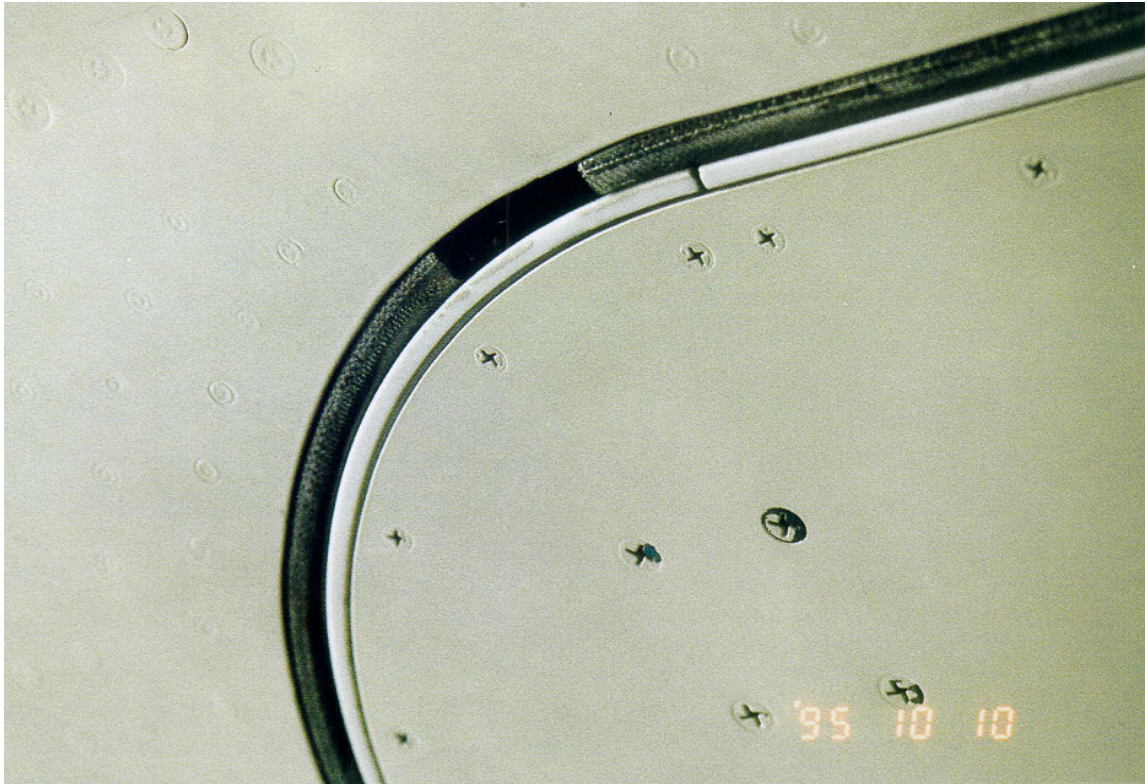
Missing door seal

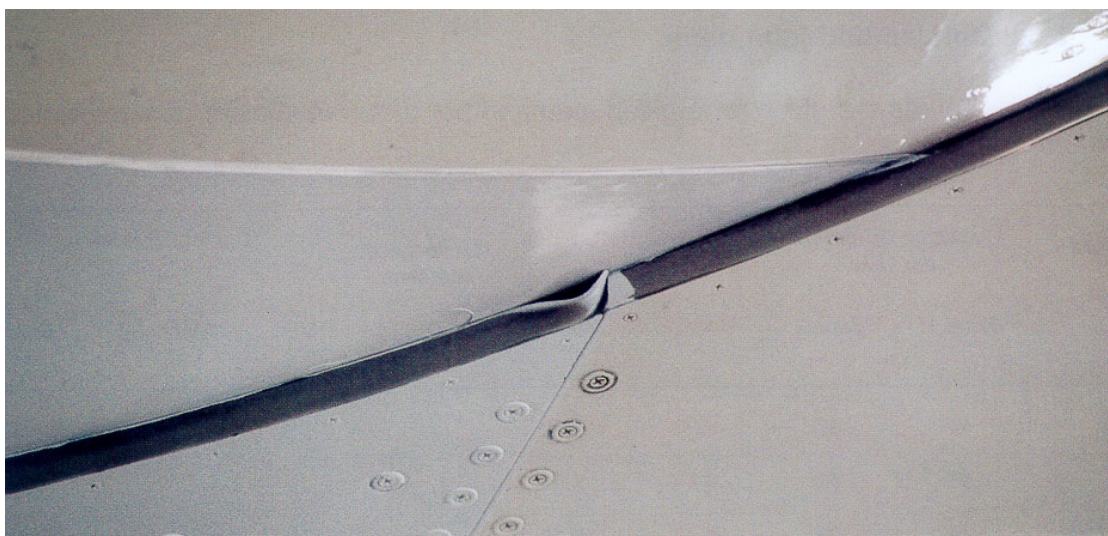
Damaged seal

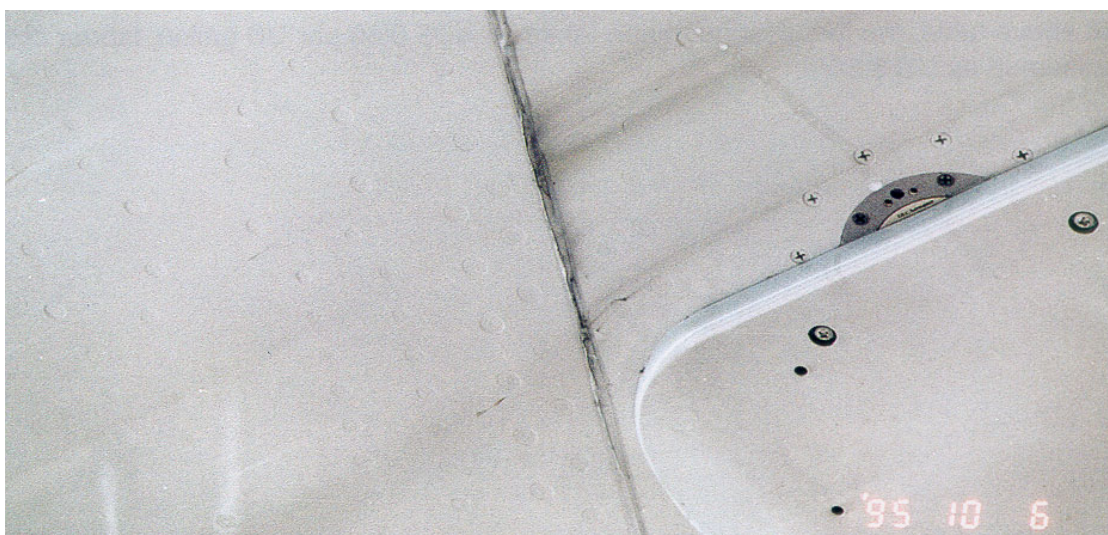
Missing seal

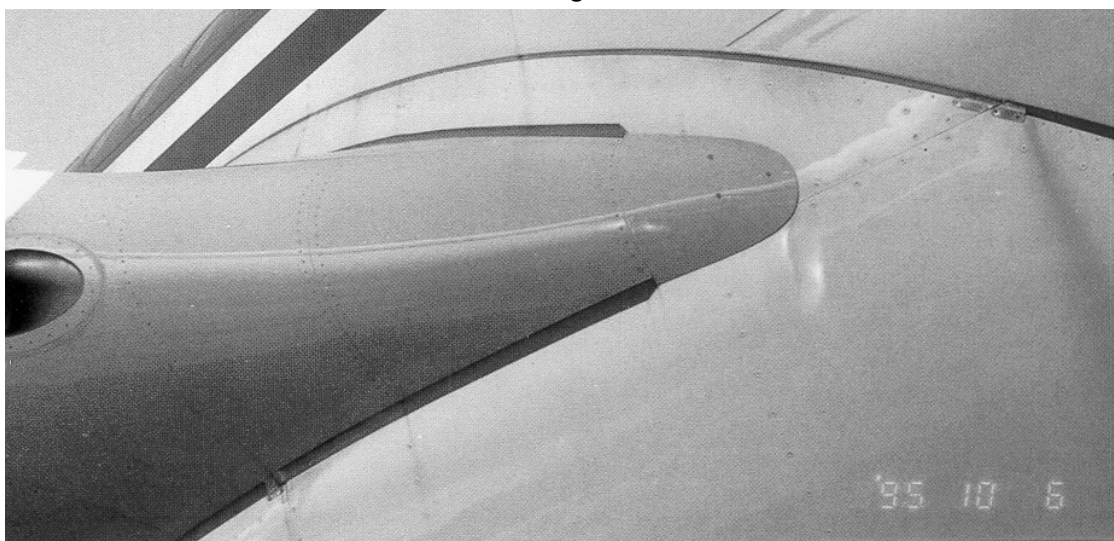
Missing seal
