# GNSS Interference

**Safety first, #29** September, 2019. Safety first is published by Airbus S.A.S. - 1, rond point Maurice Bellonte - 31707 Blagnac Cedex/France. Publisher and Editor: Yannick Malinge, Chief Product Safety Officer. Concept Design by Airbus Multi Media Studio 20192534. Reference: X00D16031905 Issue 29. Photos by S. Ramadier, BlackJack3D, P. Masclet.

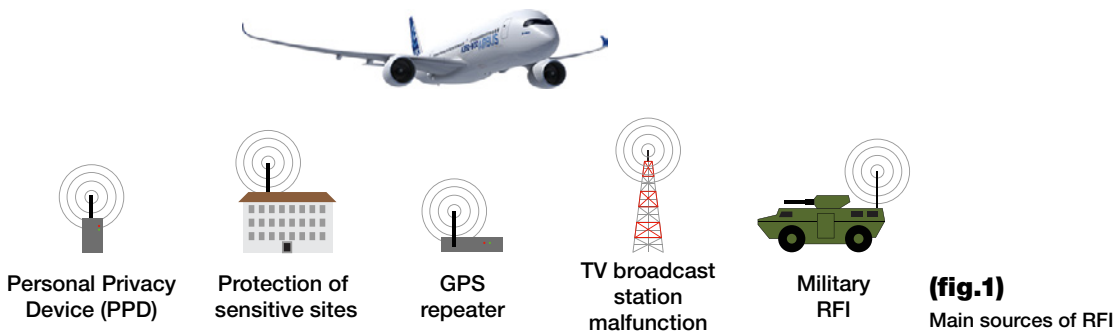
The GPS signal is a low power signal. It is comparable to the power emitted by a 60W light-bulb located more than 20,000 km away from the surface of the earth. This means that the signal could easily be disturbed by any ground source located near an aircraft and emitting in the GPS L1 frequency band (1575.42 MHz  $\pm$  10 MHz), leading to the loss of GPS data **(fig.1)**.

### Main known sources of RFI

Some of the reported disturbances were caused by portable Personal Privacy Devices that jam a GPS signal in the immediate area to avoid tracking. Operational disruptions at airports due to a loss of the GPS signal in the area around the airports have been caused when these devices were activated in the vicinity of an airport.

Certain sensitive sites may be protected using GNSS RFI for security reasons, such as correctional facilities or sites where dignitaries or political figures are living or visiting. Aircraft operating in the vicinity of these sites may be affected by interference with the GPS signal.

GPS repeaters are used to make a GPS signal available inside a hangar during aircraft maintenance. GPS repeater signals have caused interference with actual GPS signal in some reported events, causing reception issues on aircraft located close to the hangar.

A TV broadcast station malfunction reportedly disturbed the GPS signal and affected aircraft operations.

GPS RFI can also cause loss of the GPS signal in flight if too close to areas of military conflict. These areas are often known and NOTAMs inform flight crews that they may encounter interference close to these areas. It can be the case that military RFI activity is not known in advance or communicated leading to loss of GPS signal without prior notice. ■
