## Take Care of Your Brakes

This article describes carbon wear and oxidation phenomena. It recalls the maintenance procedures used to identify worn or oxidized brakes, flight crew procedures, and good practices to prevent brake wear and oxidation.

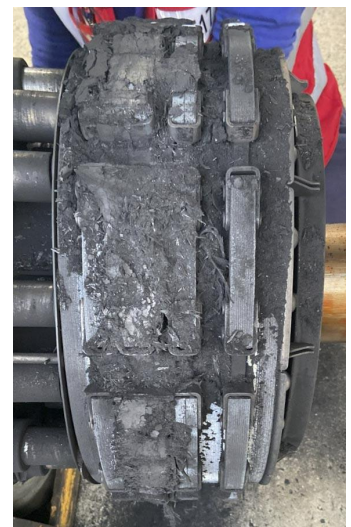
**(fig.4)** Heavily oxidized brake disks

Catalytic oxidation of the brakes is generally caused by contact with deicing or cleaning fluids. The potassium or sodium coming from some aircraft and runway deicing fluids acts as a catalyst and further accelerates the oxidation (**table 1**). The presence of the catalyst also reduces the temperature at which significant oxidation occurs. When the potassium or sodium is absorbed by the carbon it remains within the material causing catalytic oxidation to continue well after the end of the winter season. The outer disks, including the pressure plate, are most exposed to external pollution and are usually more susceptible to catalytic oxidation.

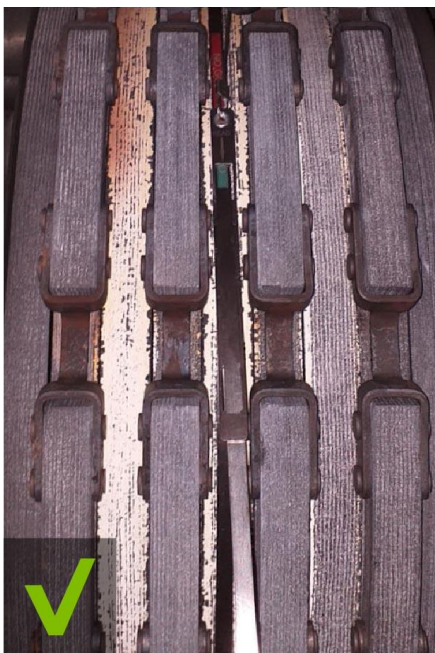
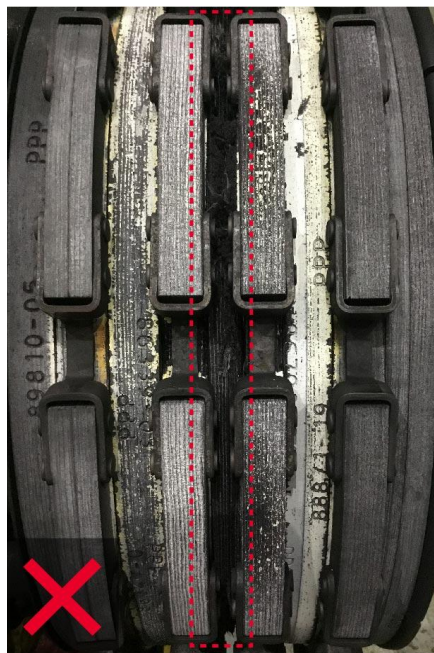
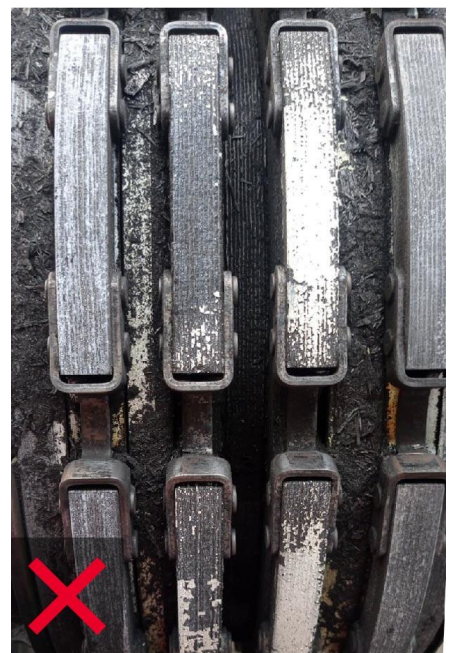
No sign of oxidation

Oxidized stator 3

Highly oxidized brake

**(fig.6)** Examples of non-oxidized and oxidized brakes

Visually inspect the brake assembly at every wheel removal, in accordance with the corresponding AMM/MP procedure, to check that there is no damage or crack on the disks and to check the condition of the brake components. Pay particular attention to any signs of oxidation marks, and if the oxidation is beyond acceptable limits, replace the brake **(fig.6)**.

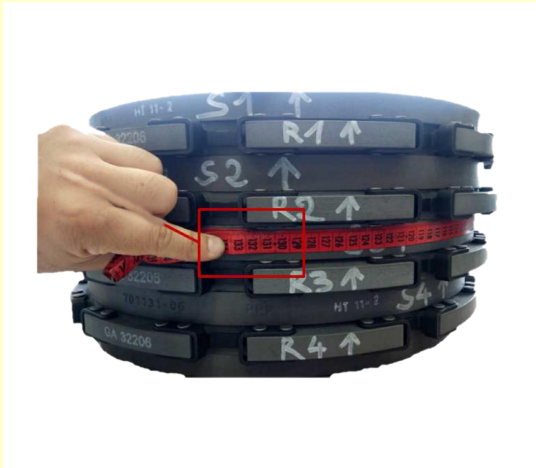
**(fig.7)** Optional inspection to measure the perimeter of the central stator on Safran Landing Systems and Messier-Goodrich brakes

Some operators are more exposed to the risk of brake rupture due to their specific operations. Airbus proposes an optional brake inspection with the wheel removed. This inspection was developed together with brake manufacturers and can be added to the AMM procedure by request of the operator. Steps were added to the brake inspection procedure that require measuring the outer perimeter of the central stator (Safran Landing Systems and Messier-Goodrich brakes) **(fig.7)** or the radius of the friction surface (Collins Aerospace brakes) **(fig.8)**. The reduction of this measured value provides an additional indicator of brake oxidation.

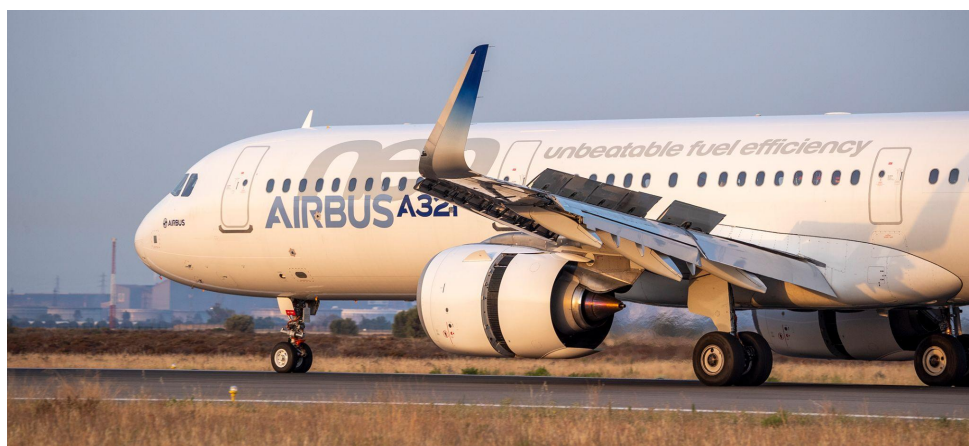
The use of thrust reversers reduces the energy to be absorbed by the brakes. It is therefore a good option to use thrust reversers to limit brake oxidation, especially on short runways.
