**Claude LELAIE**

Experimental Test Pilot

# VMU Tests on A380

# Safety First

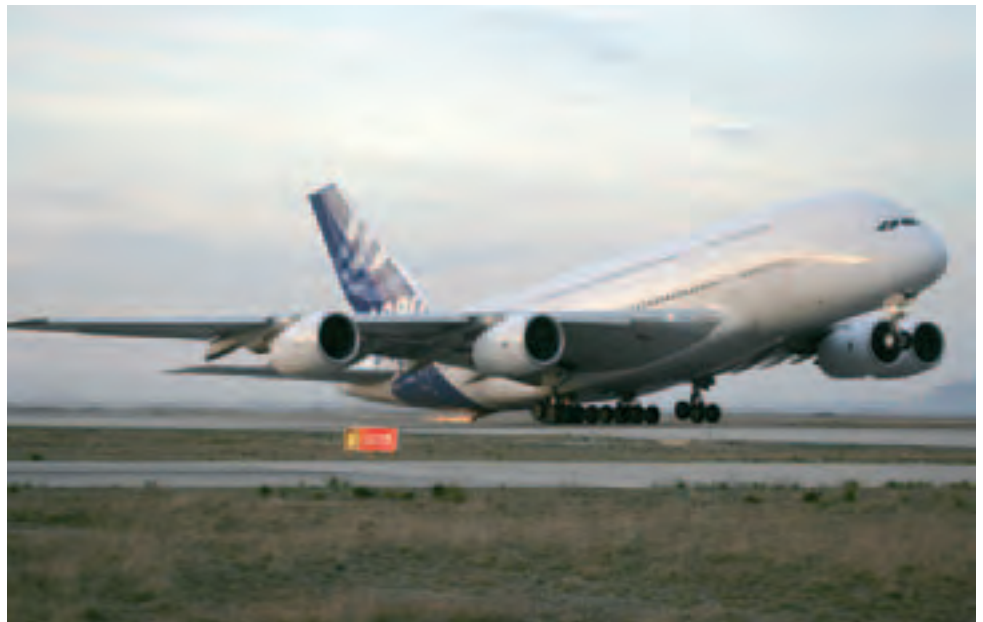
On the A380, there was not only a need to establish the VMU for computation of the take off performance, but it was also necessary to perform some tests at the very

beginning of the development for the optimisation of the take-off aerodynamic configuration. This was done in the first three months of the development.

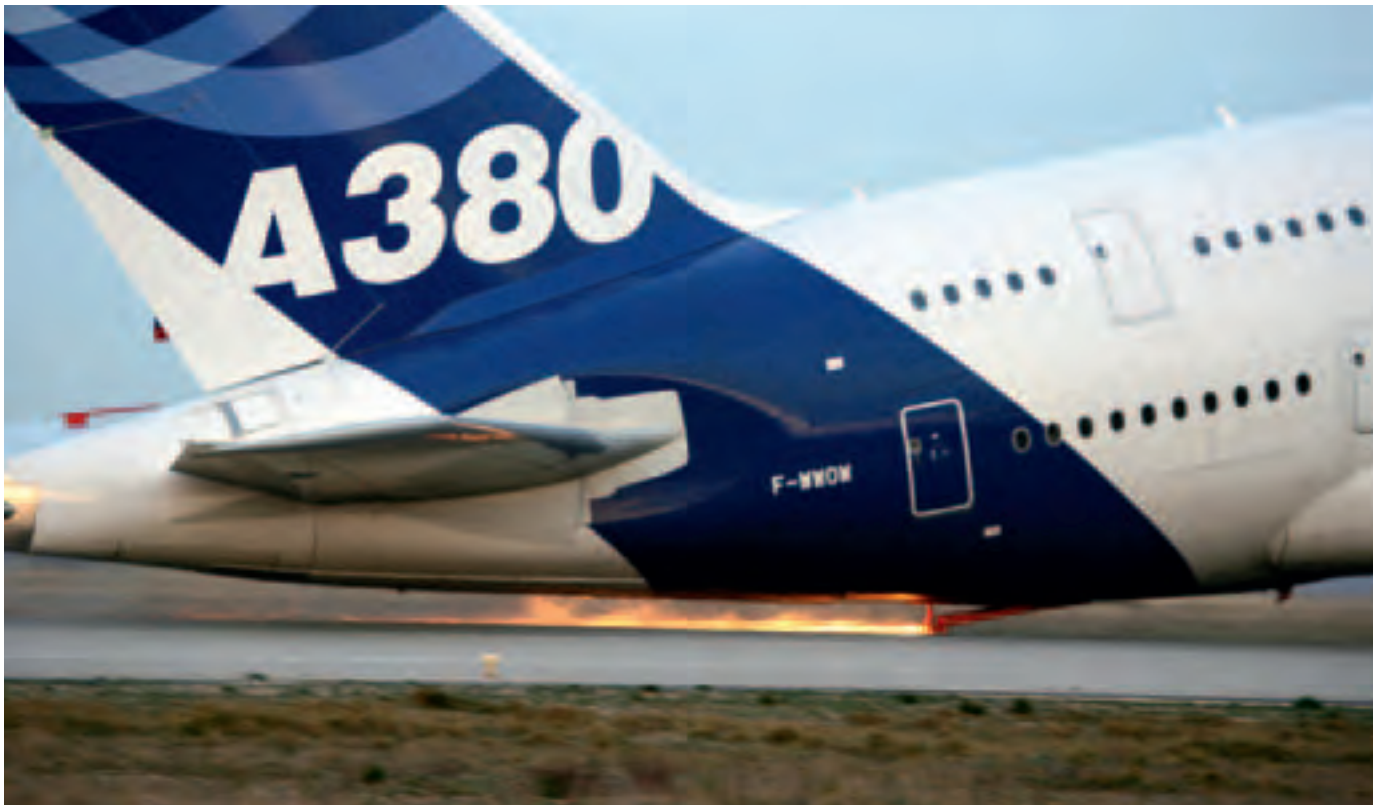
The first stalls were performed on flight 3 with more being carried out in the following days. It allowed us to make a first choice among the configurations to be retained. Globally, the results were very good, even better than expected. The

stalls with a reduced slat deflection were not so satisfactory as it was possible to generate too much side-slip. With the initial position the stall characteristics were excellent. Easy choice!
