*Flight Operations Support - Customer Services Directorate*

# **GETTING HANDS-ON EXPERIENCE**

## **WITH AERODYNAMIC DETERIORATION**

### **A PERFORMANCE AUDIT VIEW**

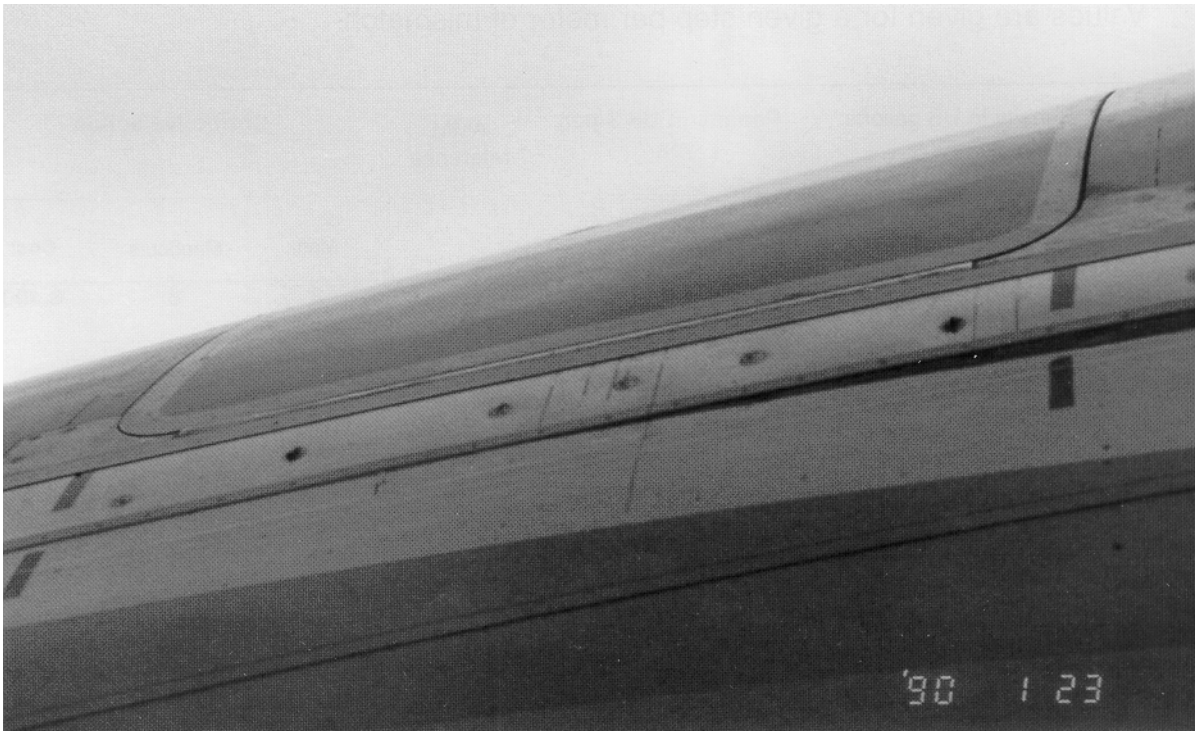
Mismatched passenger doors
