# Don't Forget to Check the Alternate

Pre-flight checks are essential to detect any hidden failure before the flight.

This article explains why failing to perform the pre-flight check may prevent the detection of a hidden failure of the alternate braking system. It also includes maintenance recommendations for troubleshooting when the flight crew reports the failure of an alternate braking test.

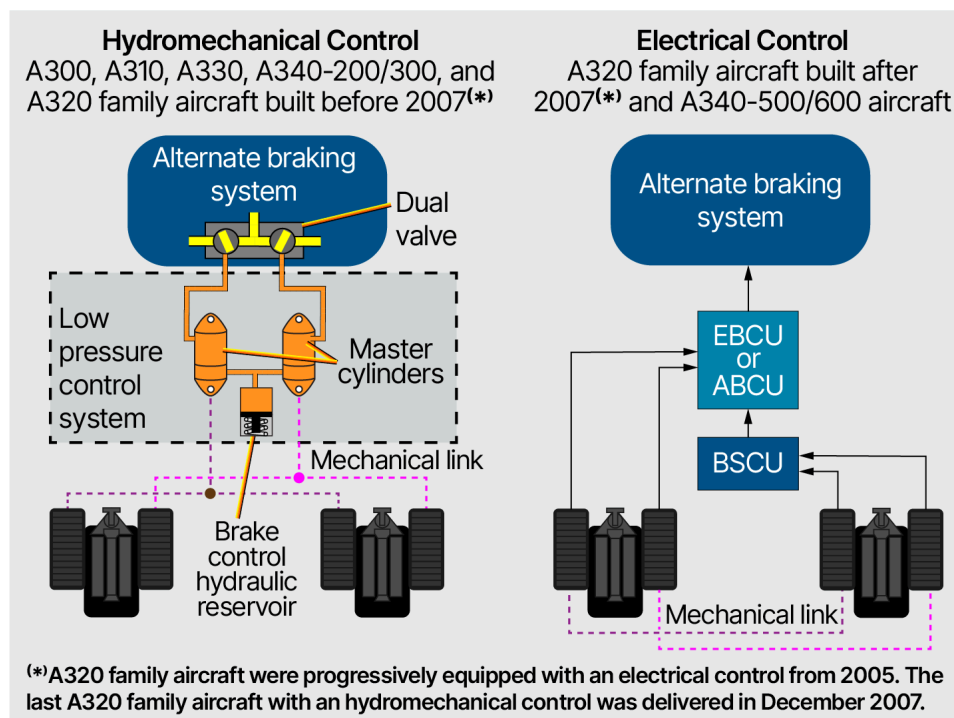
**(fig.5)** Types of control for the alternate braking system on A300, A310, A320 family, A330, and A340 aircraft

The brake pedals are mechanically connected to two master cylinders, converting the pedal displacement into a hydraulic pressure that activates the dual valve (**fig.5**). The dual valve regulates the quantity of hydraulic pressure coming from the blue (A330, A340-200/300 aircraft) or the yellow hydraulic system (A300, A310 and A320 family aircraft) to activate the brake pistons.

The position of the brake pedals is sent to the Braking & Steering Control Unit (BSCU) and Emergency (or Alternate) Braking Control unit (EBCU or ABCU).

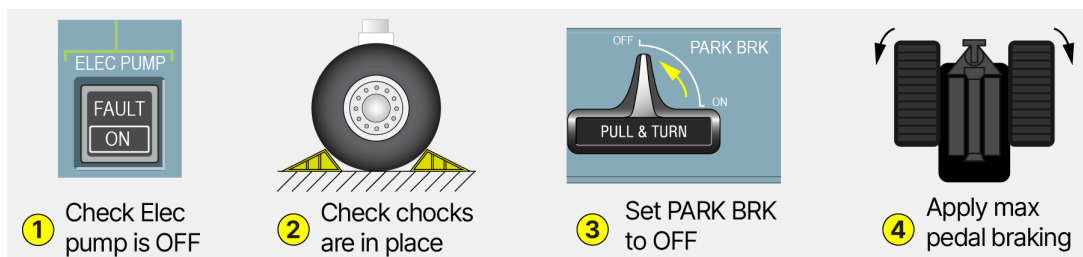
(fig.6) Check of the Alternate Braking System (part 1 of 2)

① The flight crew should first check that the blue (A330 & A340-200/300 aircraft) or yellow (A320 family, A300 & A310 aircraft) electrical pump is OFF. ② Then, they should check that the wheel chocks are in position. ③ The flight crew should set the parking brake to OFF. ④ Fully pressing the brake pedals compresses both master cylinders that send hydraulic pressure to open both sides of the dual valve.

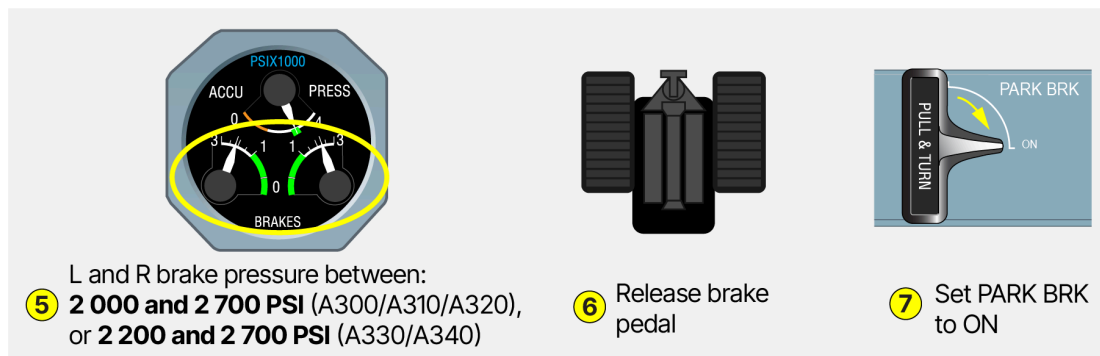
**(fig.7)** Check of the Alternate Braking System (part 2 of 2)

The brake pedals have an **artificial feel** that requires some force to activate the brakes. If the flight crew feels that the artificial feel is lost while pressing the brake pedals (brake pedals are "spongy"), **maintenance action must be performed**. This indicates that there is air in the low pressure control system.

When the brake pedals are fully pressed, **⑤** the brake pressure must be between 2 000 (or 2 200 PSI) and 2 700 PSI on both sides of the triple pressure indicator. If not, maintenance action must be performed. **⑥** The flight crew must then release the brake pedals and **⑦** set the PARK BRK back to ON, so that they can check the brake wear indicators during the exterior walkaround.
