# Fuel Leak Management in Flight

A fuel leak can have serious consequences, especially because of the risk of fire and fuel starvation. When a fuel leak is detected, it is essential to follow the operational procedures to maintain the safety of the flight. This article highlights how to detect and confirm a fuel leak on A300-600, A310, A320 family, A330, A340, A350, and A380 aircraft. It also recalls which actions to perform, especially shutting down the engine in the case of an engine fuel leak to prevent any risk of engine fire. Fuel leak management for A220 aircraft will be addressed in a future article.

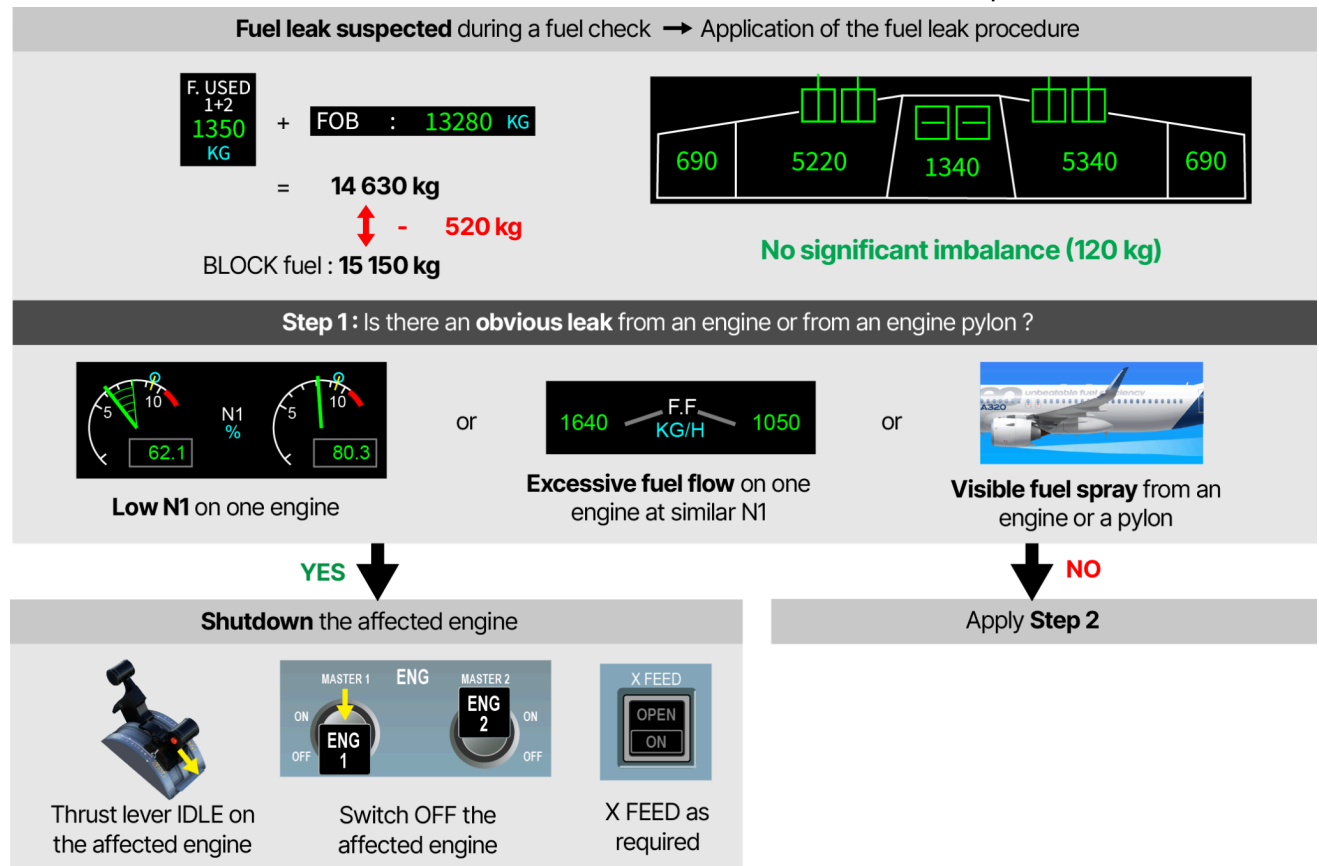
(fig.8) First step of the FUEL LEAK QRH procedure on an A320 family aircraft

If an engine fuel leak is confirmed, the affected engine must be shut down to avoid any fire risk and contain the leak.

When an engine fuel leak is confirmed, there is a **high risk of engine fire**. The **affected engine must be shut down and must not be restarted** for the remainder of the flight.

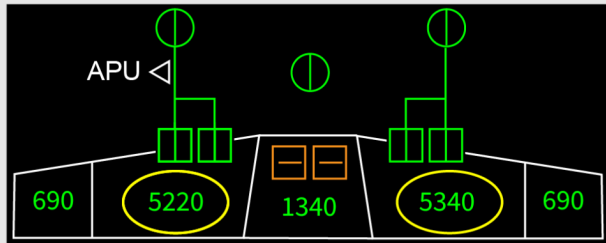
(fig.9) Second step of the FUEL LEAK QRH procedure on an A320 family aircraft

If an engine fuel leak is not directly confirmed, the next step of the fuel leak procedure is to stop all fuel transfers and isolate each tank in order to locate the source of the leak. By doing so, each engine will be supplied by its own associated wing tank.

Prevent any fuel transfer from CTR tank (L & R XFR OFF or CTR PUMP 1 & 2 OFF) and maintain X FEED closed

Monitor the depletion rate of each engine's tank  
Imbalance (T0) = 5340 - 5220 = **120 kg**

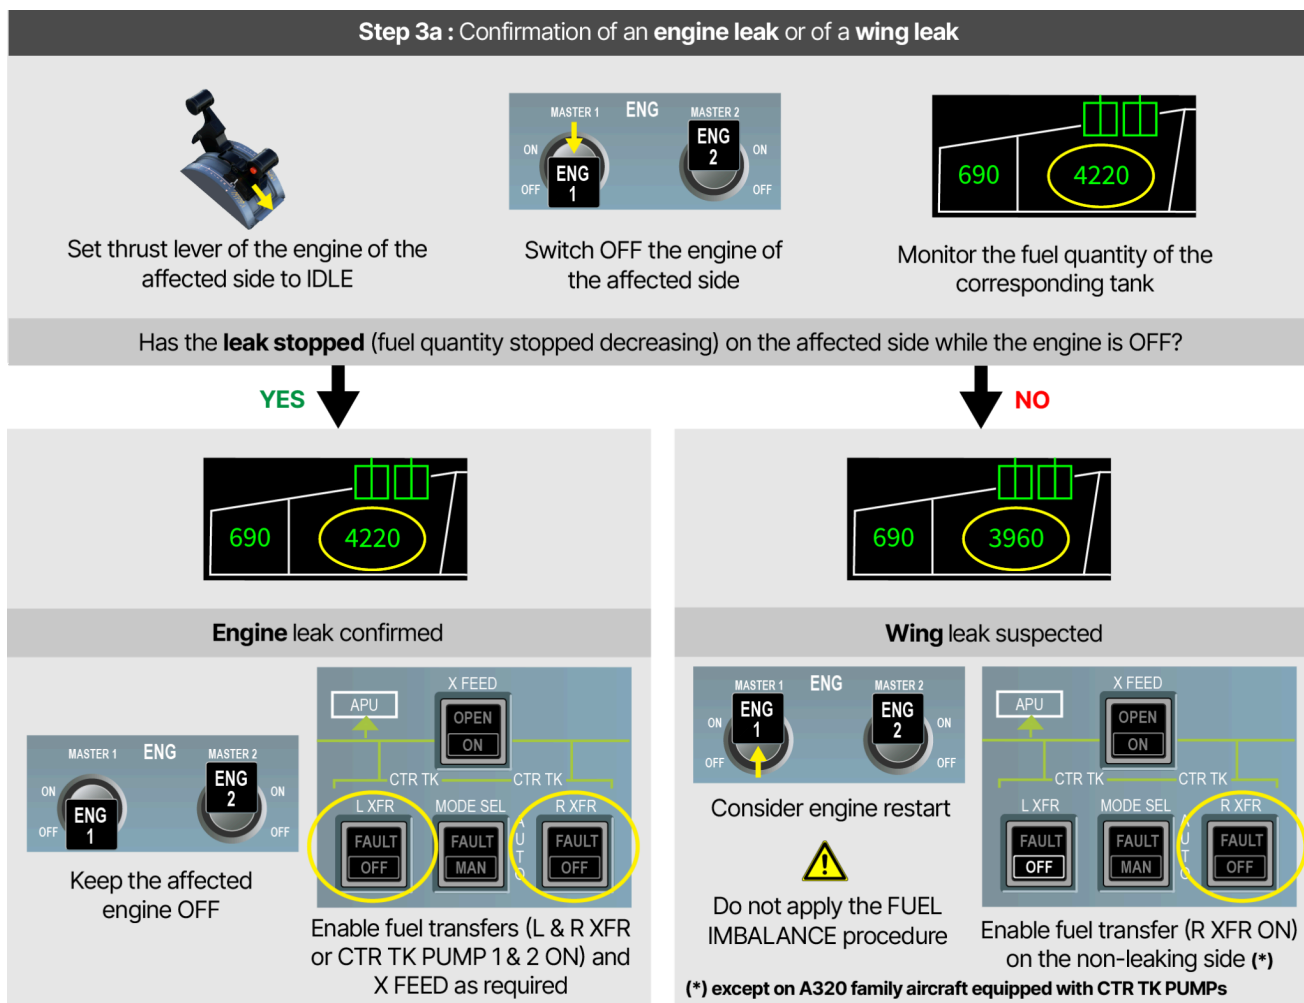
(fig.10) Confirmation step in the case of a suspected engine or wing leak on an A320 family aircraft

A significant asymmetric depletion indicates a possible leak from the engine/pylon or from the wing of the side with the higher depletion rate. **The engine from the affected side must be shut down to confirm the leak location:**

- **If the leak stops after the engine shutdown** (fuel quantity in the corresponding tank remains constant), it indicates that **the leak comes from the engine**. The engine must remain shut down for the remainder of the flight.
- **If the leak did not stop** (fuel quantity in the corresponding tank is still decreasing), **a wing leak is suspected**, an engine restart can be considered. On A320 aircraft, fuel transfer can be enabled again on the non-leaking side.

If a wing leak is confirmed, it is important for the flight crew not to attempt to manually balance the wing tanks in order not to feed the leak even if requested by other procedures.

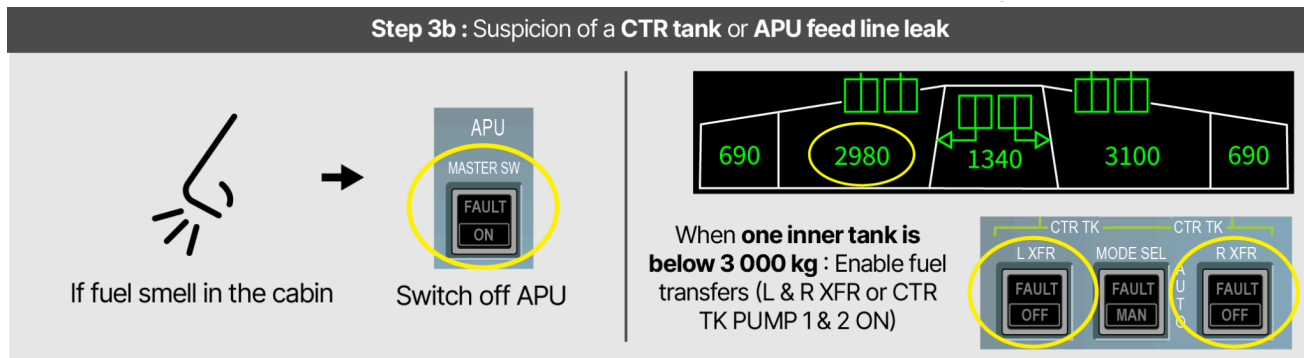
(fig.11) Actions to perform when a CTR tank or APU feed line leak is suspected on an A320 family aircraft

If there is no asymmetry in the fuel depletion rate between the two sides (left or right), the possible locations of the fuel leak are the center tanks, the trim tank feed line or the trim tank (if installed), or the APU fuel feed system.
