## Preventing Loss of Engine Generators on A320 Family, A330 and A340 Aircraft

Some cases of emergency electrical configurations on A320 aircraft were reported to Airbus where both Integrated Drive Generators (IDGs) failed in sequence due to worn components inside their Constant Speed Drive (CSD).

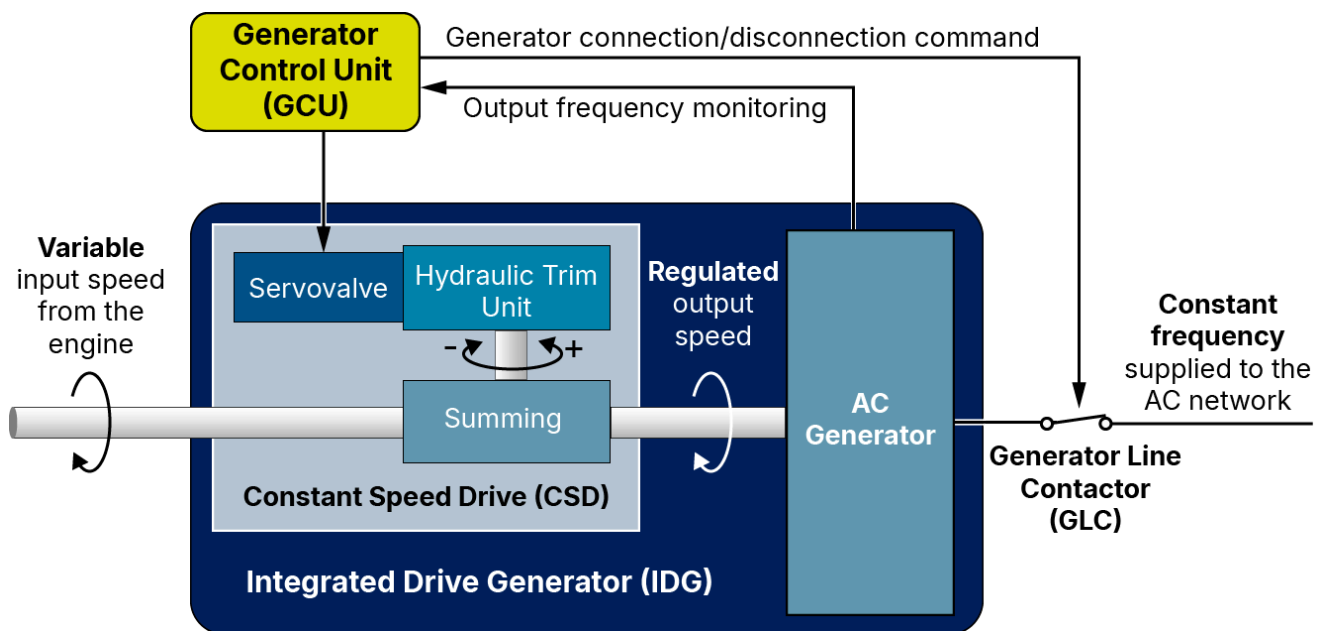
(fig.2) IDG concept

This type of generator provides AC power at a constant frequency. To do so, a **Constant Speed Drive (CSD)** is integrated into the IDG to convert the variable input rotation speed from the engine into a constant output rotation speed to the AC generator unit (**fig.2**). The **Generator Control Unit (GCU)** monitors the output frequency of the generator and sends regulation commands to the servovalve of the hydraulic trim unit to add or subtract rotation speed to the input speed coming from the engine in order to obtain a constant output speed.

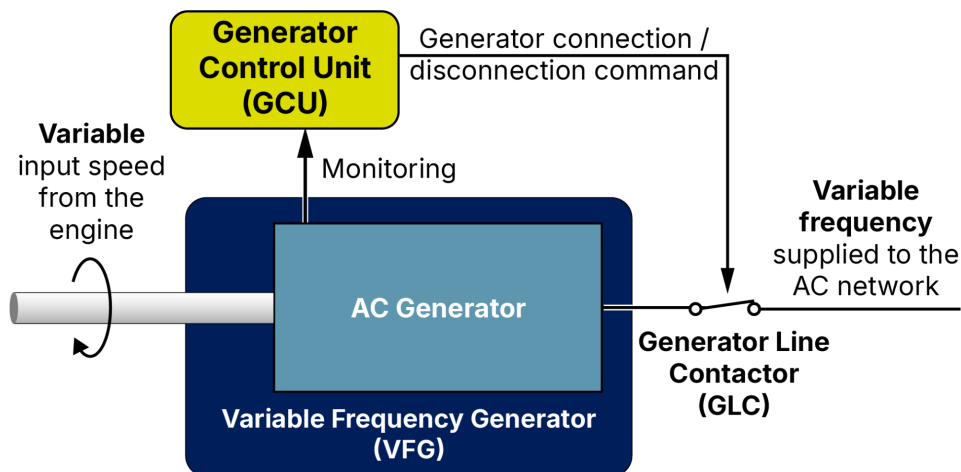
(fig.3) VFG concept

This type of generator does not have a CSD (fig.3). They provide **AC power voltage with a variable frequency to the aircraft electrical network**. These generators are installed on engines of A220, A350 and A380 aircraft. When necessary, frequency regulation is performed using power converter components within the aircraft's systems
