# The importance of the pre-flight, flight controls check

**By: Albert Urdiroz**  
*Flight Safety Manager*

# 01 January 2005

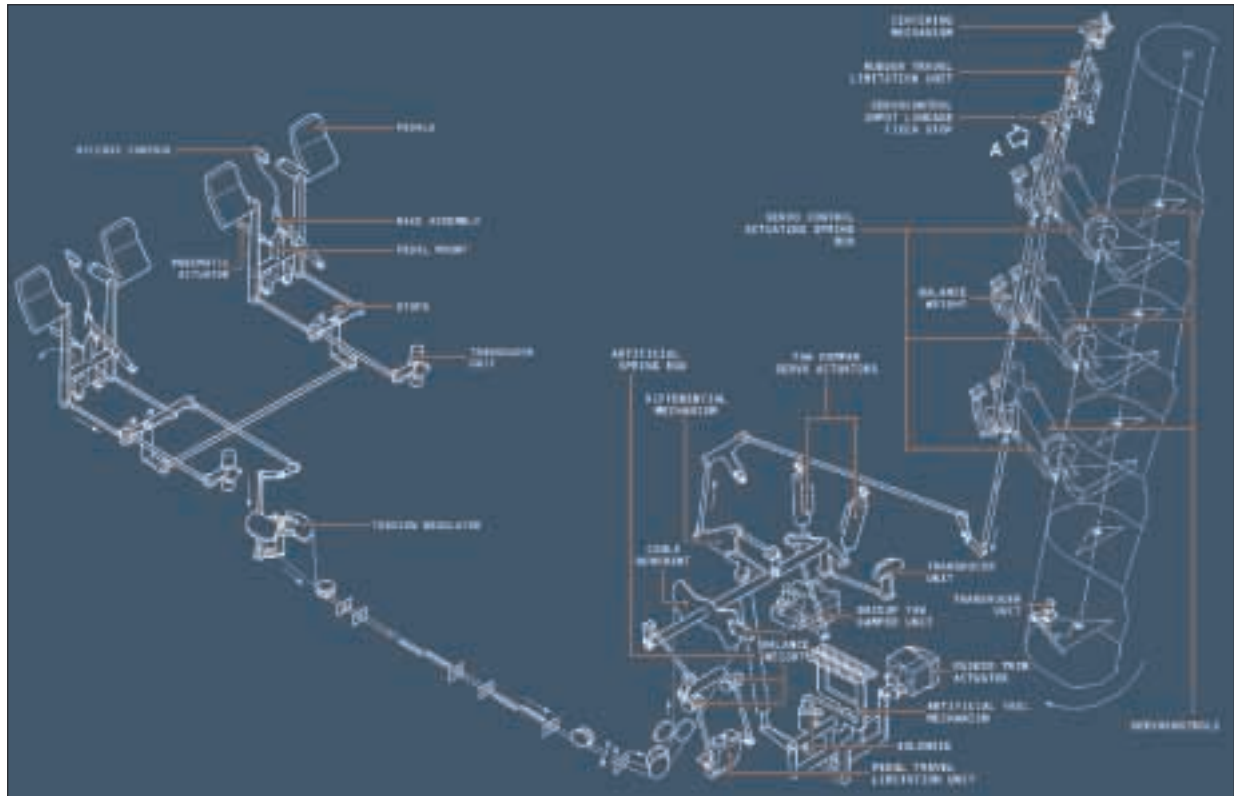
The majority of the components represented in figure 1 are involved:

We may come to similar conclusions on other axis, and/or other aircraft types. Note on fly-by-wire systems, it would be electrical wiring instead of mechanical linkage.

The F/CTL check is thus not limited to the relationship in between the servocontrols, observed with the surface position indicators, and the controls at cockpit. The whole system is checked.
