# Thrust Reverser Selection is a Decision to Stop

This article describes an event where the flight crew performed a go-around after they had selected thrust reversers on an A320 aircraft. The reverser on one engine remained deployed until the end of the flight.

# CASE STUDY

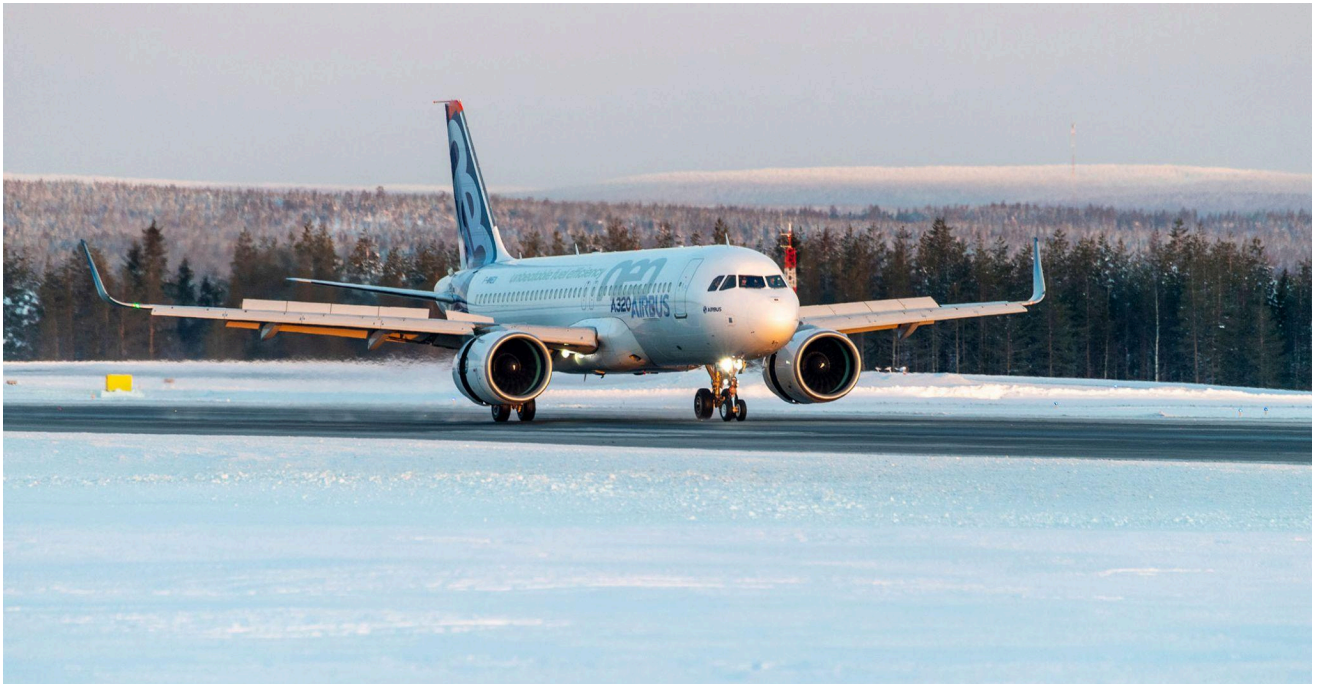
A similar event, described in a previous Safety first article, occurred on an A300-600 with a different reverser system architecture. The root cause was different, but it also highlighted how adherence to the SOP for landing would have prevented the incident.
