## Closing MEL Items: Why Sooner is Better

This article recalls the importance of fixing MEL items at the earliest opportunity to reduce this risk of exposure to multiple failures, and provides best practices where MEL extensions are necessary to maintain the highest possible margin of safety.

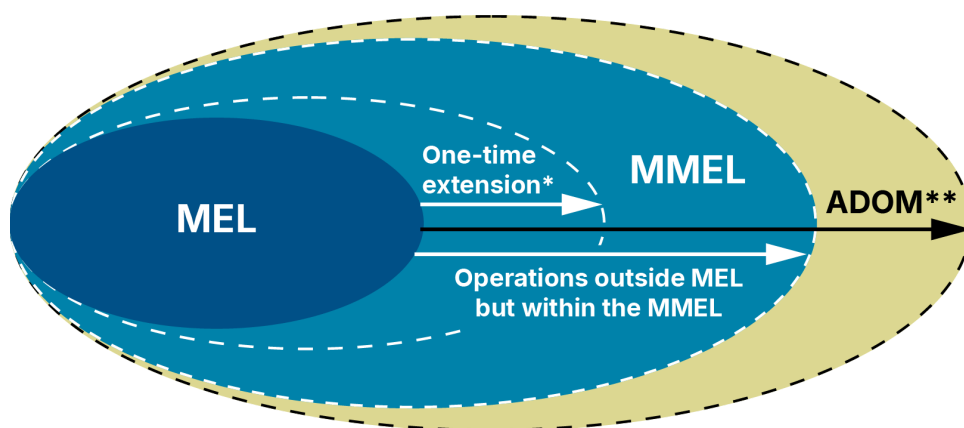
(fig.2) Possible MMEL/MEL extensions

**Any MEL extension must be agreed with the Operator's local authorities**

**\* Not applicable to repair interval A**

A one-time extension of standard repair intervals (B, C, D) is possible as defined by regulations (EASA Part-ORO.MLR.105(f), CS MMEL.135 and TCCA CASA 2022-02 for repair intervals B, C and D; FAA OpsSpecD095 for repair intervals B and C). Where applicable, this one-time extension is taken into account in the safety analysis of each MMEL item. An acceptable level of safety is therefore maintained for such cases. A dedicated process for the application of one-time extensions must be defined with the operator's national airworthiness authority.

The MEL defined by the operator for their aircraft is either as restrictive or more restrictive than the MMEL provided by the OEM for the aircraft type. An operator has the option to operate the aircraft outside the conditions of their MEL provided it complies with the equivalent conditions of the MMEL. An acceptable level of safety is maintained as the dispatch remains within the certified MMEL scope. It is however considered as a deviation from the operator's MEL and formal approval must be given by their relevant national aviation authority each time this option is required.

To avoid AOG situations, under exceptional circumstances, Airbus has developed a process called **Approved Deviation to OSD-MMEL (ADOM)**. It is a document issued by Airbus to support operators if they need to urgently dispatch an aircraft outside of the scope of the MMEL. For each ADOM, a safety analysis is performed following the same safety methodology as for the development of the MMEL items refined to the actual aircraft status and the planned mission to ensure that sufficient safety margins are maintained. Additional limitations can be required.

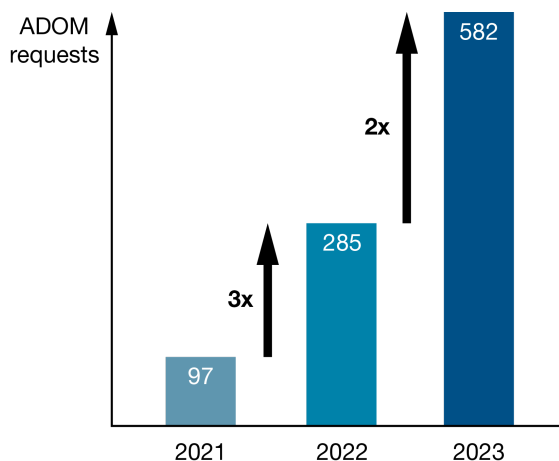
**(fig.3)** Evolution of the number of ADOM requests between 2021 and 2023

The number of ADOM requests has increased significantly each year since 2021. One reason is the difficulty to obtain parts due to the post pandemic supply chain challenges. This can further delay the repair or replacement of the affected equipment, increasing the exposure to multiple failure situations as described in the case study above. ■
