# High Load Event Reporting

All pilots will encounter high load events over their flying career. The evaluation of the aircraft's airworthiness following these events is enabled by the pilot's report of any speed exceedance and excessive vertical or lateral accelerations caused by turbulence and hard landings. This article describes how to recognize and respond to all types of high load events and the evolution of the information available to support analysis of events, which will determine what maintenance actions are necessary to ensure an aircraft is safe to fly.

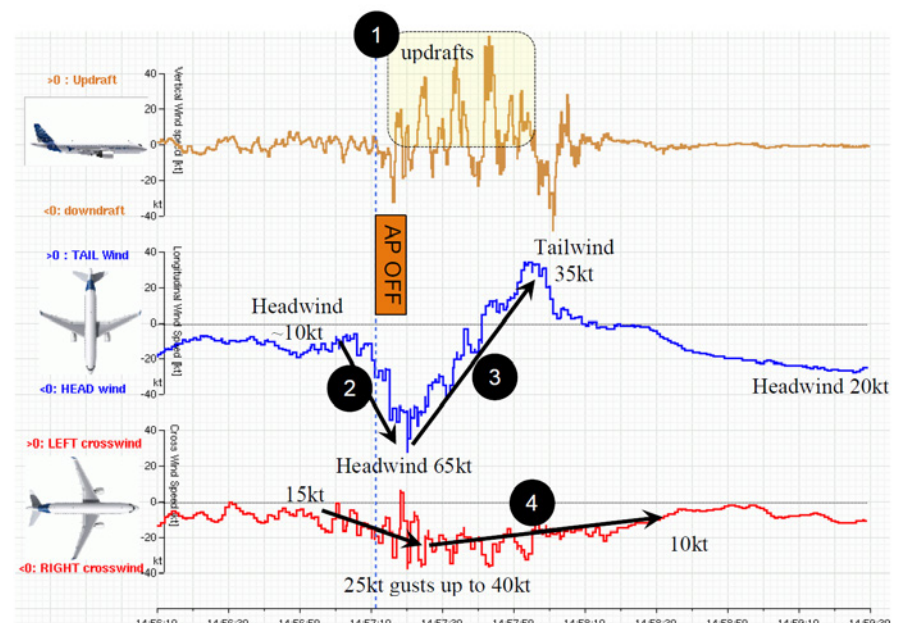
(fig.7)

An example of a Handling Qualities Analysis of wind evolution using flight recorder data from an excessive turbulence event showing that the aircraft experienced several vertical gusts at 4kt/s, which were mainly updrafts (1). The headwind sharply increased from 10kt to 65kt at a rate of ~4kt/s (2) then changed to a 35kt tailwind, with a gradient of 100kt in 35sec at ~3kt/s and significant gusts (3). The right crosswind component was around 15kt before encountering the turbulence when it increased up to 25kt with several gusts of up to 40kt (4).

The HQA, based on the FDR raw data readout (**fig.7**), is carried out in parallel with the load analysis generally required for structural inspections. The aircraft’s release back into to service is out of the scope of the HQA. The main objectives of the HQA are to understand an event and its origin and to provide information on operational best practices to the airline to avoid re-occurrence. Through the HQA activity Airbus proactively supports airlines in maximizing the efficiency of their operations as well as monitoring the fleet for system and design consistency, with enhancing safety as its primary objective. ■
