# Parking and Storage Return to Service

## SUMMARY LETTER

Providing guidance during Parking & Storage and support for a smooth return to service

15 March 2024

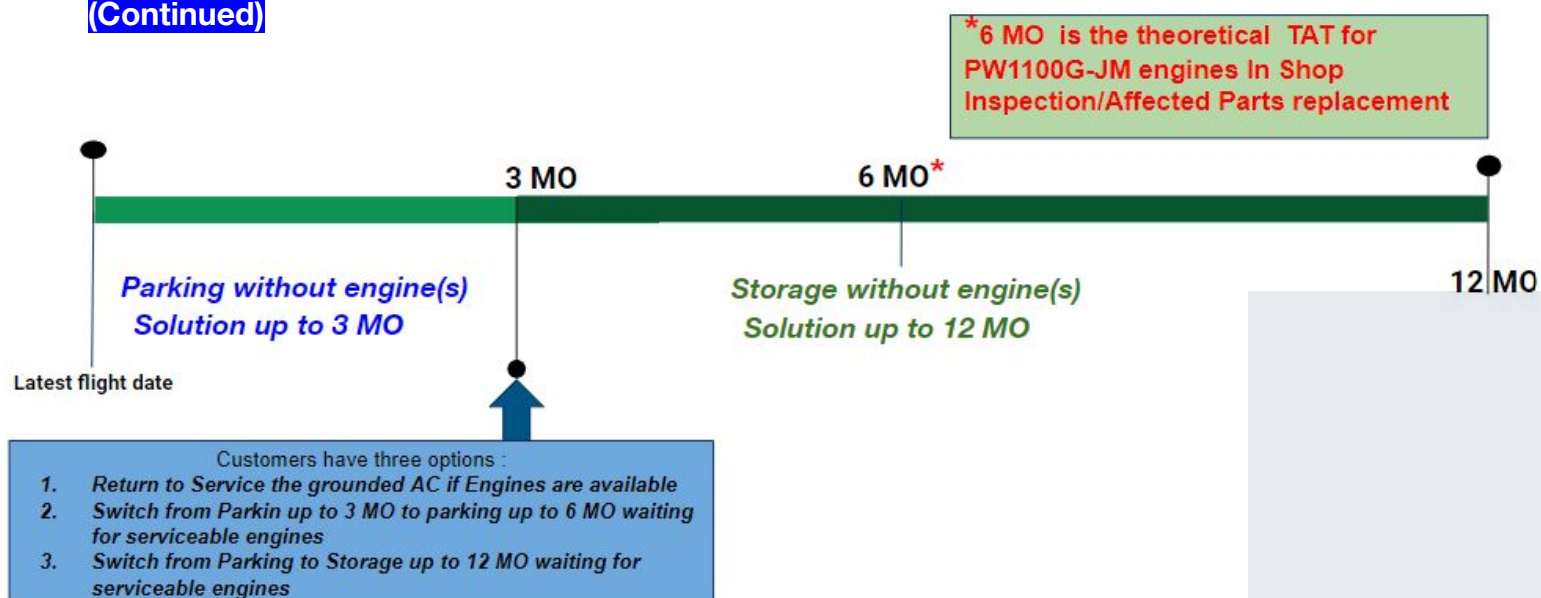
## P&W Engine Shortage – P&S Pre-Defined Solution (PDS) RDAFs (A320NEO - PW1100G) (Continued)

Customers can take benefit of the Parking without engine(s) up to 3 MO solution. If it is not possible to return to operation at the end of the 3 month parking period, they can extend the parking period using the second PDS Parking without engine(s) up to 6MO and/or switch to storage, taking benefit of the third PDS Storage without engine(s) up to 12 MO.

These Pre-Defined Solution RDAFs are dependent upon a full application of all work-steps from the AMM chapter 10 procedures, except for those work-steps that cannot be done without serviceable engines.

- Parking w/o engine(s) up to 3 MO w/ or w/o TRs. The following configurations are covered:
  - One or Two engines removed,
  - All Nacelle removed on the side where the engine(s) is(are) missing or Thrust Reversers only kept installed.
- Parking up to 6 MO w/o NRF w/o engine(s) w/ or w/o TRs. The following configurations are covered:
  - One or Two engines removed,
  - All Nacelle removed on the side where the engine(s) is(are) missing or Thrust Reversers only kept installed.
- Storage w/o engine(s) up to 12 MO w/ or w/o TRs. The following configurations are covered:
  - One or Two engines removed,
  - All Nacelle removed on the side where the engine(s) is(are) missing or Thrust Reversers only kept installed.

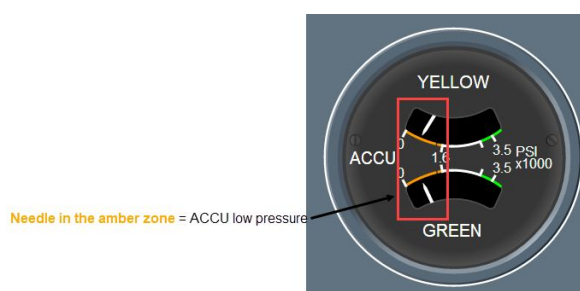
## ATA 32 SPURIOUS DISPATCH MESSAGE (NO GO) (A350 PROGRAM)

Post parking/storage, some A350 operators reported spurious dispatch messages (NO GO) at or after pushback if the aircraft is powered up with low braking accumulator pressure, causing delay.

If the aircraft is powered up with a braking accumulator in the Amber zone prior return to service, it is recommended to perform BITE scanning of BSCS1 and BSCS2 after power-up to confirm no fault is latched (MP TASK A350-A-45-45-XX-00002-345A-A) in BSCS. For more info please refer to TFU [32.43.00.032](#).

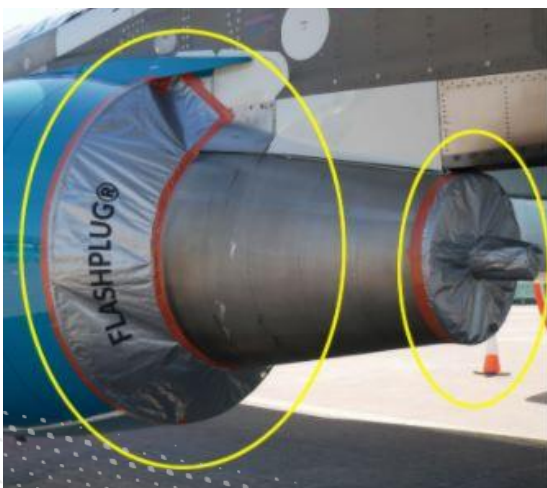
This engine preservation solution has been developed in response to operators' need to preserve their engines on-wing. Not only is the solution a fast and cost effective one, but the FLASHPLUG® is also smaller and easier to handle than traditional engine preservation solutions. The FLASHPLUG® weighs a mere 700 grams and can be folded into a tiny package for future use in the fly-away kit and can be shipped in a usual document express envelope. It takes less than 10 minutes for a mechanic to fit the FLASHPLUG®. [Any question, please contact us via through Airbus Spares portal.](#)

- Installation time of 8 minutes (one mechanic)
- Low cost (cheaper than film & tape option)
- Re-usable (can be re-fit multiple times)
- Special Adhesive Formulation (will not damage paint or leave sticky residue)
- Small & lightweight (can be packed with Fly Away Kit)

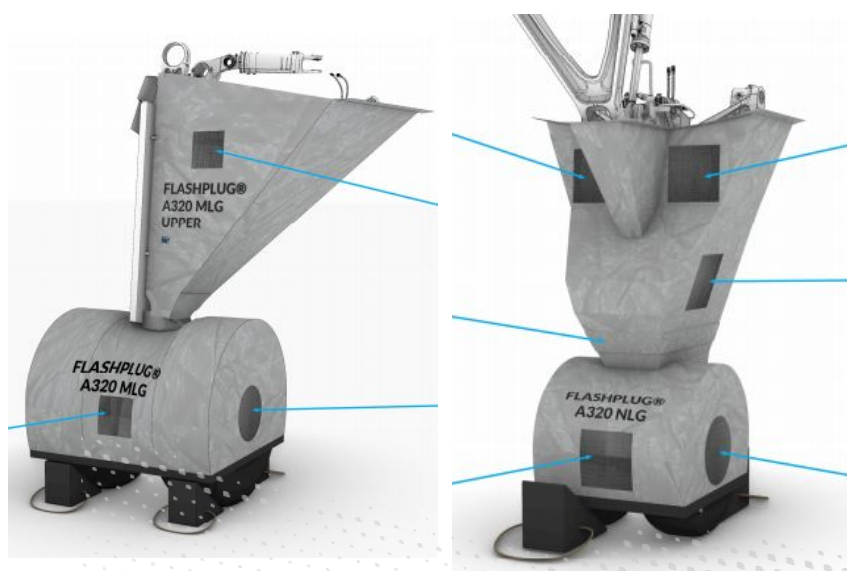
The new landing gear covers can be installed by one person in 8 minutes per landing gear, it is a reusable product and also it mitigates the risk of paint damage and animal nesting.

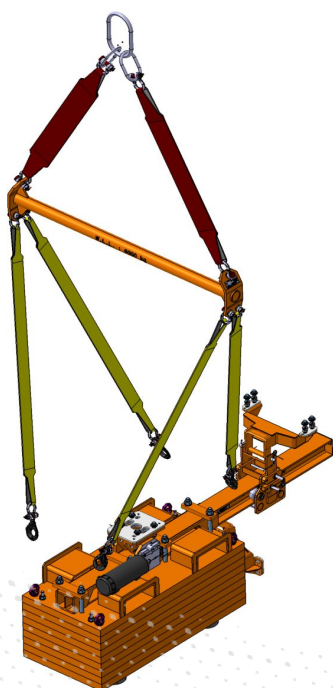
# ATA 71 | DUMMY WEIGHT

**W**hen the engines are removed during a structural check, weight ballasts need to be placed in the cargo compartment to ensure the Aircraft stabilization. This drastically limits the access for inspections in that area and increases the turn-around time as well as the effort of resource allocation.

The engine dummy weights have been co-developed with one of our customers, including weight plates local manufacturing and assembly that allow an easy transportable, cost-effective solution that can be used for parking and storage with removed engine nacelle. This tool is directly procurable via SATAIR, through Airbus Spares portal.

- Unique solution for all A320 Family engine types
- Move, store and preserve the Aircraft with 1 or 2 engines removed
- Safe and easy to use thanks to a lifting beam and forklift
- Customer choose his own local weight plates manufacturer

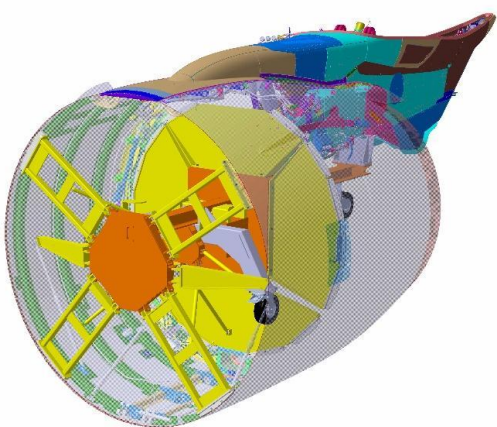
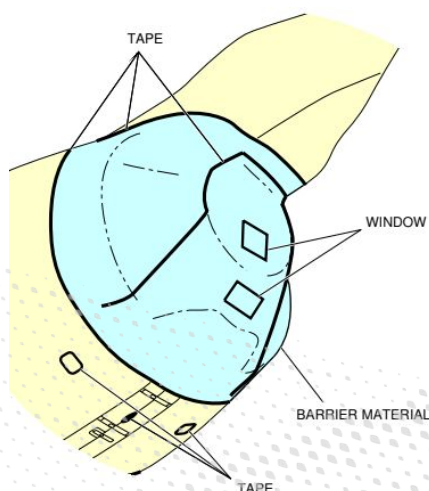
To support A320 Family Pratt & Whitney operators that are required to store their Aircraft, a specific Dummy Engine Tool is currently under development to facilitate the operation. It aims to be installed in place of the engines while keeping the cowls in place. This solution is expected to be available by the end of 2024.

- Save storing space
- Move, store and preserve the aircraft with the fan and reverse cowls in place
- Open and close the engine cowls with dummy engine in place
- No need to store engine cowls
