# Takeoff Surveillance & Monitoring Functions

Airbus has continuously improved takeoff safety since the “TO CONFIG TEST” pushbutton was first introduced on A300 and A310 aircraft, and with the development of the Takeoff Surveillance (TOS1 & TOS2) and Takeoff Monitoring (TOM) functions.

The TOS2 package that was initially developed for the A350 is now available for A320 family and A330 aircraft. This is an opportunity to review the checks that are performed by each function, from cockpit preparation to takeoff.

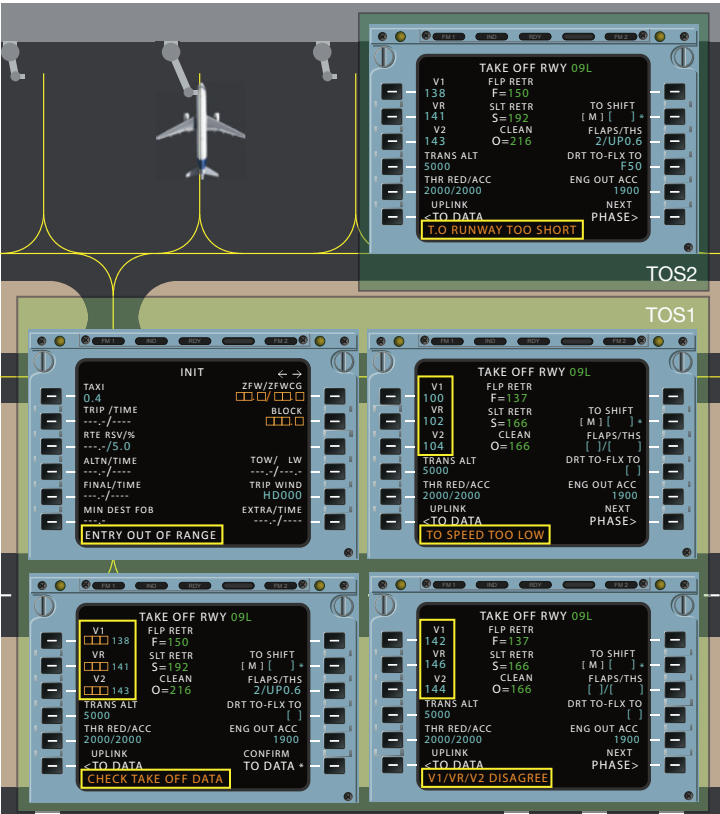
During the cockpit preparation, TOS1 checks for gross errors on weight or takeoff speeds inserted into the FMS. The MCDU/MFD can display the below scratchpad messages (fig. 1).

TOS2 computes the Lift Off Distance (LOD) expected with the performance dataset entered by the crew (weight, thrust, Flaps, OAT and VR/V2) and compares it with the available runway length of the takeoff runway selected in the FMS. The LOD computation takes into account any takeoff shift entered in the MCDU/MFD. If the available runway length is lower than the LOD, the MCDU/MFD scratchpad displays a **T.O RUNWAY TOO SHORT** message (fig. 1).

**(fig.1)**  
TOS1 and TOS2 potential scratchpad messages during cockpit preparation

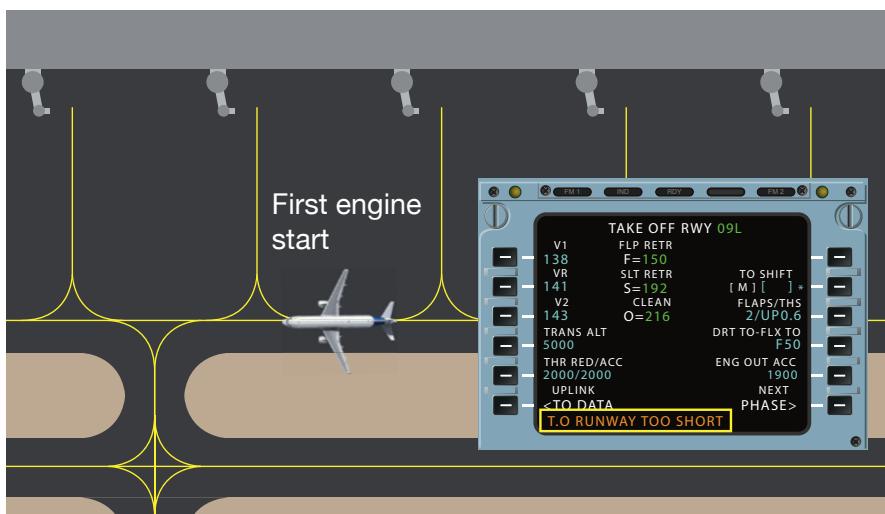
(fig.2)

TOS2 re-performs a LOD check at engine start, using actual fuel quantity data now available from the fuel system. If the available runway length is lower than the LOD, the MCDU/MFD scratchpad displays a **T.O RWY TOO SHORT** message (fig.2). ■

TOS2 potential alert at first engine start

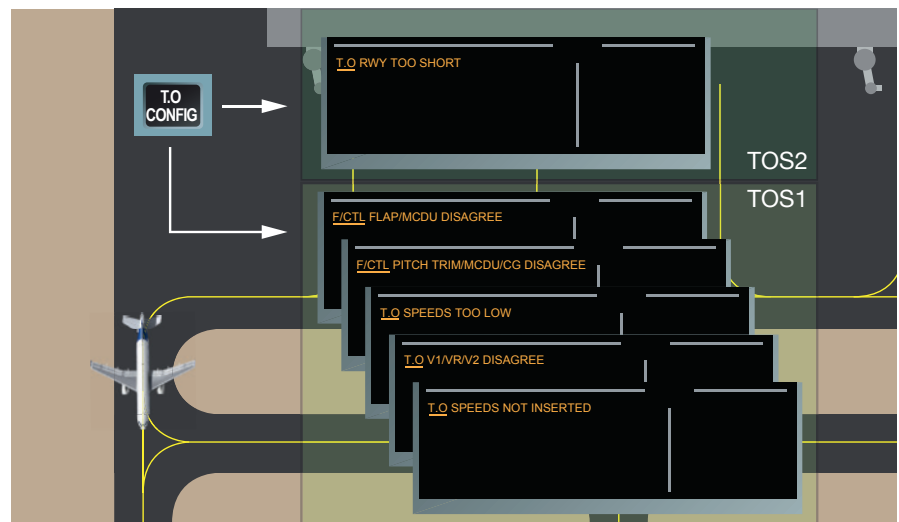
TOS1 checks consistency between the Flaps setting inserted by the crew in the Takeoff PERF page and the actual flaps setting. If there is an inconsistency, this will trigger the **F/CTL FLAP/MCDU DISAGREE** (A320/A330/A340) (fig.3) or **F/CTL FLAP/FMS DISAGREE** (A350/A380) ECAM message.

TOS1 also compares the trim setting entered by the crew into the Takeoff PERF page with the actual Trimmable Horizontal Stabilizer (THS) position and with the trim computed by the FAC/FMGEC/FE based on the CG value provided by the fuel management system. If an inconsistency is detected, this will trigger the **F/CTL PITCH TRIM/MCDU/CG DISAGREE** (A320/A330/A340) (fig.3) or **F/CTL PITCH TRIM/FMS/CG DISAGREE** (A350/A380) ECAM message.

TOS1 performs an additional takeoff speeds check in the same way as it was done during the cockpit preparation phase. If one of the checks fails, the Flight Warning System triggers an ECAM alert and displays the associated MCDU/MFD scratchpad message **(fig.3)**:

TOS2 performs an additional LOD check. If the available runway length is lower than LOD, the Flight Warning System triggers the ECAM alert **T.O RWY TOO SHORT** **(fig.3)** and displays the associated scratchpad message. ■

TOS1 and TOS2 potential alerts when the T.O CONFIG pushbutton is pressed

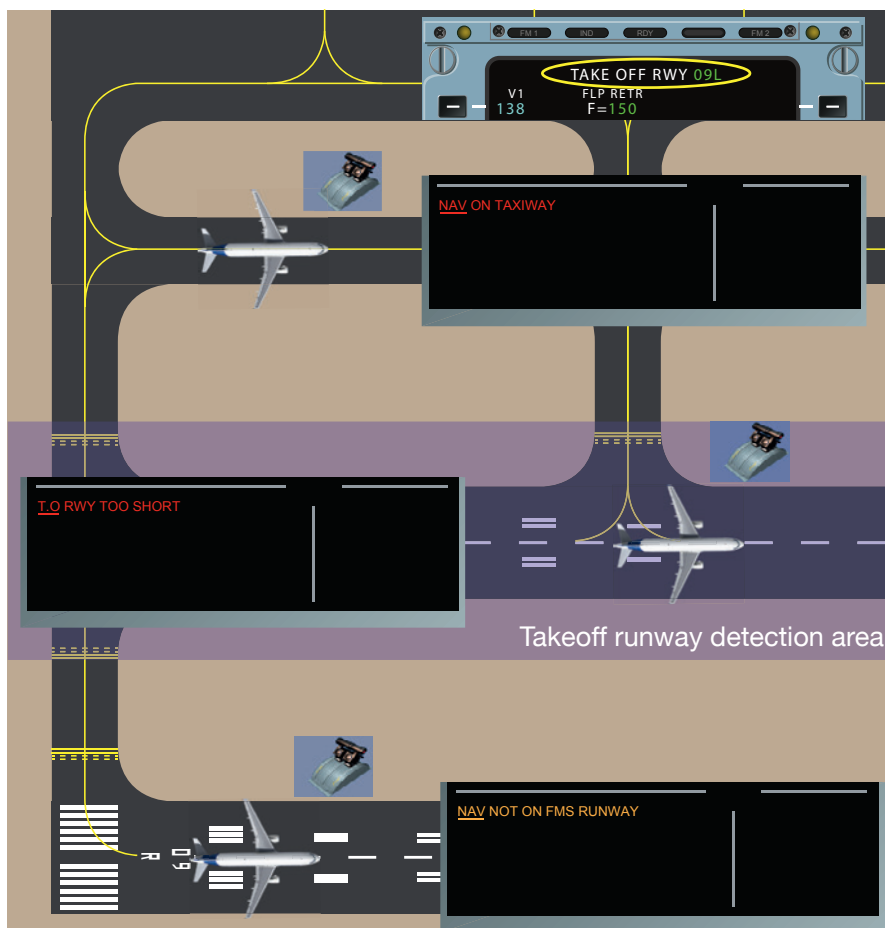
When the crew applies takeoff thrust, TOS2 checks if the aircraft is positioned within an area that contains the takeoff runway entered in the FMS **(fig.4)**.

When the flight crew applies takeoff thrust, TOS2 performs a final LOD check based on the real aircraft position. If the runway distance available in front of the aircraft is lower than the computed LOD (e.g. an aircraft commencing takeoff from a wrong runway intersection or from an incorrect runway with an insufficient length), this will trigger the red ECAM warning **T.O RWY TOO SHORT** (fig.4). ■

**(fig.4)**  
TOS2 potential alerts at takeoff thrust application

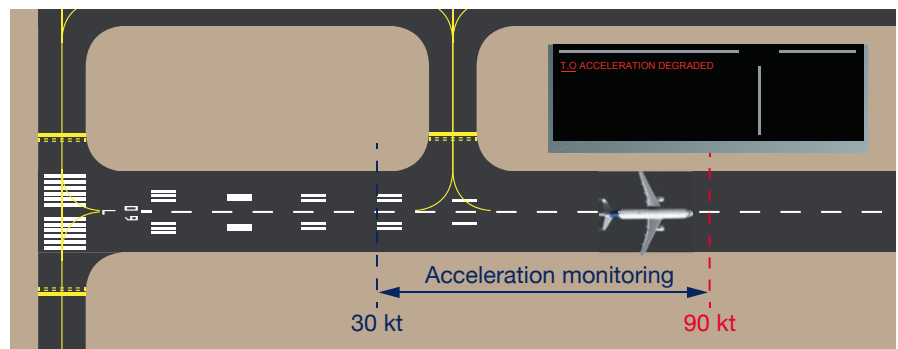
(fig.6)

TOM provides an additional safety-net during the takeoff roll. From 30 kt, it compares the expected acceleration with the real acceleration of the aircraft. If the difference between the real aircraft acceleration and its expected acceleration is more than 15 % when the aircraft reaches 90 kt, TOM will trigger the red ECAM warning **T.O ACCELERATION DEGRADED**.

TOM alert displayed if the difference between the aircraft's actual acceleration and its expected acceleration is more than 15 % when the aircraft reaches 90 kt

Many ECAM alerts are inhibited between 80 kt and 400 ft (takeoff inhibition phase). Any warning received during this period must be considered as significant. For this reason, Airbus recommends to reject the takeoff if the **T.O ACCELERATION DEGRADED** warning is triggered. The TOM function is designed so that if this warning appears when the aircraft reaches 90 kt, the flight crew can safely perform a rejected takeoff before V1. ■
