*Flight Operations Support - Customer Services Directorate*

# **GETTING HANDS-ON EXPERIENCE**

## **WITH AERODYNAMIC DETERIORATION**

### **A PERFORMANCE AUDIT VIEW**

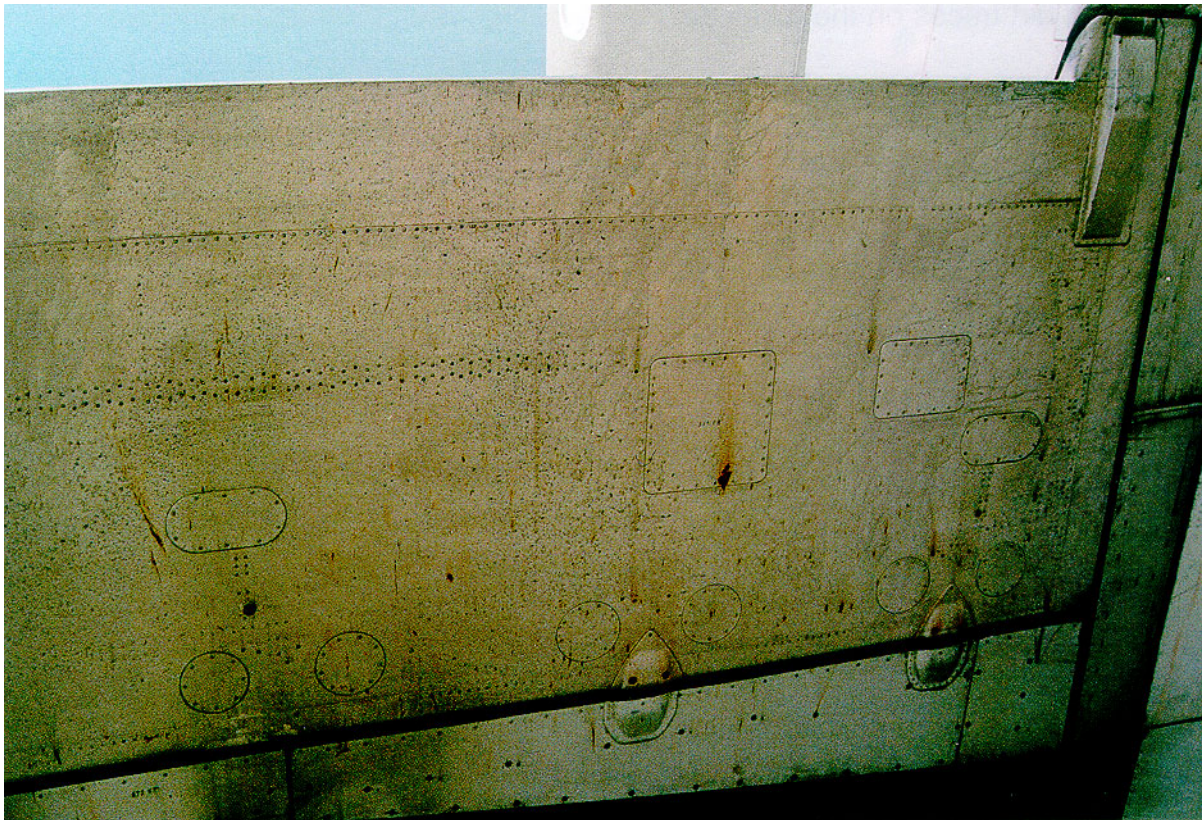
Surface deterioration can lead to significant fuel penalties, especially if the skin is rough or dirty. For a complete aircraft - in the worst case - the penalty can be as high as US\$ 60,000 per aircraft per year. Another serious penalty would certainly be on the airline's commercial image!

Flap

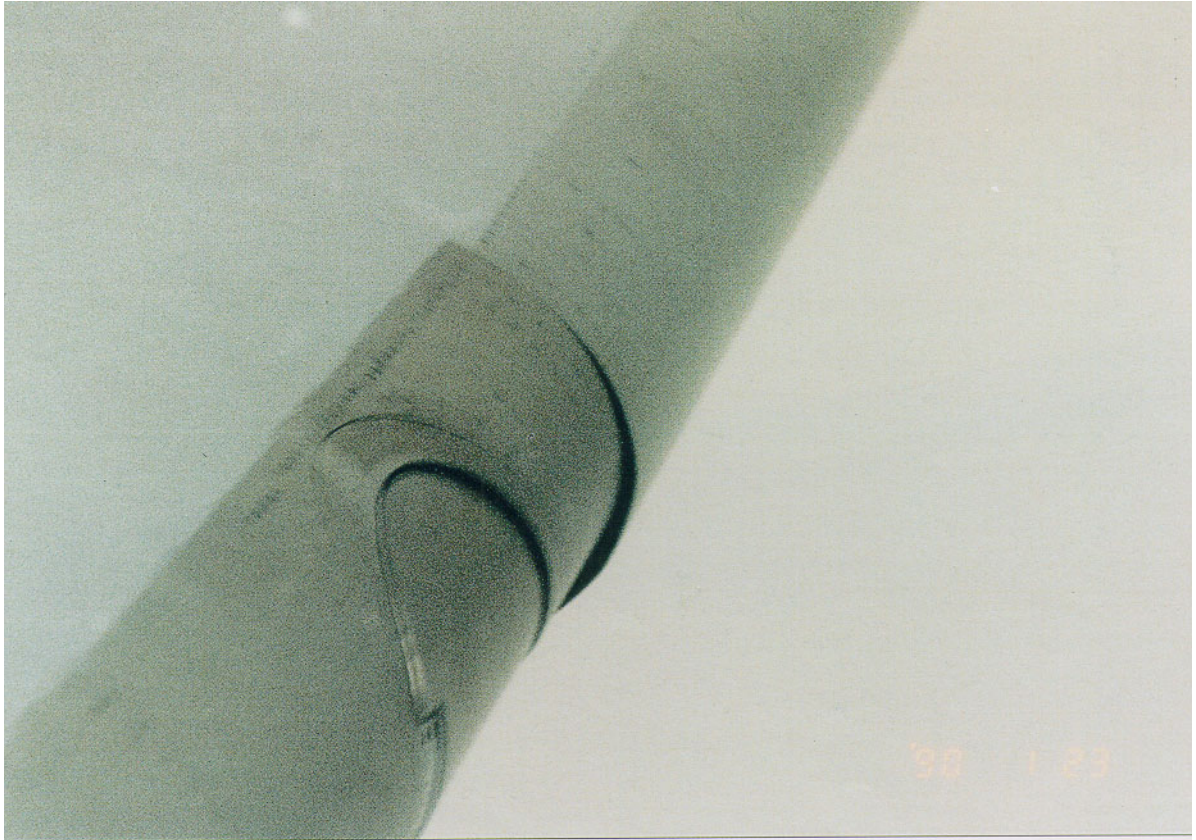
Misrigged slats

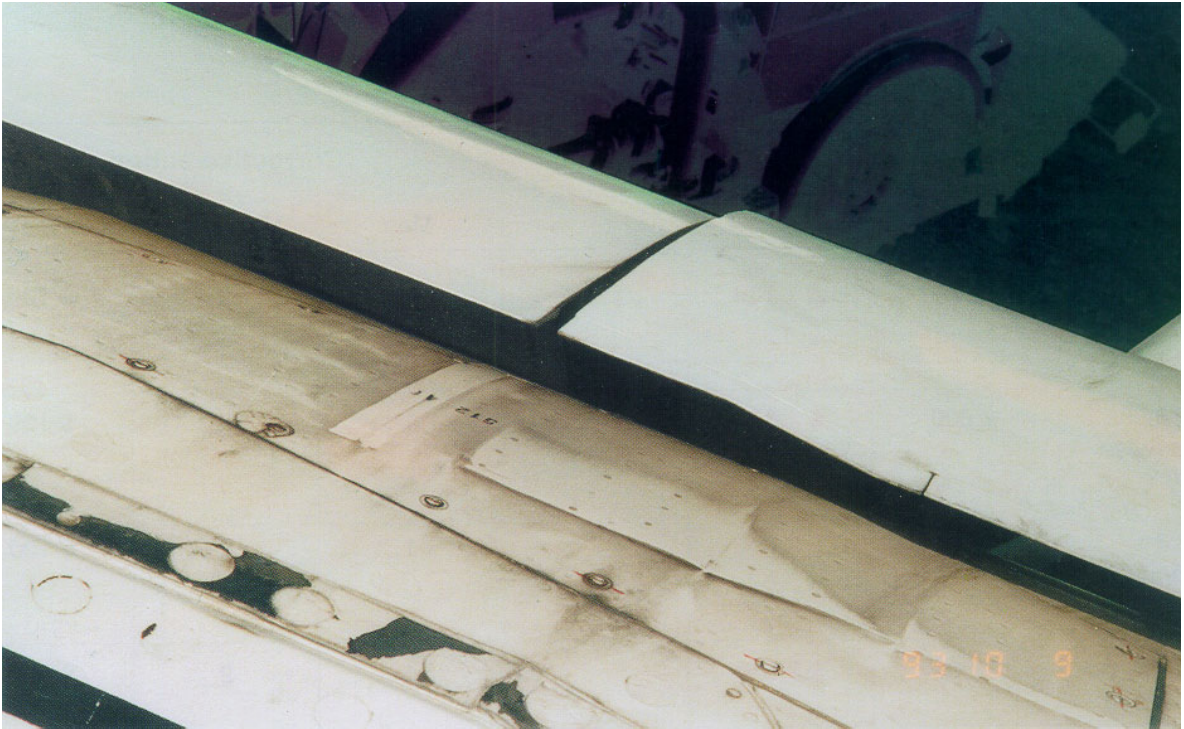
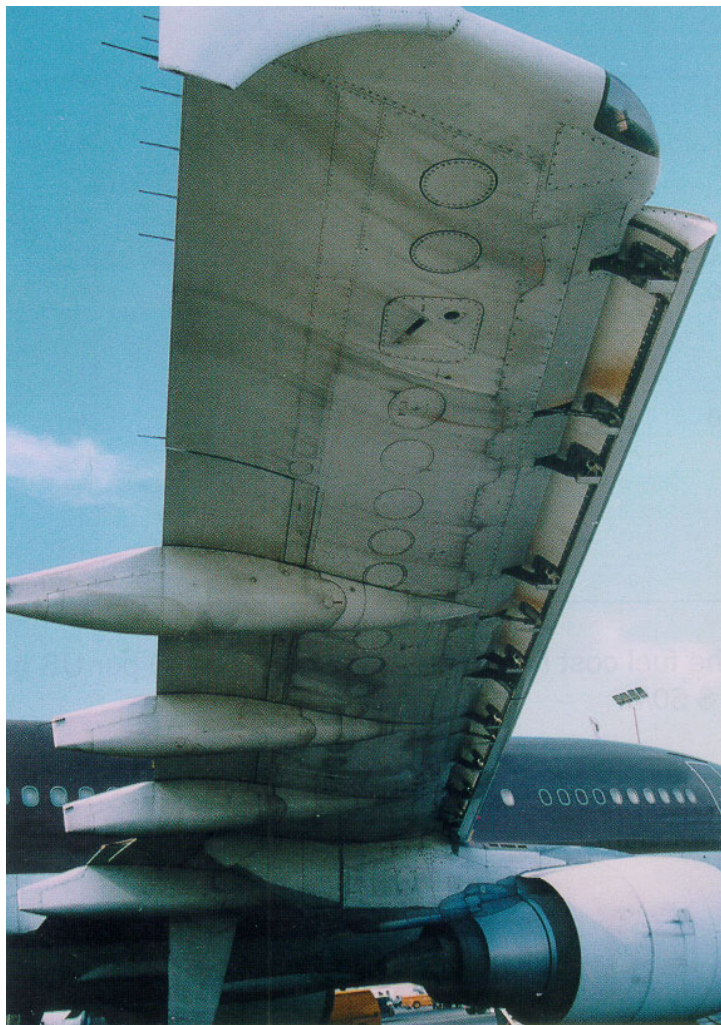
Absence of spanwise slat seal

No traces

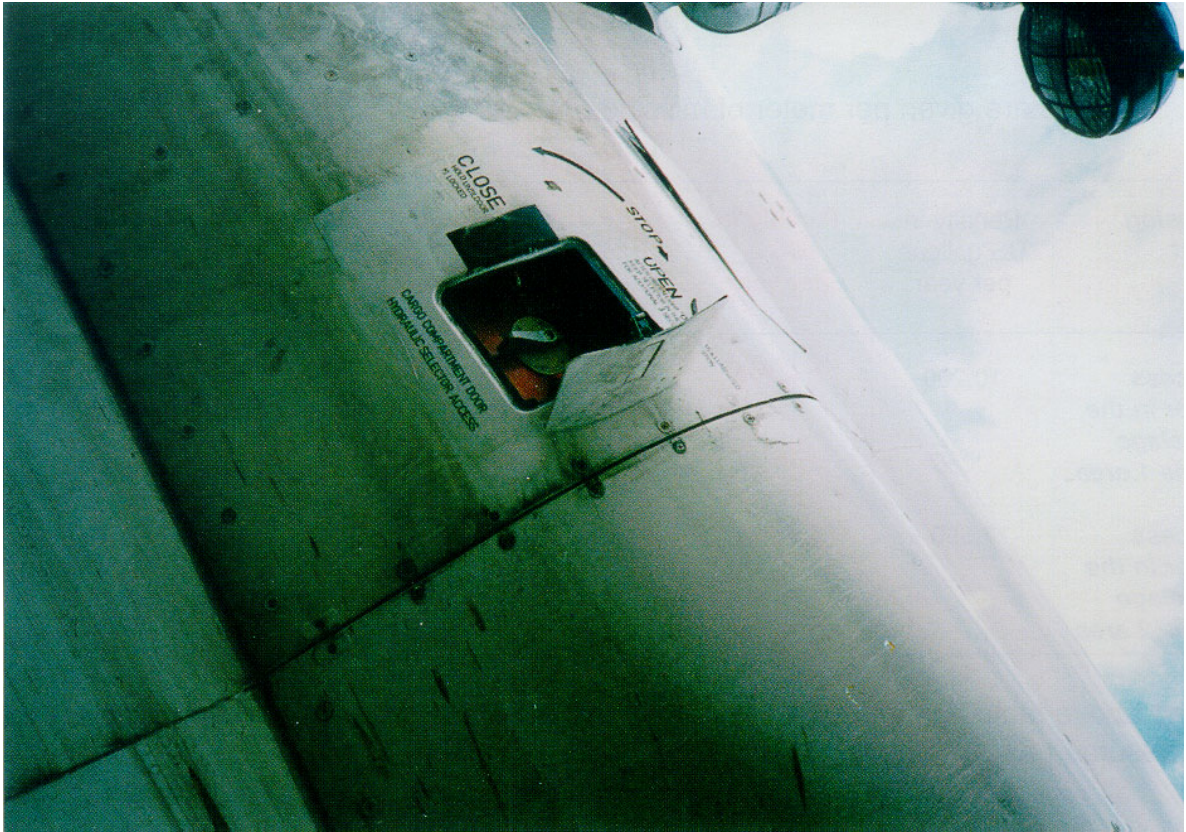
Service door

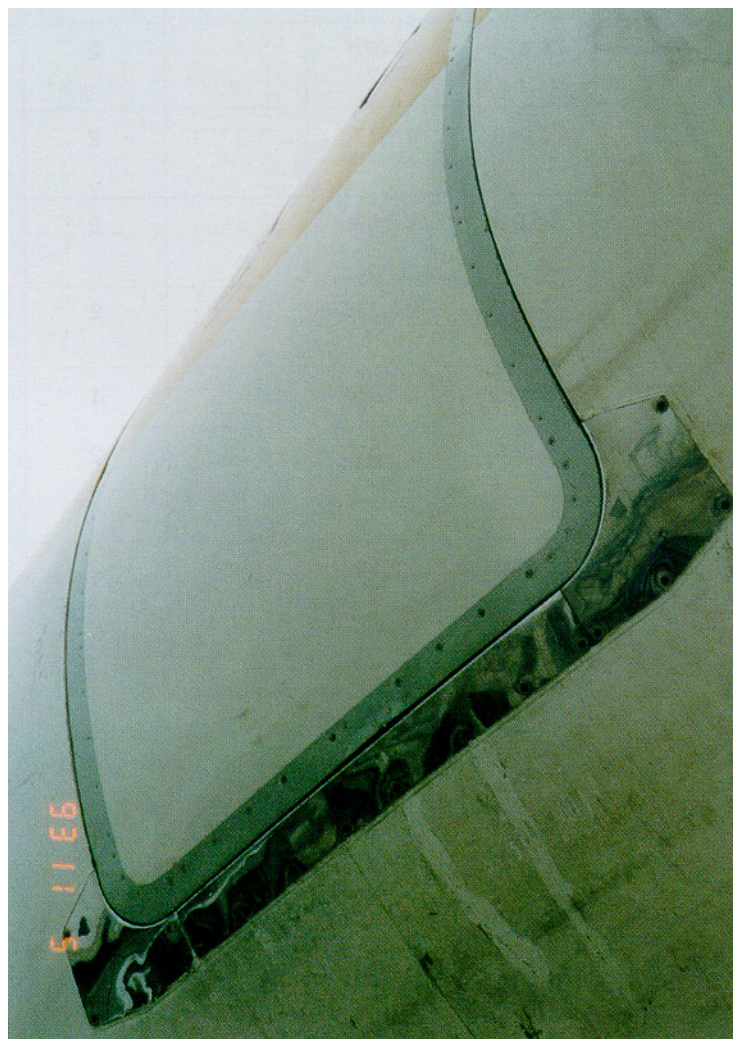
Mismatched passenger doors

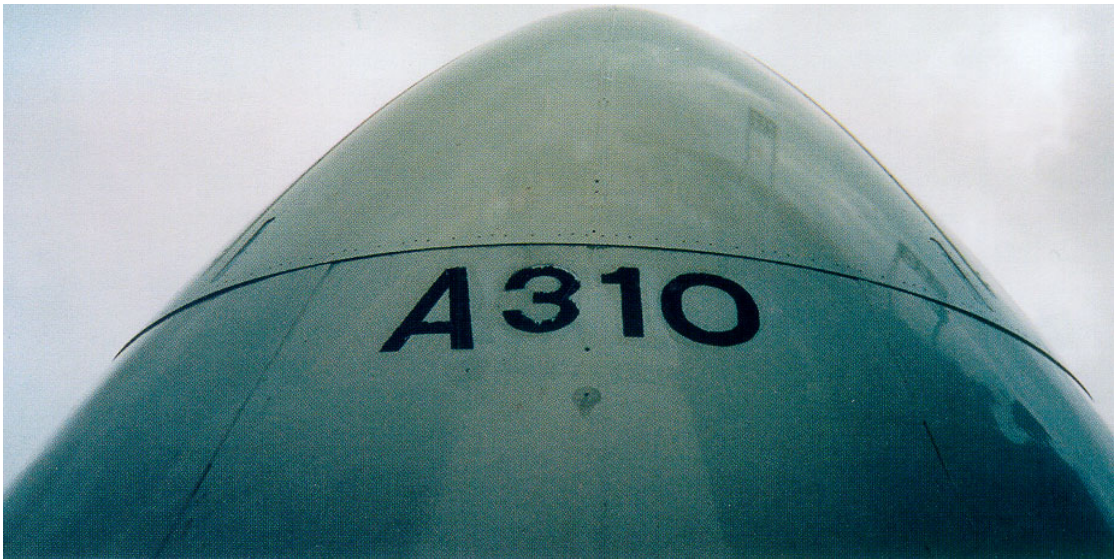
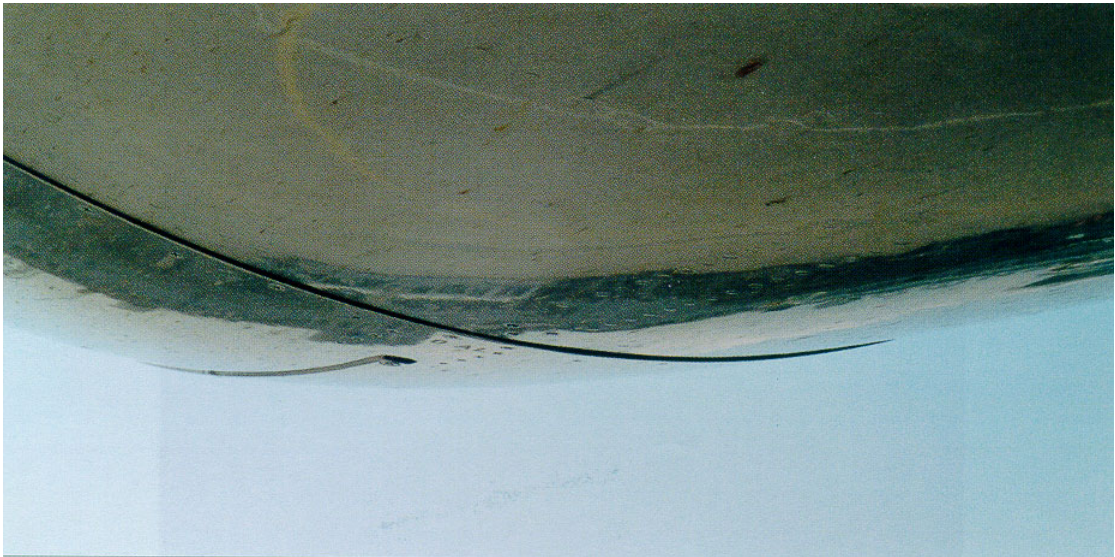
Radome misfit

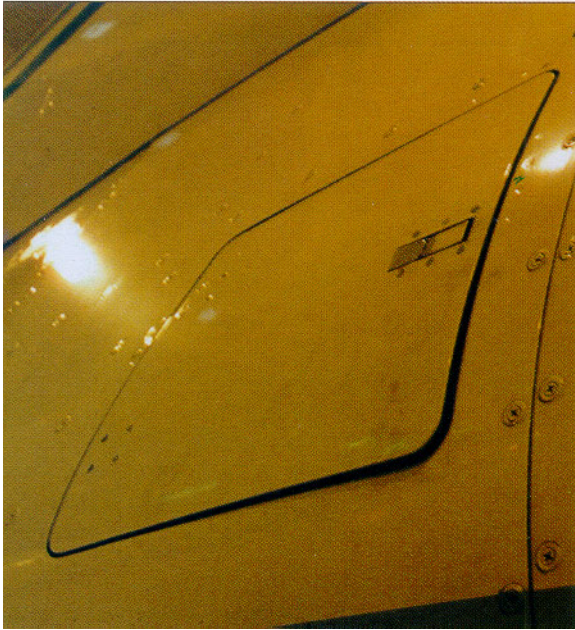
Mismatched access doors

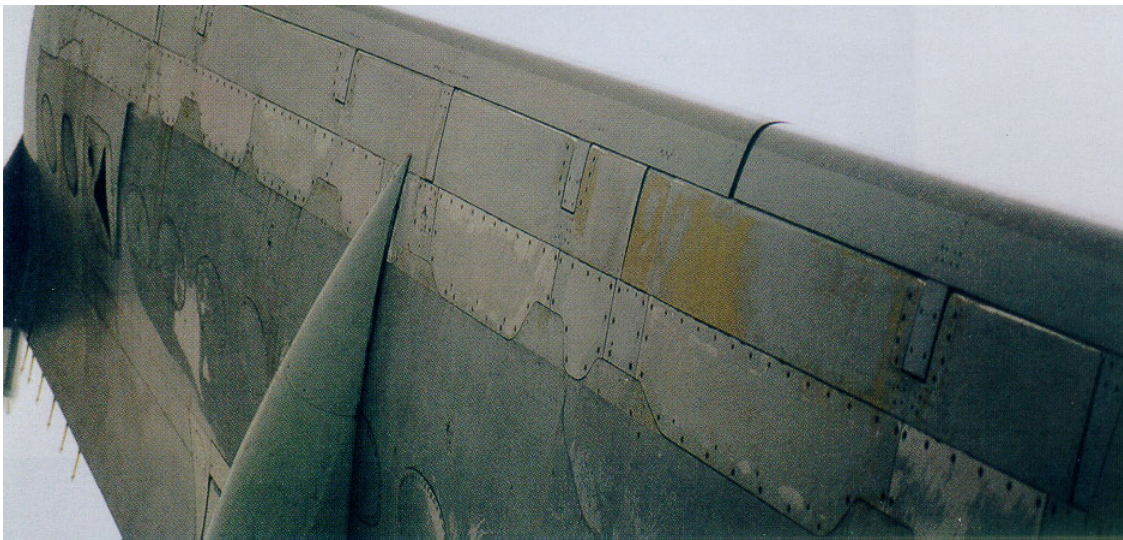
Lower wing roughness

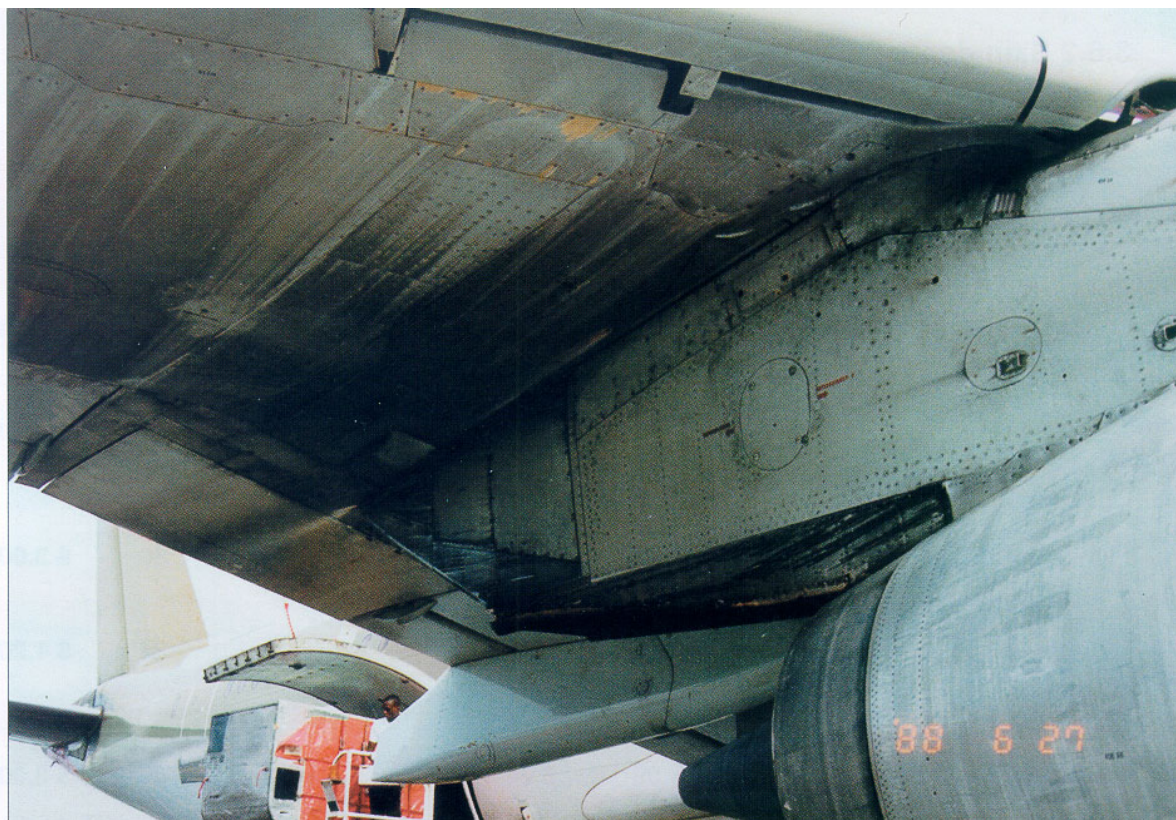
Lower wing roughness

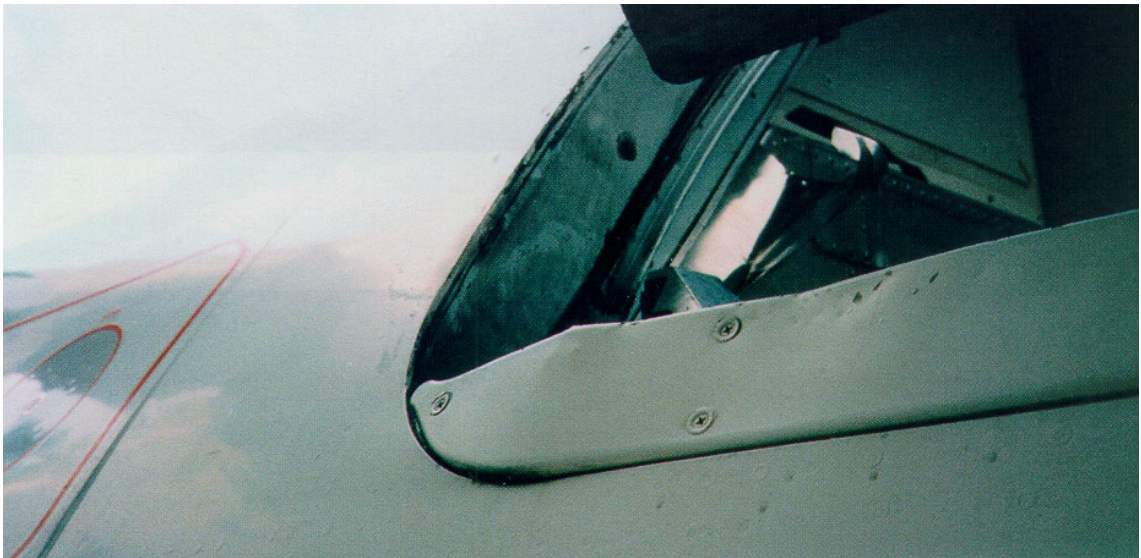
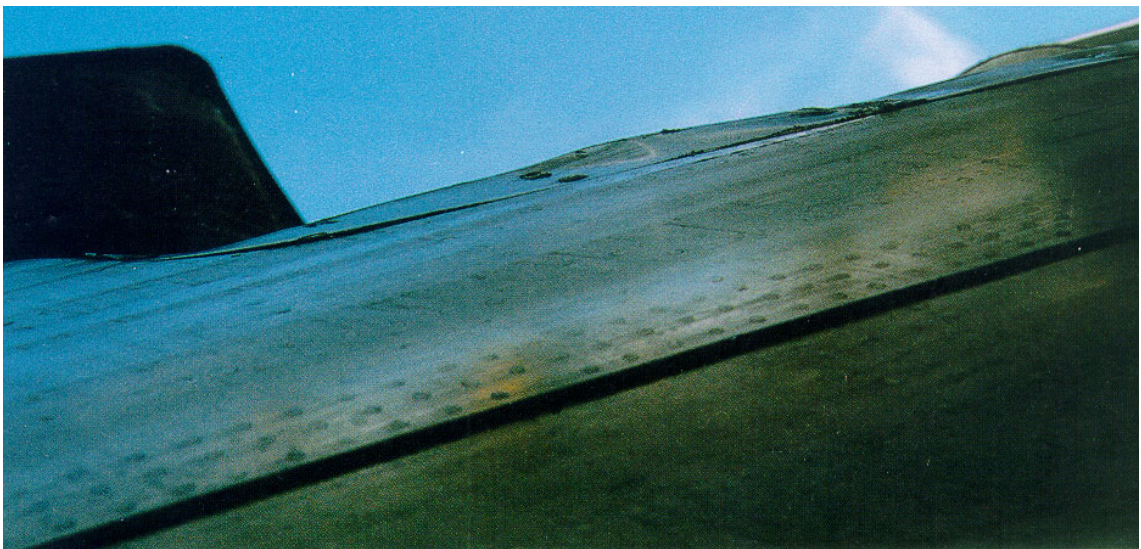
Dented scuff plates

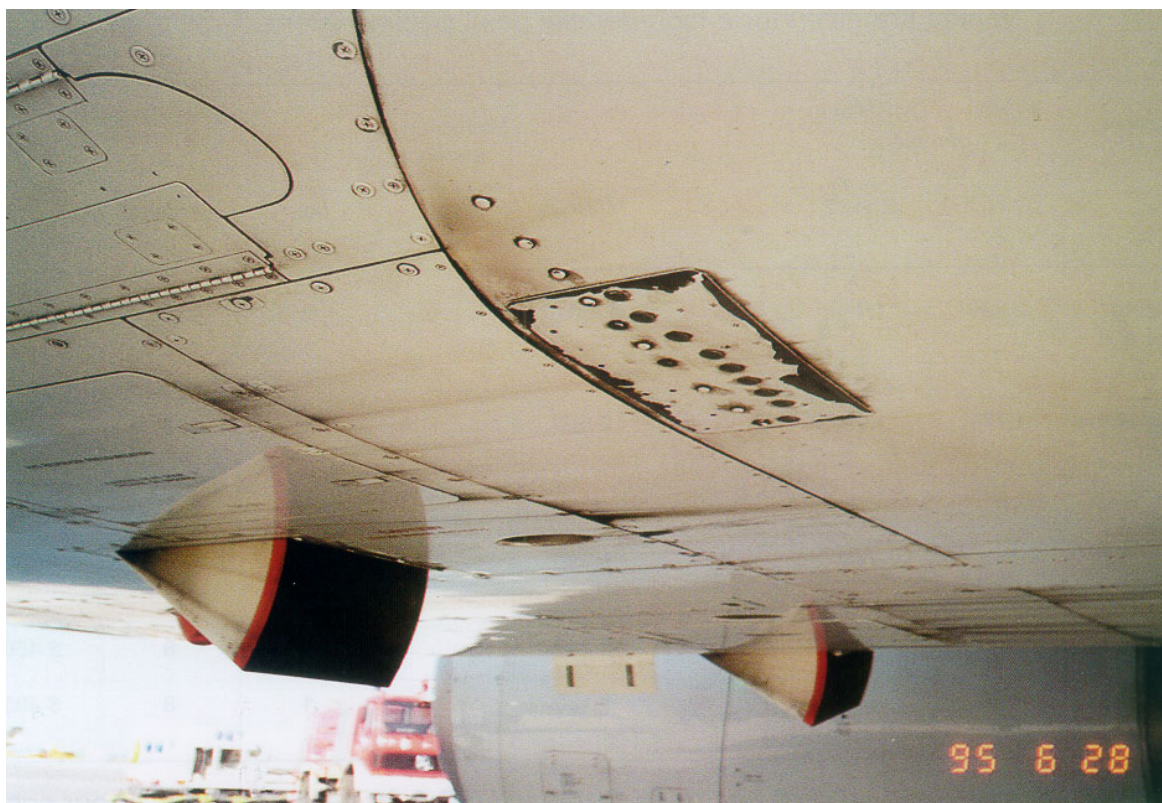
External patches

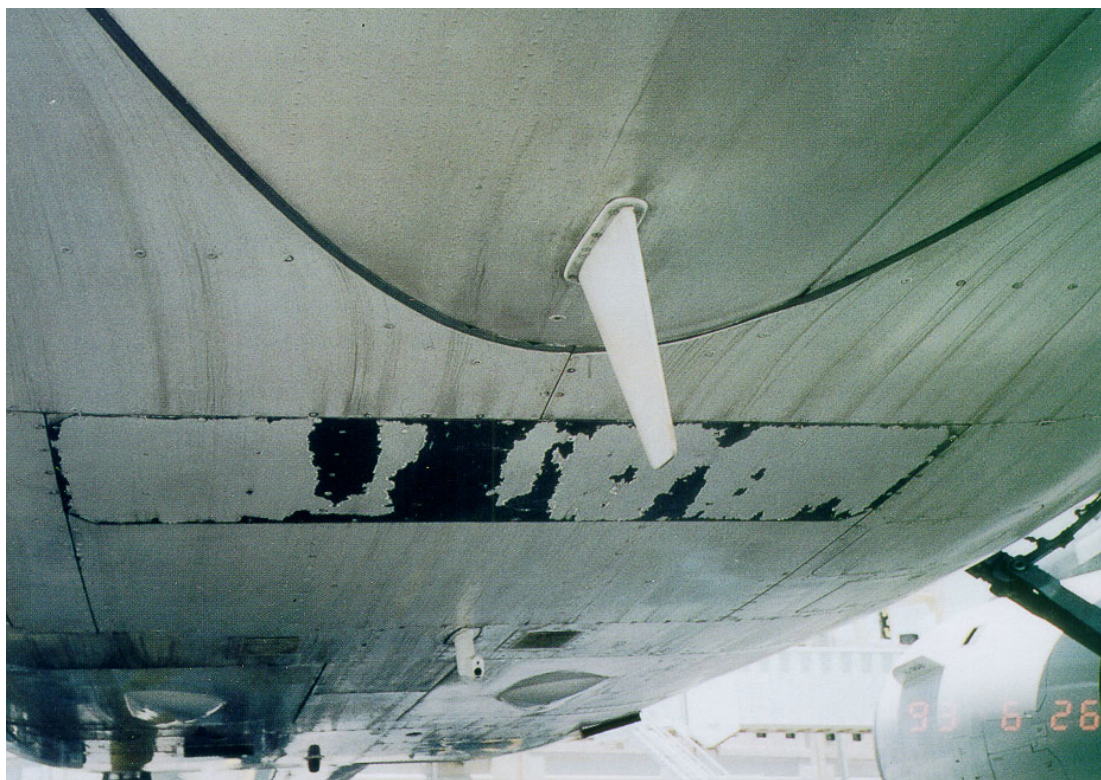
Paint peeling on the  
belly fairing

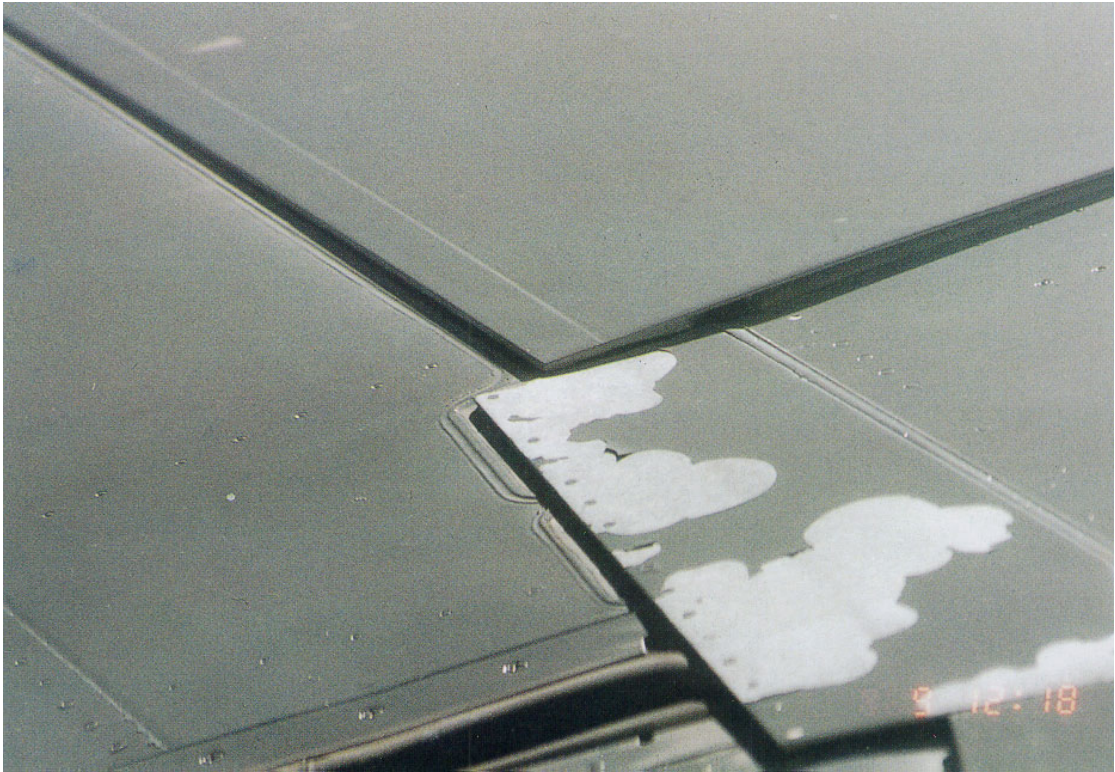
Paint peeling on the upper-  
wing

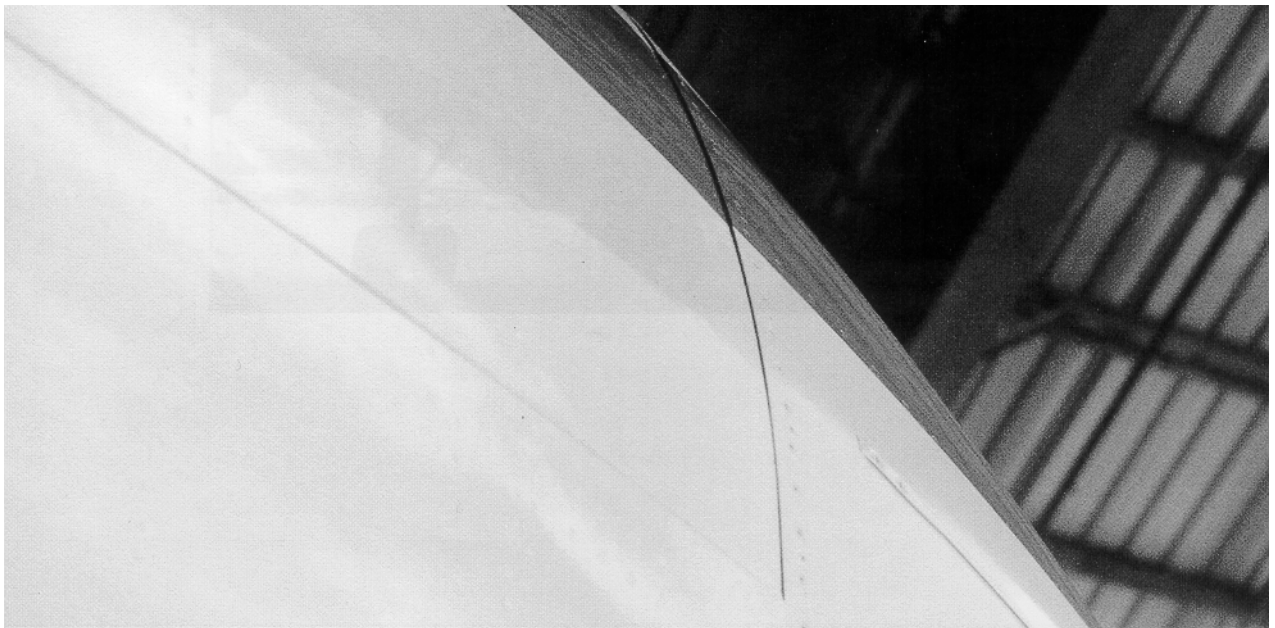
Radome misfit

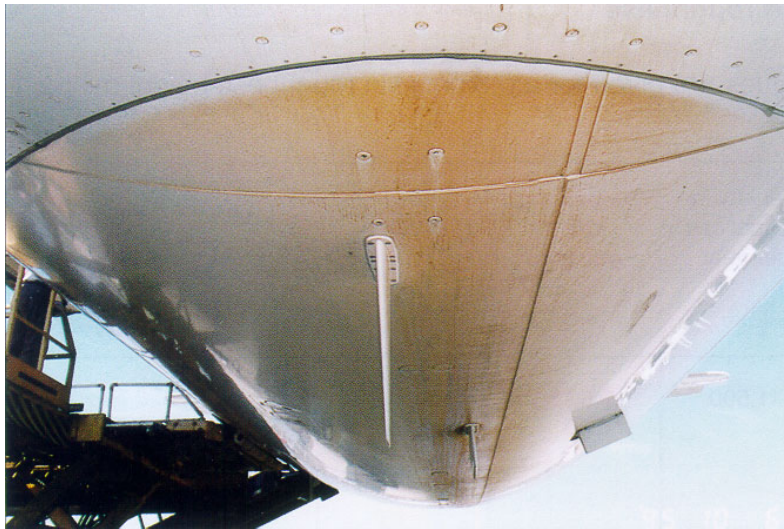
Skin roughness

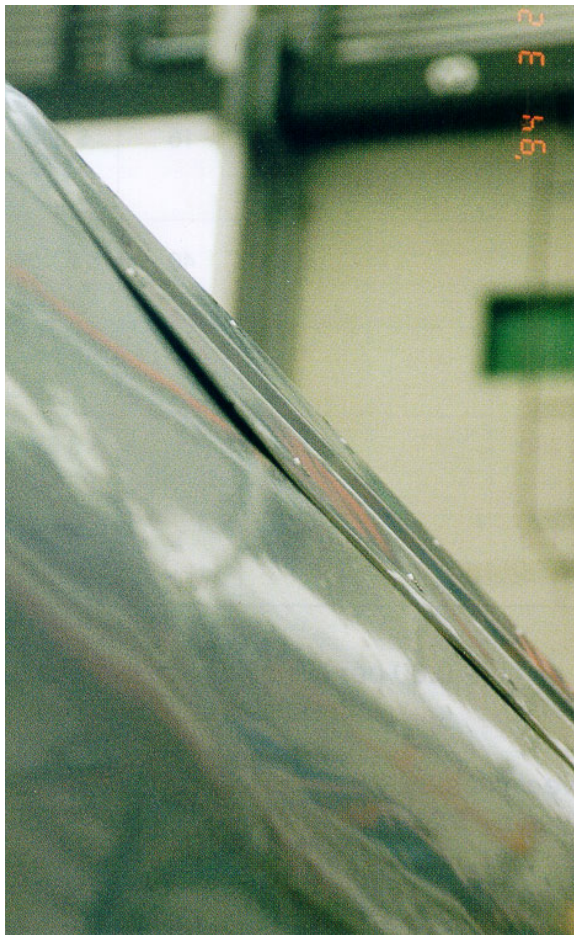
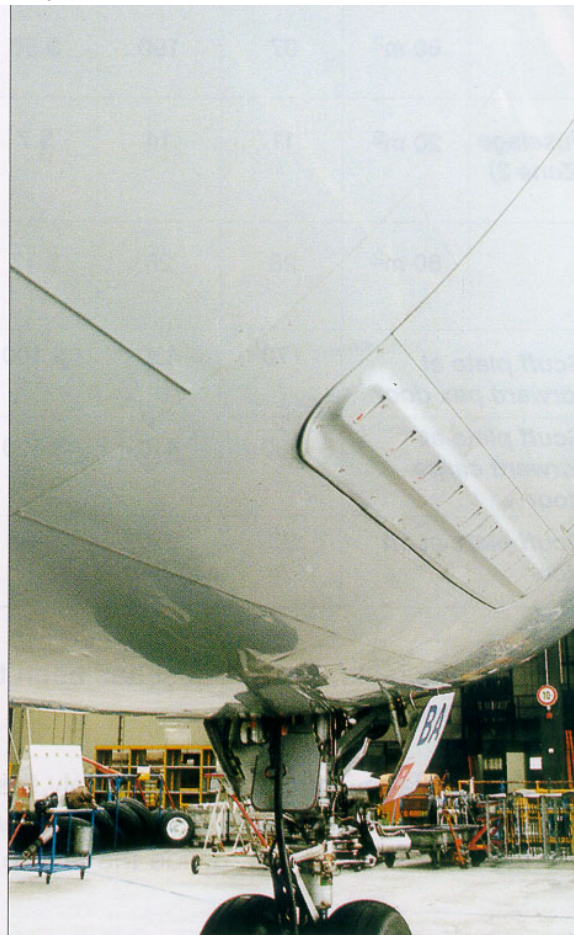
Dented scuff plates

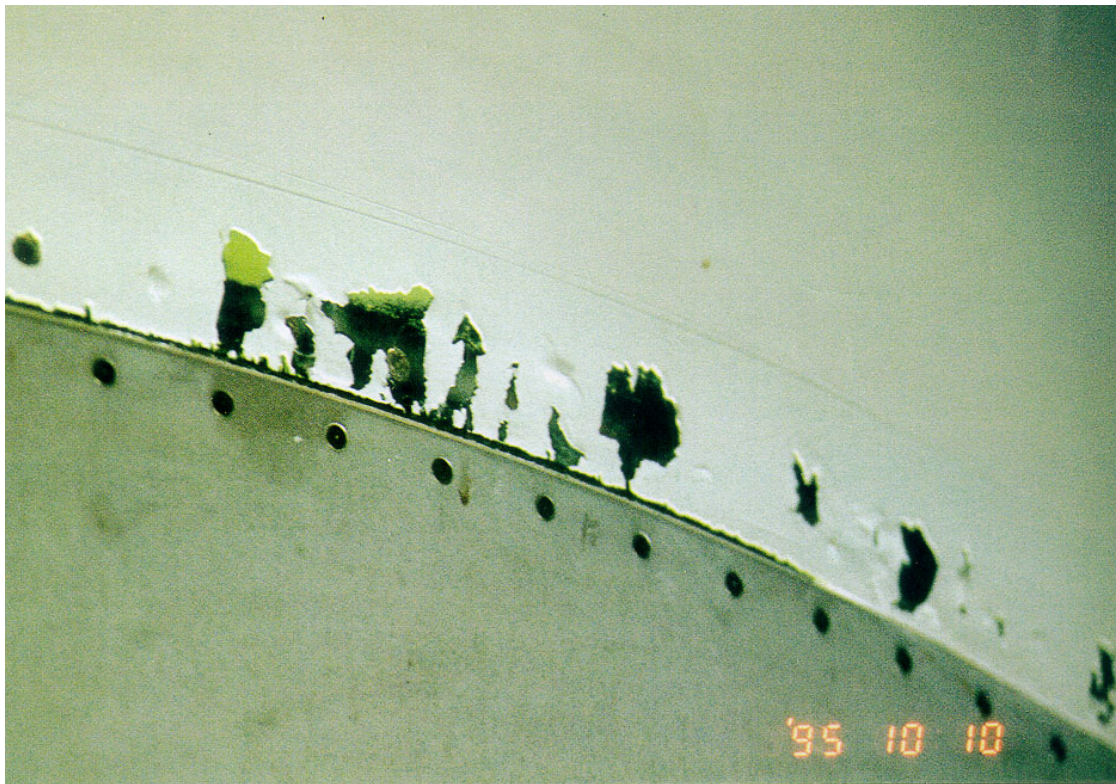
Paint peeling
